Development of the Port of Baku
Port Master Plan
Civil Engineering Assessment
Phase III Report, Vol IV
21 March 1997

Civil Engineering Assessment

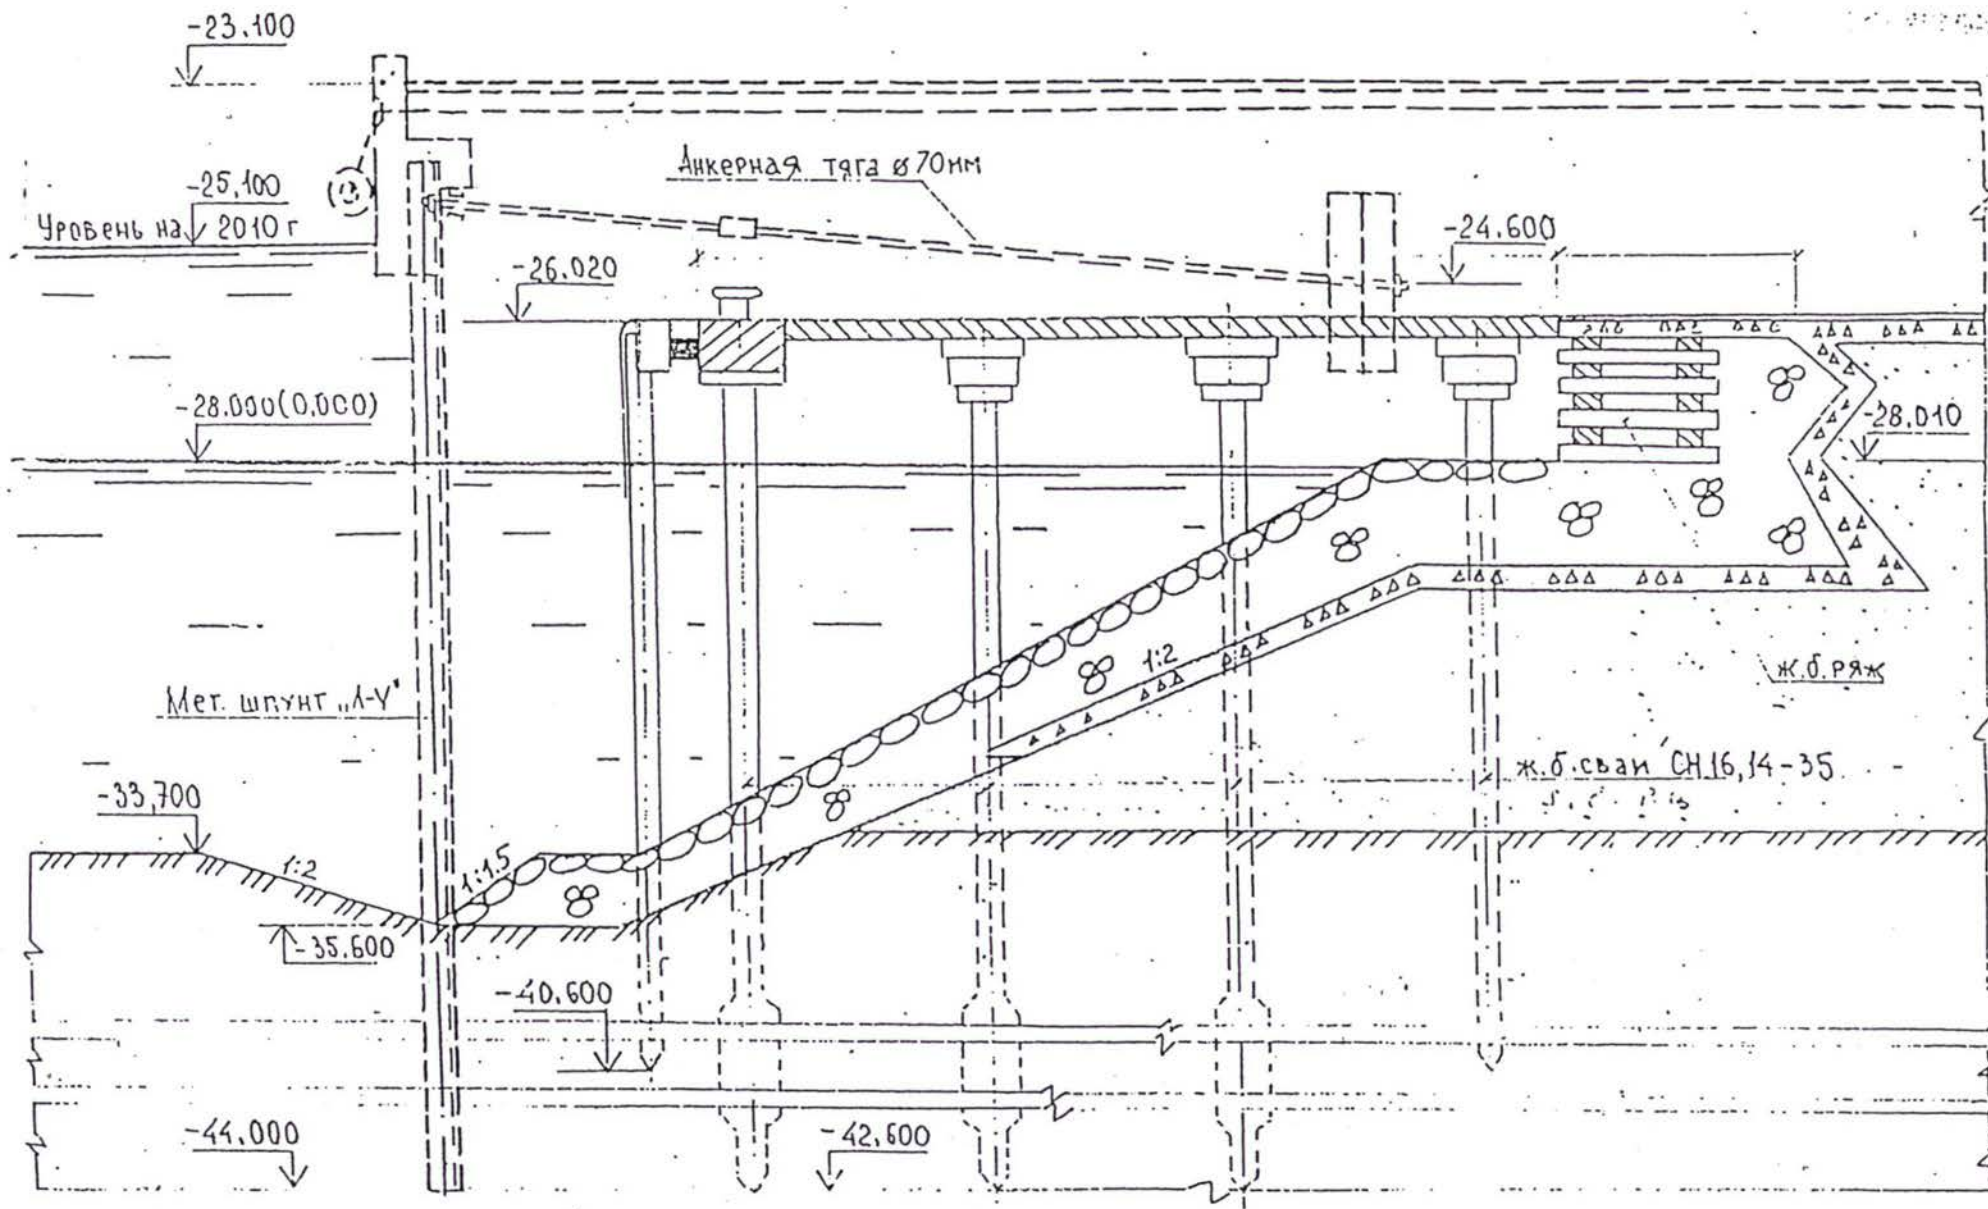
Fig 4.3 PLATFORMS NEAR SEA STATION

Fig 4.3 gives a typical cross section. It consists of a concrete platform on concrete piles. Under the platform, the slope is ballasted with stone. At the top of the slope, a grid of concrete beams, filled with stone, forms the barrier between shore and structure. According to the Kaspomniiproject report, the structure was build in 1969. The waterfront beam has been raised by some 50cm over nearly the complete length. This was for coping with over topping water caused by sea set-up and wave generation basically from winds from the South. This structure consists of three perpendicular sections with a length of respectively 98m, 55m and 112m west and east of the passenger jetty and 40m. At the first section an old ferry boat is berthed on semi-permanent basis. The middle part is not used as berthing facility. The last part of 45m is sometimes used as berth for small harbour vessels. The fendering vanished and was replaced here and there by old tires. The surface is asphalted.

The concrete beam at the waterfront shows deteriorated concrete and uncovered reinforcing steel at several places. The fendering vanished and was replaced here and there by old tires at the places where ships are berthed.

The asphalted surface is satisfactory and has been repaired when needed.

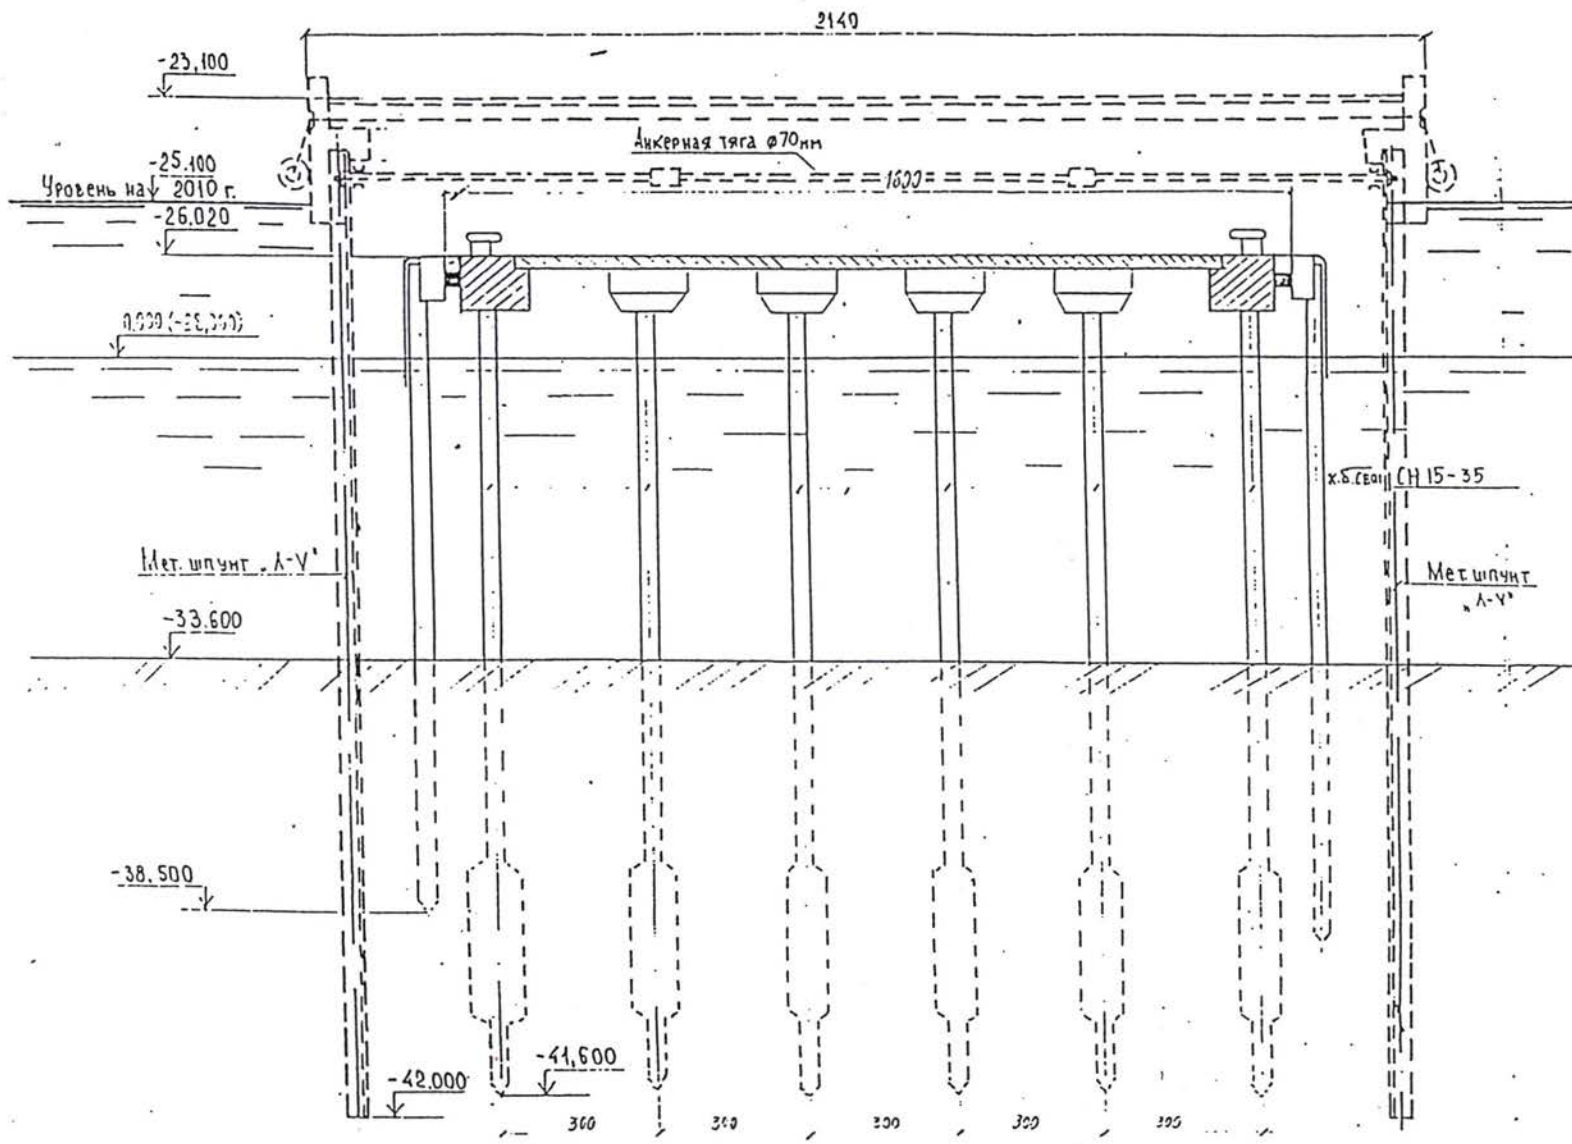
Fig 4.4 PASSENGERS PIER

Fig 4.4 gives a typical cross section of this concrete platform on concrete piles. The pier is 16m wide and 128m long. The structure is reported to date from 1969. The fendering system has not survived and has been replaced mainly by old tires. The waterfront beam has been raised with different heights according to the local sea attack. The passenger vessels other than the mixed ferries berth at this pier. The pier is not equipped with handling gear and no crane rails are installed. The surface is asphalted.

The fendering system has not survived and has been replaced mainly by old tires.

The limited distance between the water level and the waterfront beam does not allow easy berthing. Some vessels that berth here have a ship's fender at the level of the main deck or just below. In normal berthing conditions, this beam should thrust against the fendering system of the pier. However, presently, the ship's fender is well above the platform of the pier and above its topping beam. As a result of the vessel's movement the ship's fender collides with the top of the concrete beam, resulting in the deterioration of the latter. The concrete beam at the waterfront shows deteriorated concrete and unprotected reinforcing steel at several places.

The surface of the pier is in satisfactory condition. It consists of an asphalted cover above the concrete deck.

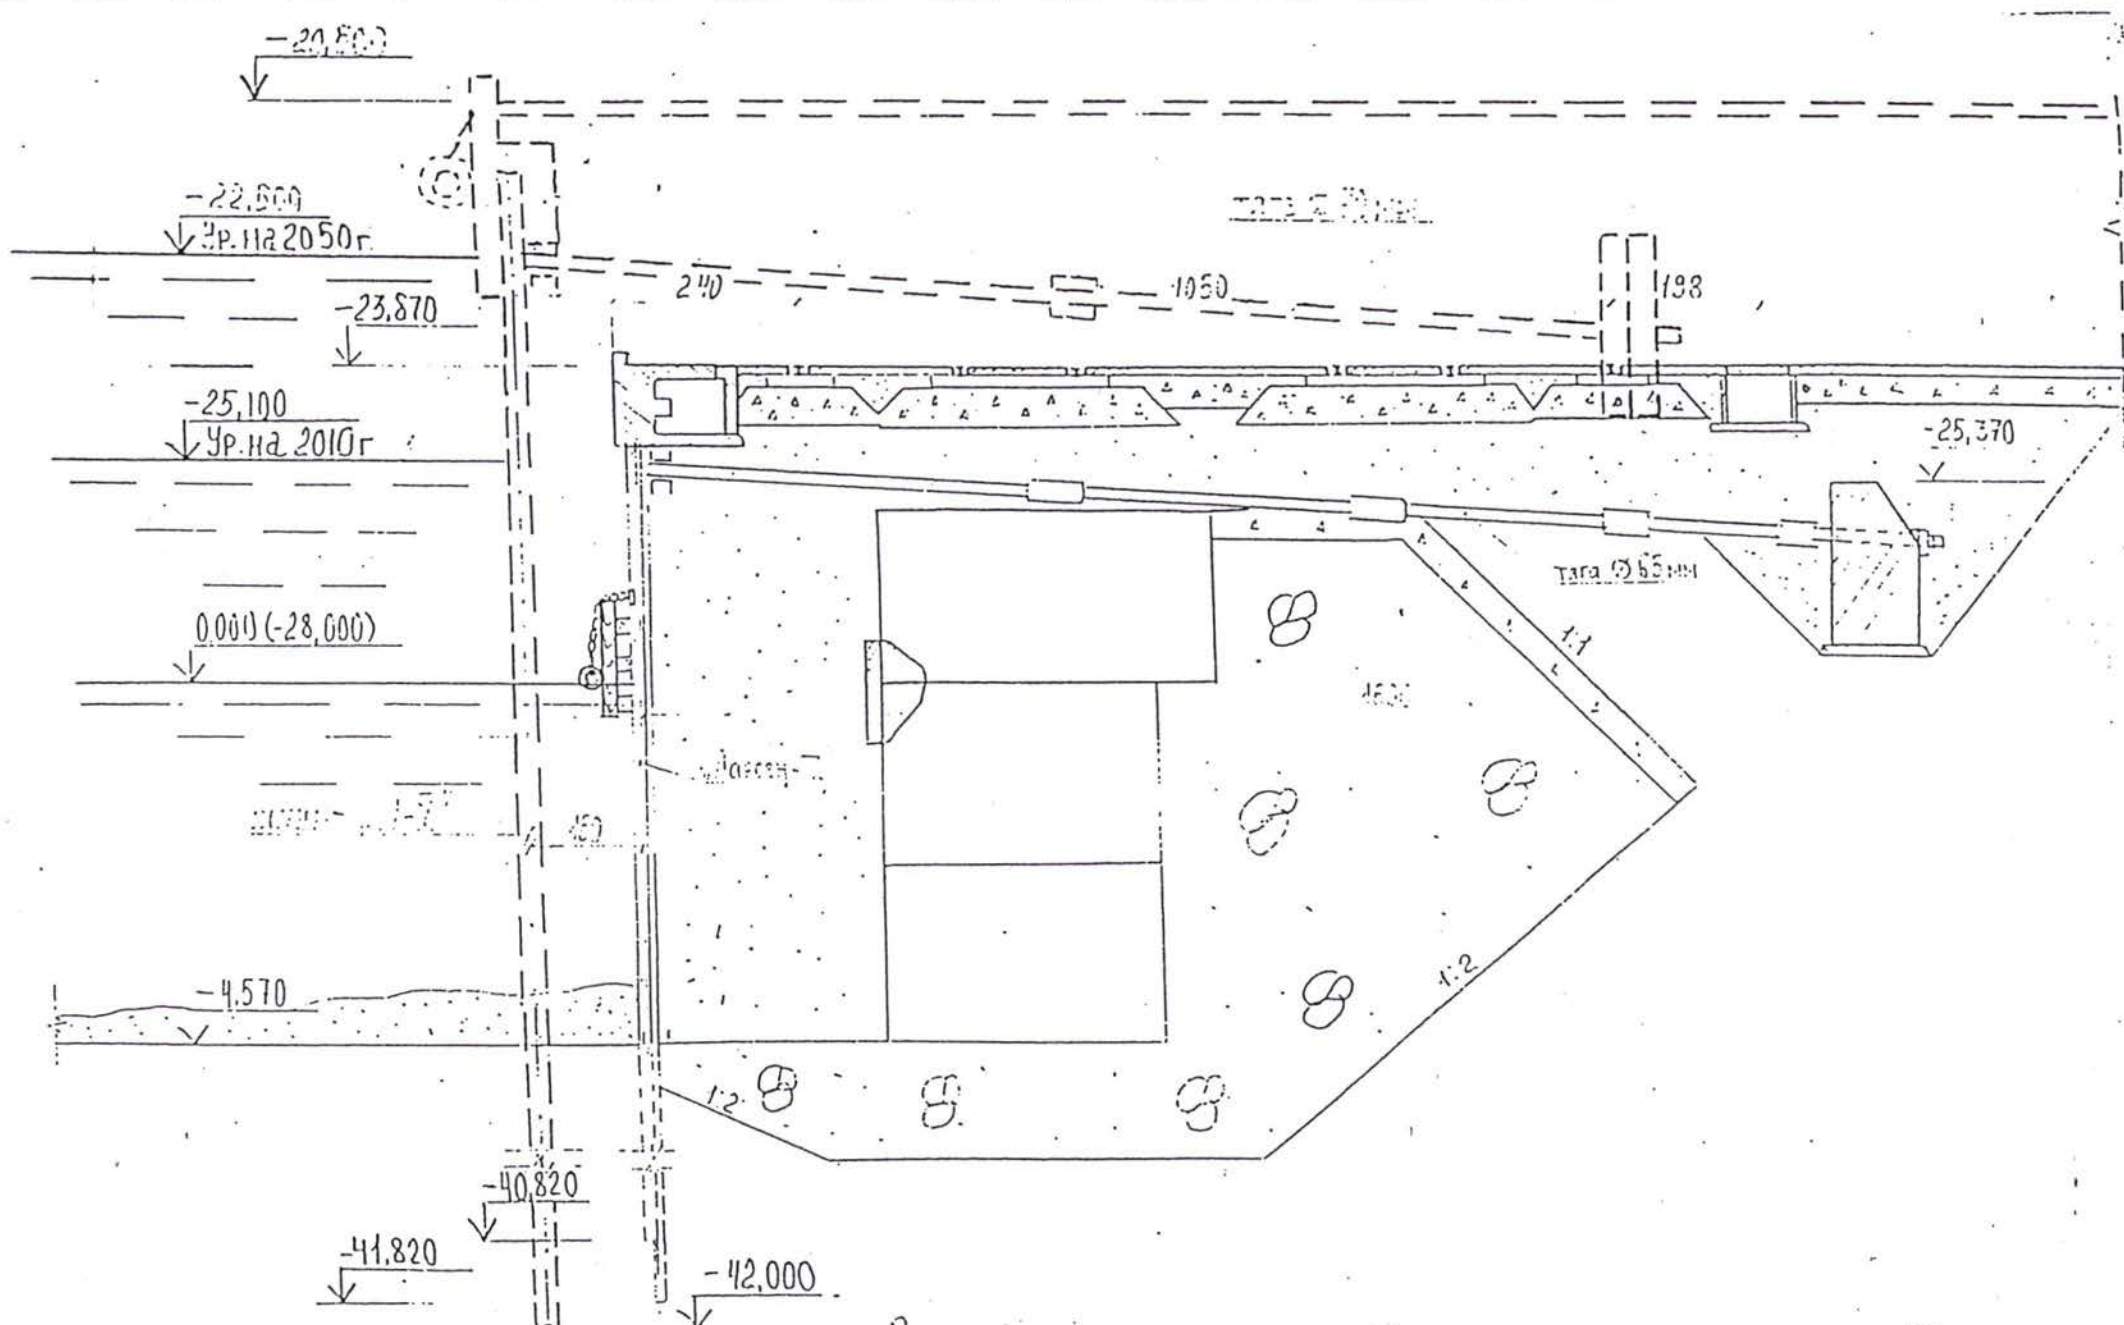
Рис. 4.5 Основной комплекс Западной и Южной Причалов
 Fig 4.5 MAIN COMPLEX WESTERN AND SOUTHERN QUAYS

An inspection of the water side of the quays showed that difficulties have been encountered in keeping the long stretches of sheet pile vertical during placing. This resulted in the need to insert at certain places wedge shaped piles or other devices for redressing the verticality. These places prove to be problematic. At these places backfill has washed out, creating craters in the apron. The port tries to repair these weak spots when they become visible. Also the connection of the sheet pile structure with the block wall has given problems and has given rise to mayor repairs.

Apart from these structural weaknesses, the port engineer reports that the unprotected sheet piles have corroded significantly over a height of several meters. During the last 20 years, the splash zone was situated over a height of several meters due to the variation of the water level. The splash zone is known to be the favoured zone for fast corrosion, especially when no protection devices are in place. The Chief engineer reports that at regular times, backfill has washed out through corrosion holes that are located well under the present water level. Regular interventions are needed to keep the quays operational.

The concrete beam above the sheet piles shows considerable deterioration and unprotected reinforcing steel. This can partly be explained by the absence of an adequate fendering system and partly by unsatisfactory quality of the reinforced concrete and care and quality control during execution.

The apron is equipped with crane rails, train rails, a drainage system and culverts for water supply, power distribution, etc. The drainage system and the culvert at the waterfront are not in very good condition. This can be explained by the weakness of the sheet pile structure and the regular repairs it needs. The apron level is at -23.87, the bottom of the culvert at -24.97 and the drainage system at -25.35. Hence, these facilities have not been below the sea level since there construction.

The sheet pile structure is not in good condition. At regular intervals repairs are needed. A major renovation of the quays is needed in order to upgrade them to reliable berths. This renovation should include the construction of a good fendering system that can be adapted according to variations of the sea level.

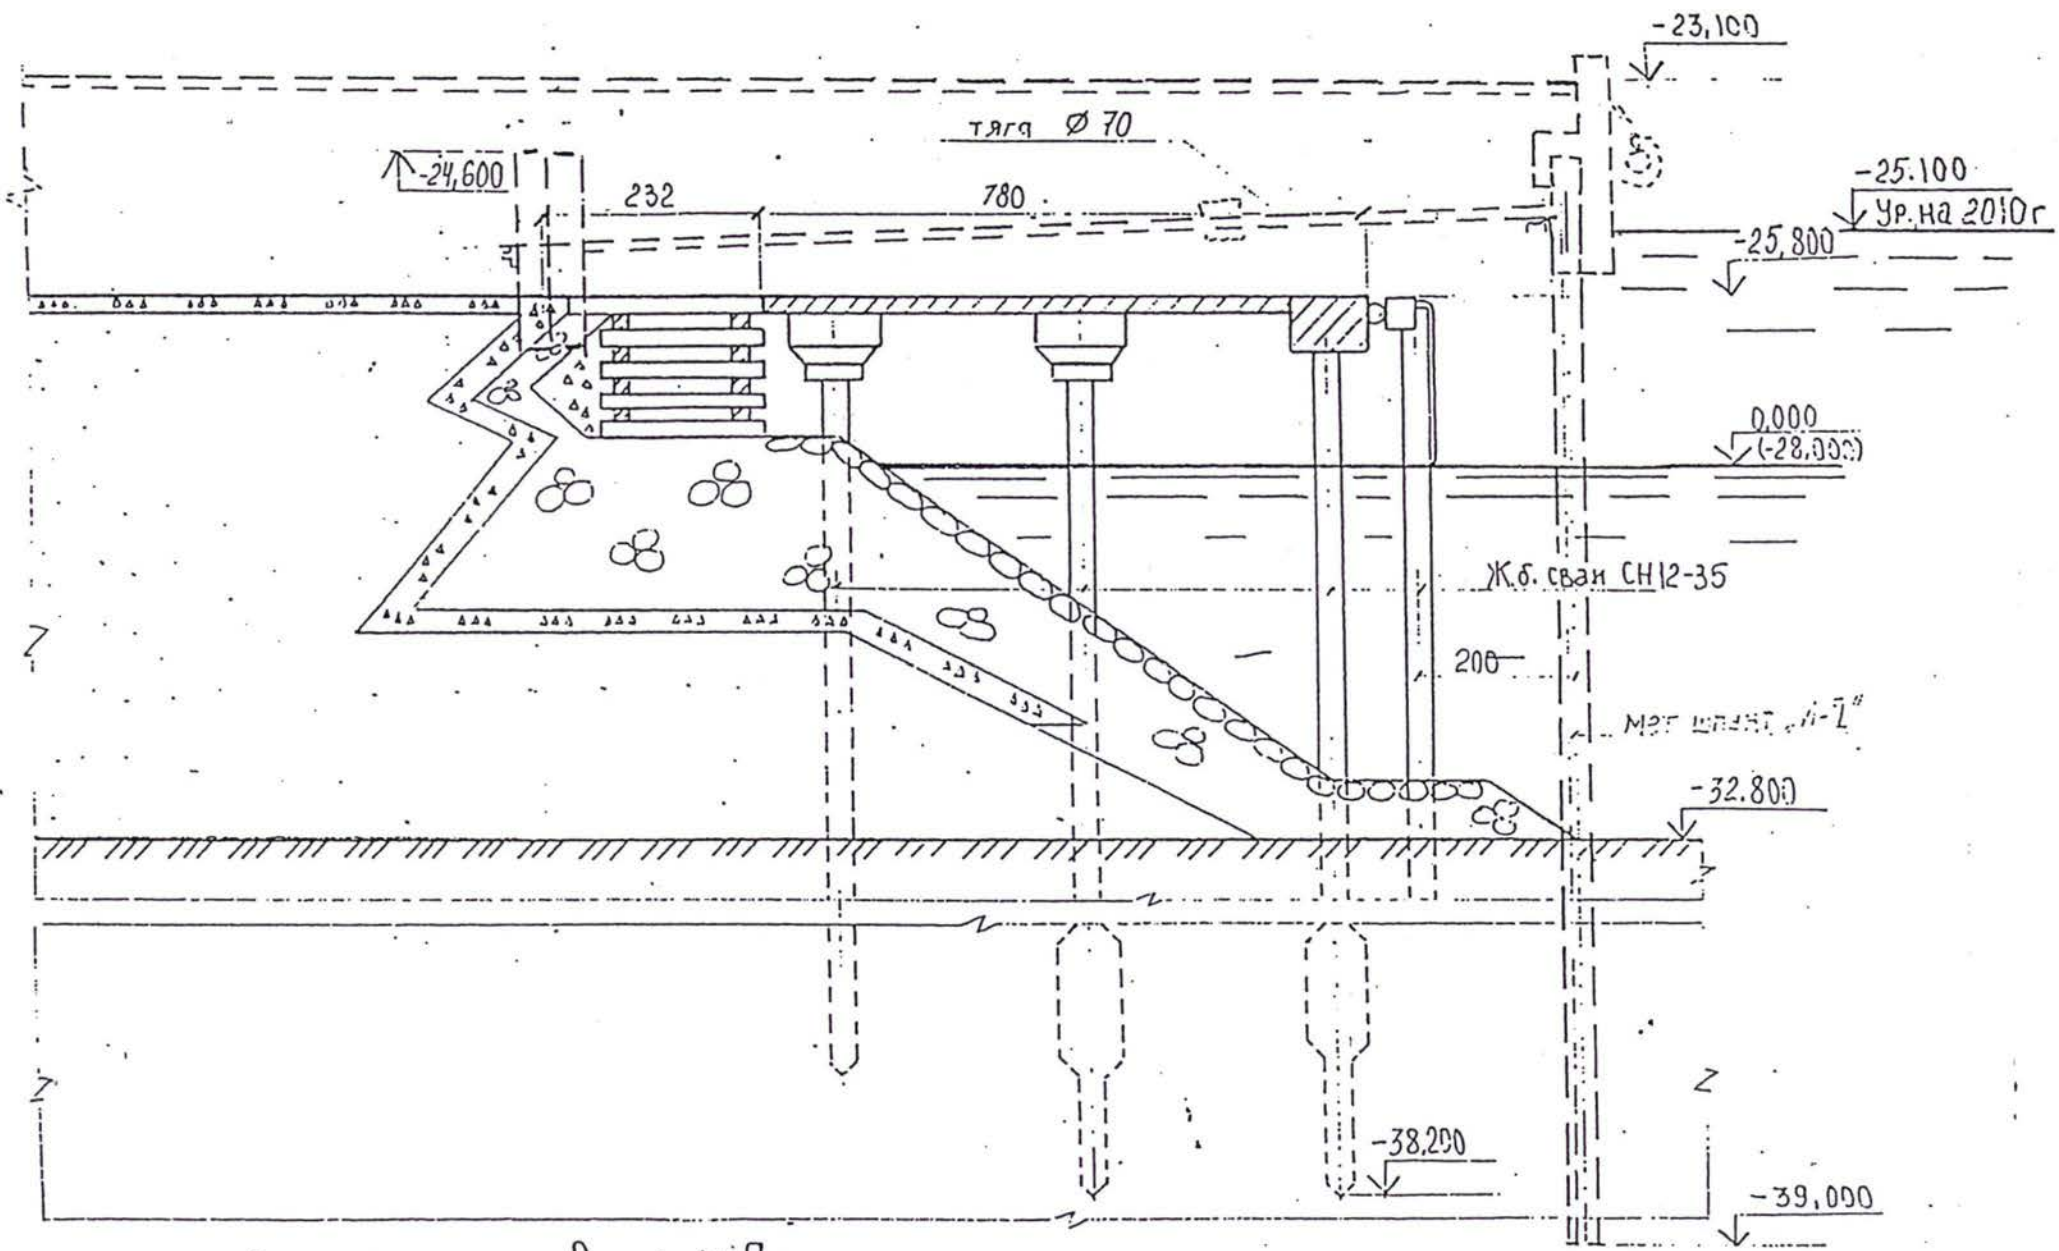
Рис. 4.12 Причал порта флота
 Fig 4.12 QUAY FOR PORT FLEET

Fig 4.12 gives a typical cross section of this quay construction, as incorporated in the Kaspomniiproject rehabilitation report of 1991. The quay is built in two straight sections. They are some 100m and 30m long. The earth platform between the berth and the sea is less wide than fig 4.12 might suggest. It is reported to be constructed in 1968. No cross section of the seawards slope protection could be traced. As elsewhere, the fendering has vanished and has been replaced by old tires. The earth platform and slope protection form a break-water structure that protects the enclosed water area against the waves coming from the South.

This quay has been damaged at places by ship collisions. Some major repair work to the concrete structure is needed.

The surface of the platform is asphalted and is in a reasonably good condition.

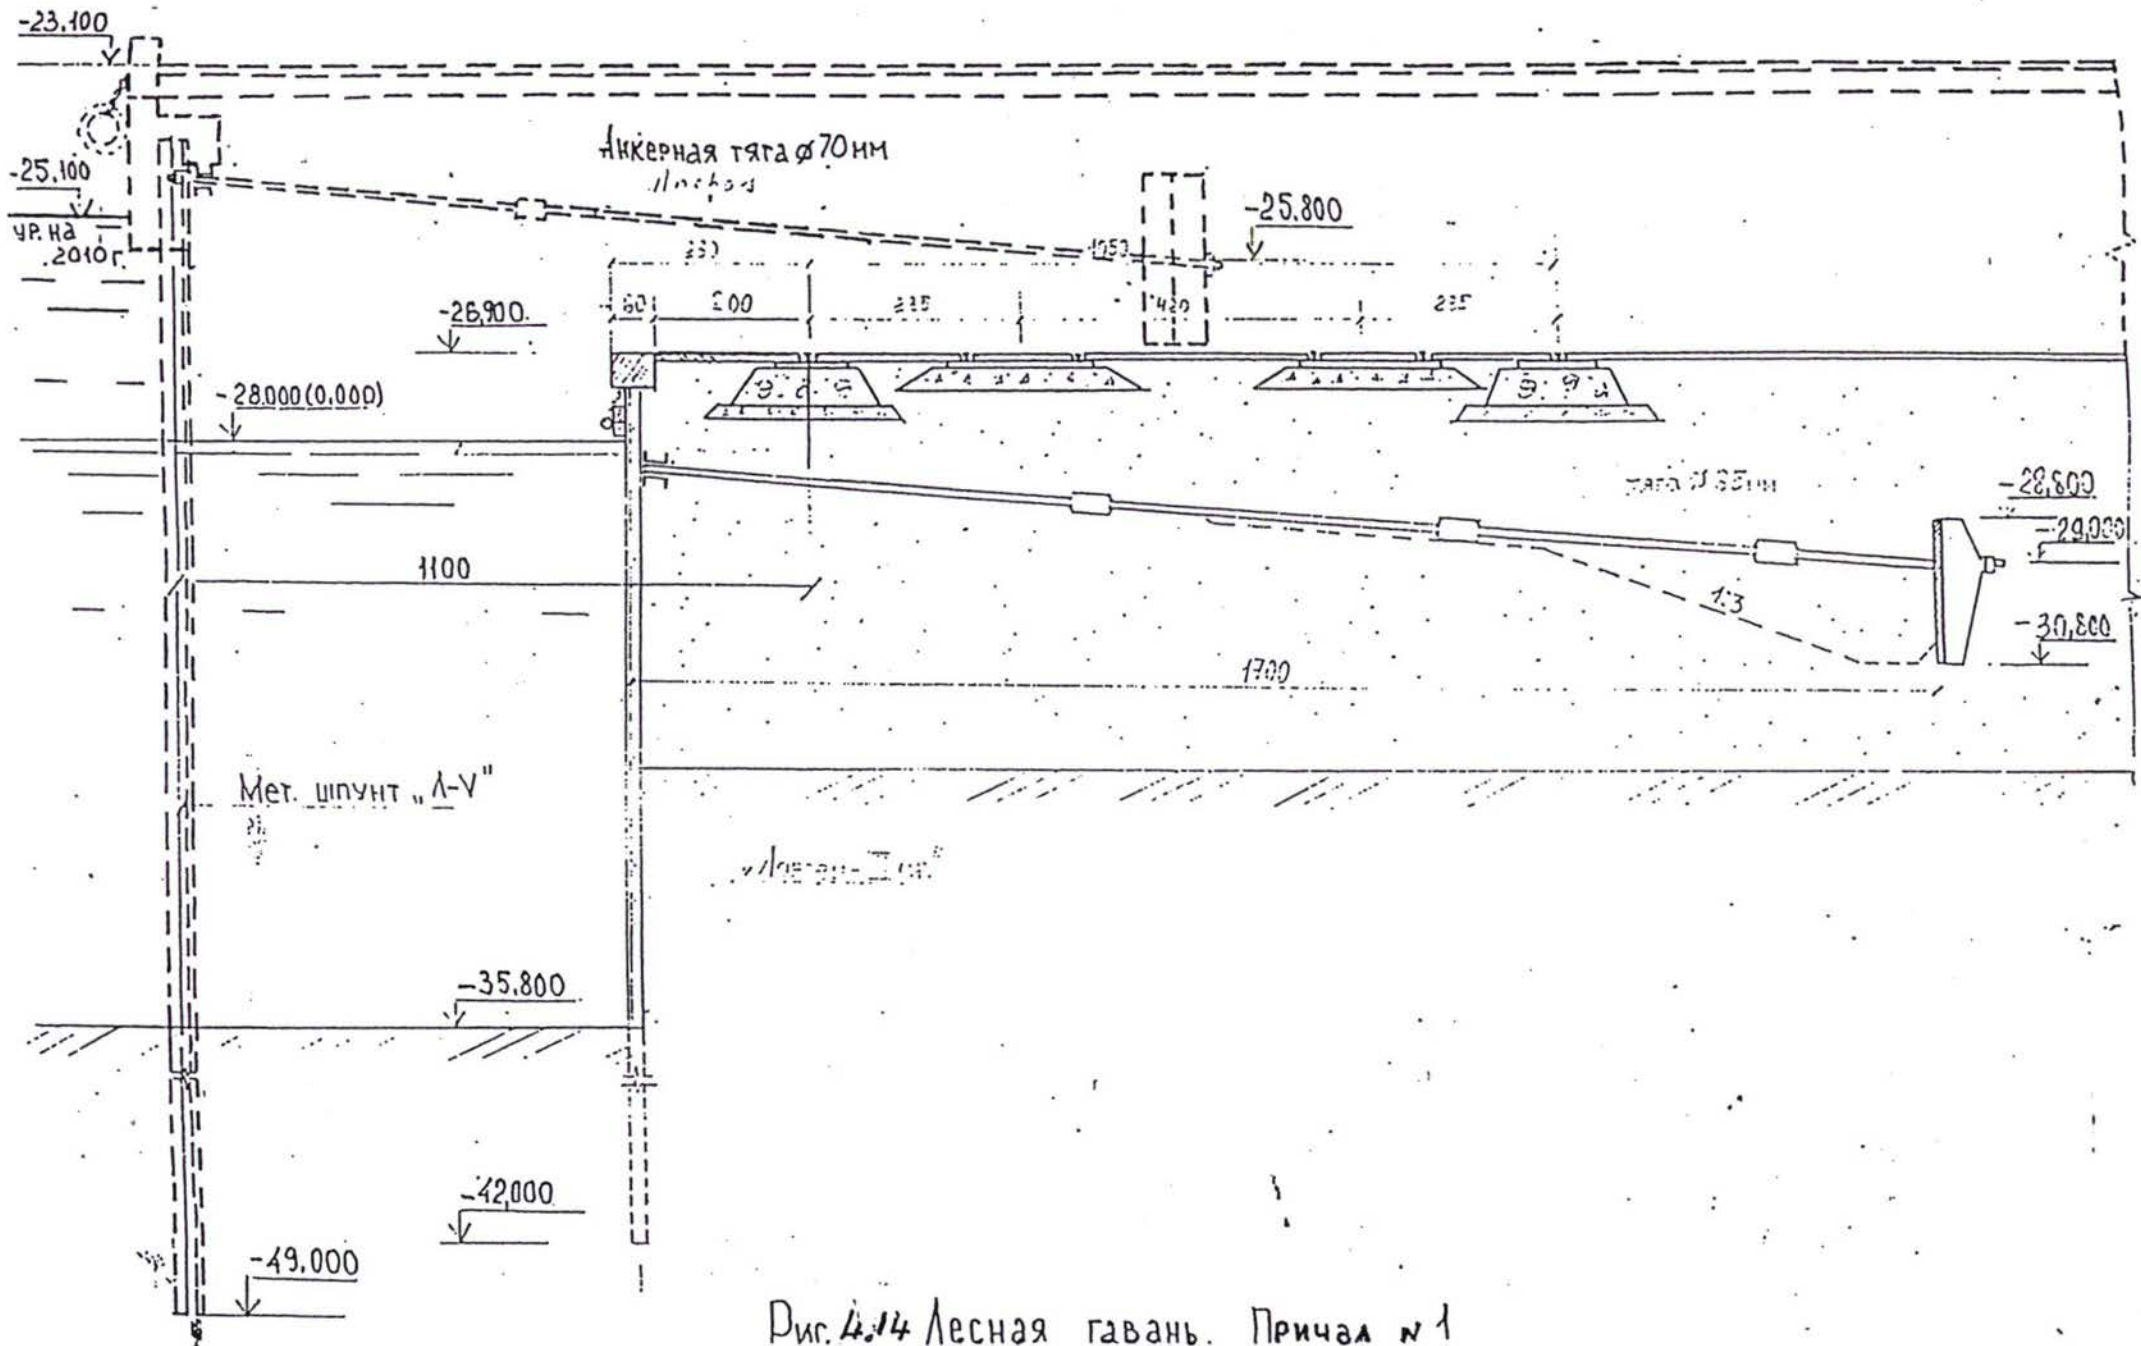
Рис. 4.14 Лесная гавань. Причал № 1
 Fig 4.14 TIMBER TERMINAL BERTH NR 1

The location of berths 1,2 and 3 are indicated on fig 4.13. The first berth is 97m long and was constructed in 1957. It consists of an anchored sheet pile construction. Fig 4.14 gives a typical cross section. At places, the topping beam is completely destroyed. Only the surface is visible now. It looks like that considerable repair works will be needed to restore this berth into operational condition.

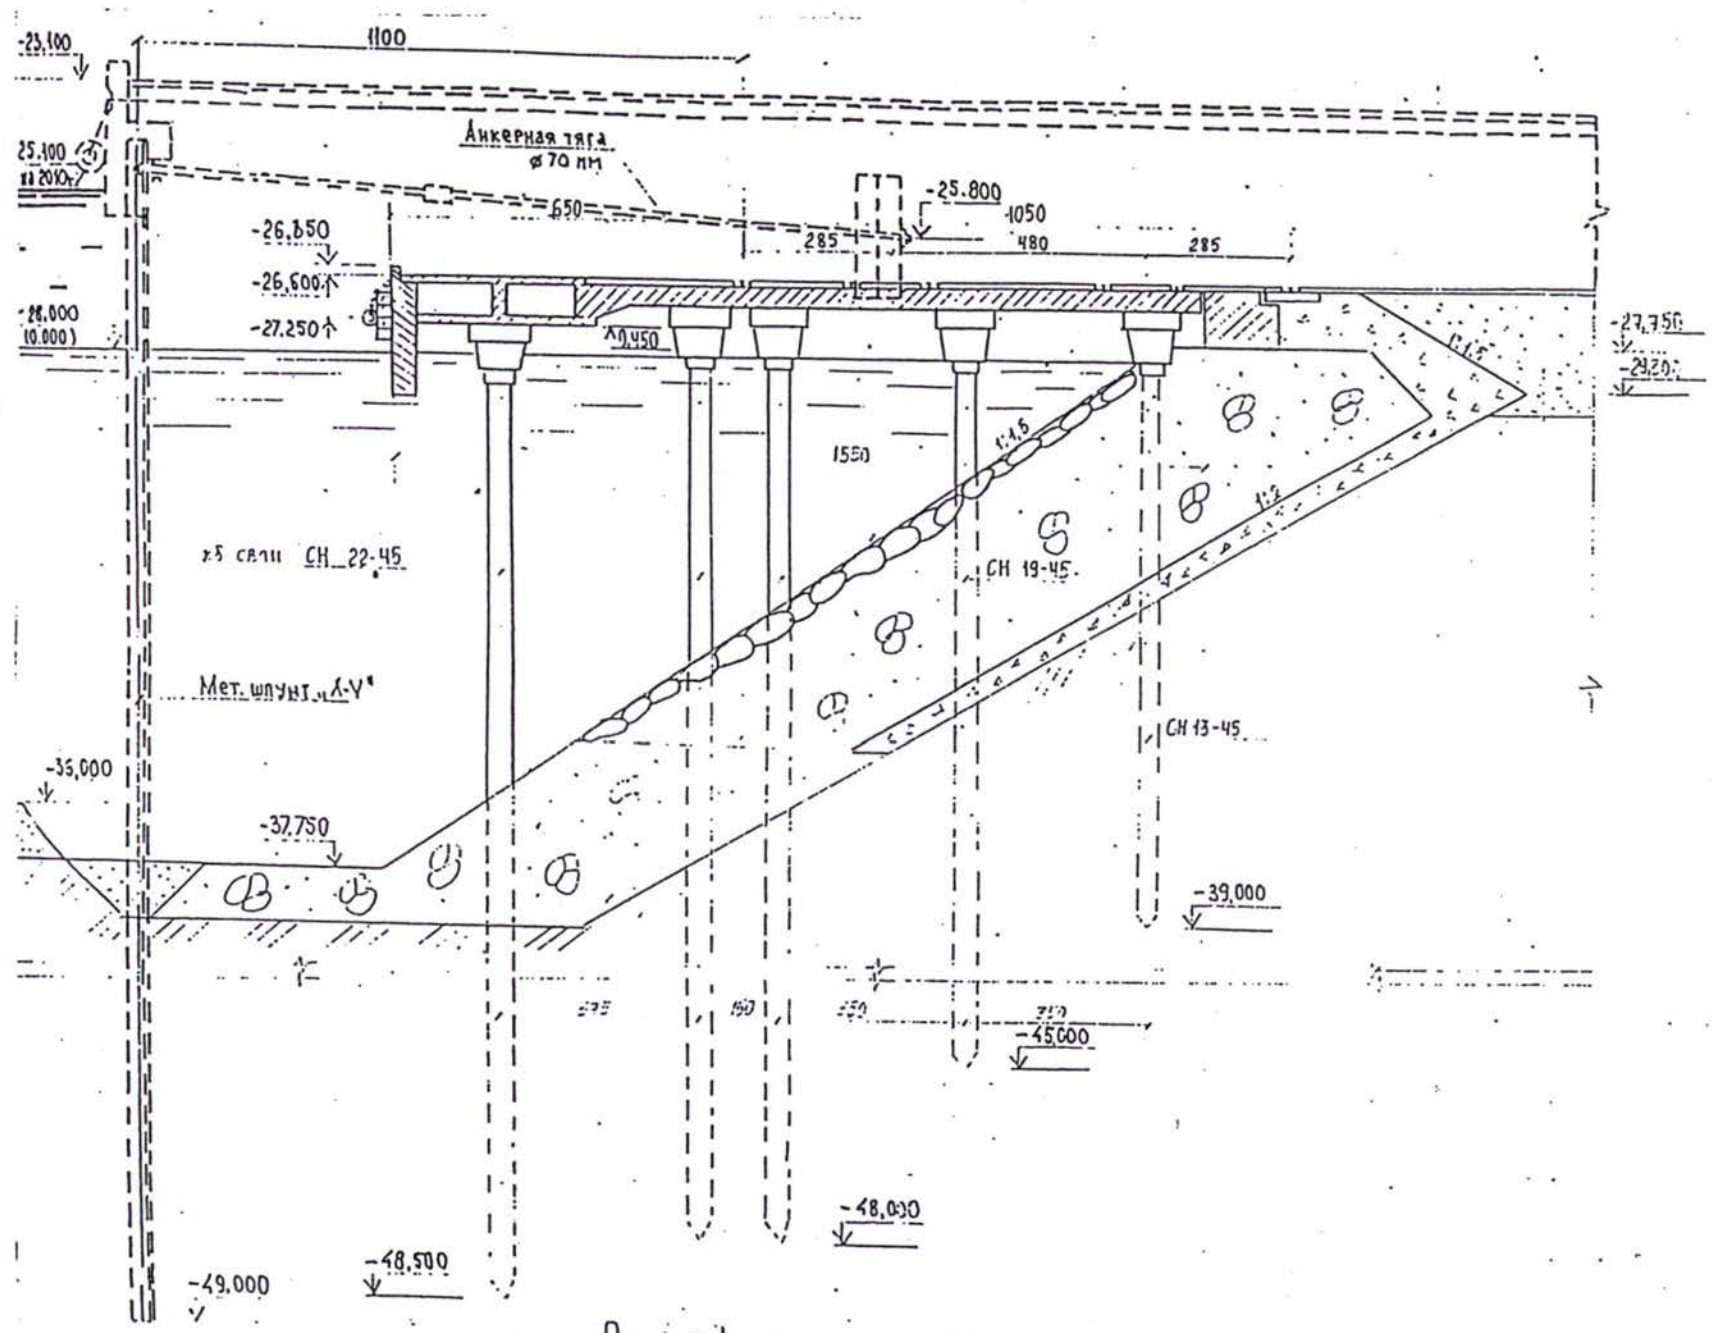
Рис. 4.15 Лесная гавань. Причалы 2, 3
 Fig 4.15 TIMBER TERMINAL BERTHS 2 and 3

The chief engineer's department reports that berth nr.2 was constructed in 1971. It consists of a concrete platform in piles. The slope under the platform is protected with stones. Fig 4.15 gives a cross-section of this berth 2 and of berth 3. Both are of the same design. Only the surface is visible now. It looks like that considerable repair works will be needed to restore nr.2 berth into operational condition.

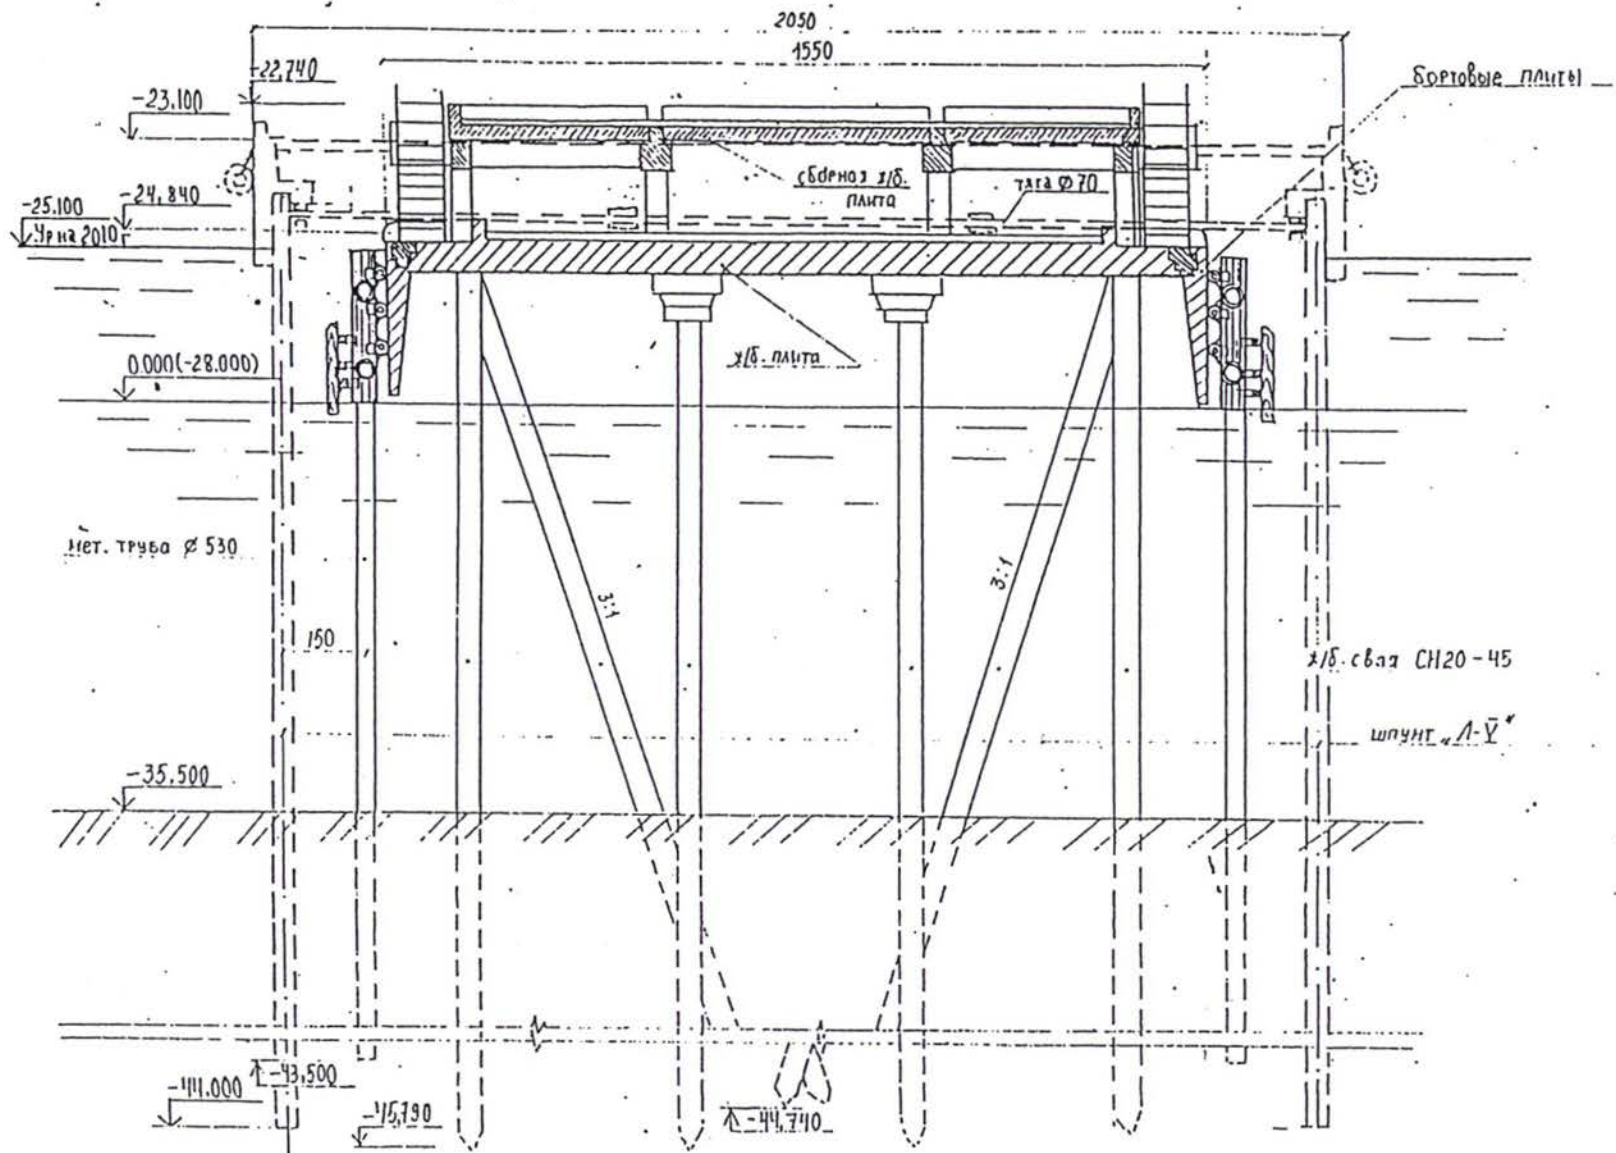
Поперечный разрез средней части пирсов 1, 2, 3 и 5
 Fig. 4.20 CROSS SECTION OF THE MIDDLE PART OF JETTIES 1, 2, 3 and 5

The jetties are founded on concrete piles and covered with concrete decks. The fender system is still in place.

The concrete parts of the jetties are in very poor condition, although it dates only from 1970. During construction, the basic rules of good workmanship have been neglected. No spacers between reinforcing bars and shuttering have been used. At places, it is visible that the reinforcement had no concrete cover from the very beginning. Some pile caps have not been placed vertically above the piles. Concrete quality is poor. At many places the concrete cracked and show the location of the reinforcement.

Apart from jetty 1, the pipes need de-rusting and painting. The pipe system of jetty 5 has been dismantled completely and the pipes of jetty 2 are partially dismantled.
