TRACECA - Project
Trade and Transport Sectors
Implementation of Pavement
Management Systems
Turkmenistan
Tedjen - Mary Road
Improvement
Engineering Report
November 1997

Volume I
Engineering and Implementation Proposals

KOCKS CONSULT GMBH
Consulting Engineers
Koblenz / Germany

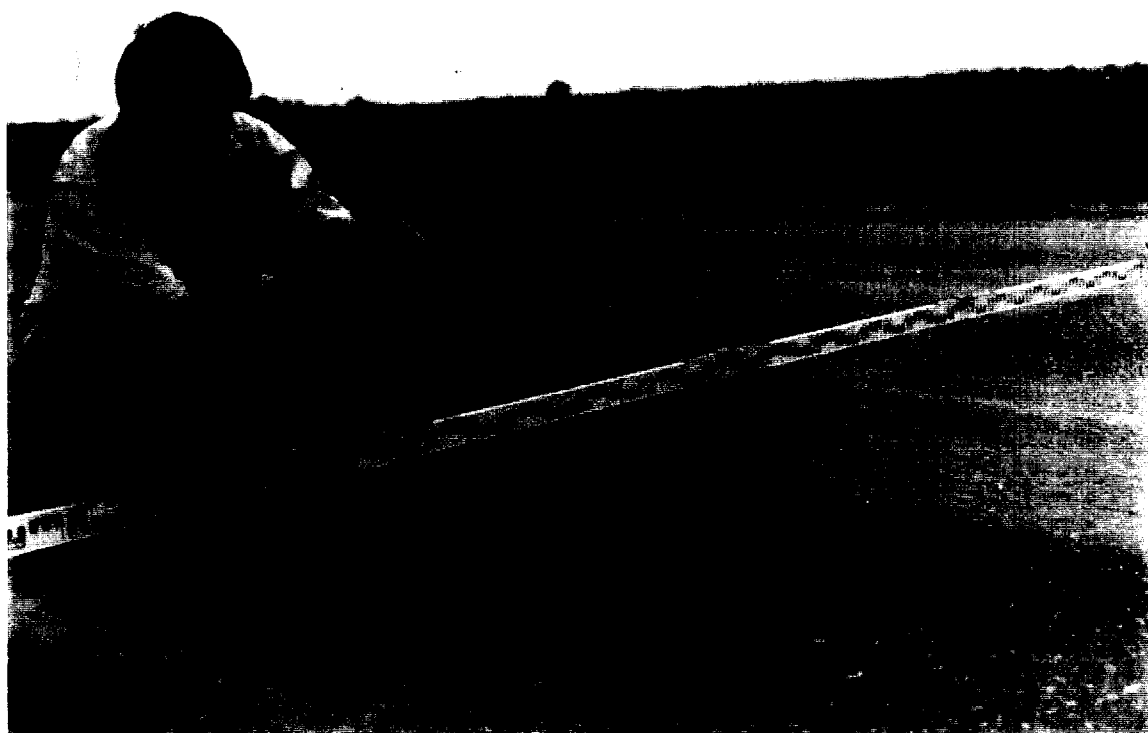
In particular, deformation of up to 180 mm are found, and several sections of the road are severely deformed. This is partly due to soft bitumen which is laid as cold mix, and also to insufficient stability of the base course and subbases, with insufficient grading and insufficient CBR values. Also, the bituminous mix is not well graded, but consists of river gravel with large and small size fractions only.

ТИПИЧНАЯ ДЕФОРМАЦИЯ ПОКРЫТИЯ
TYPICAL SURFACE DEFORMATIONS
