TRACECA Project
Trade Facilitation (TNREG 9308)
Customs Border Post
Report - Appendix 1
October 1996

Surface Transport Customs Control Points

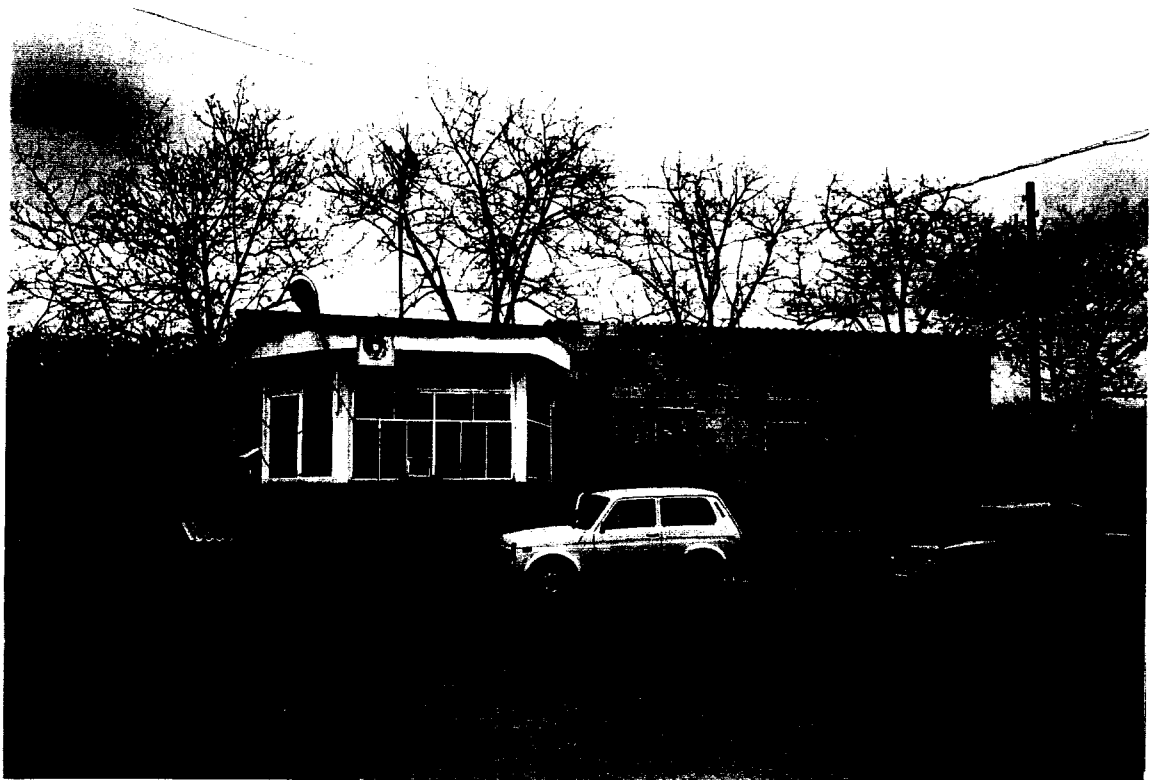
ARMENIA - Bagratashen

Buildings No and Condition: Single separate office rented from Armenian Railways.

Adjacent Rail Conditions: Track appears in working condition.

Office Equipment: None.
Data Processing: None.
Communication Equipment: Telephone broken . Use radio.
Power: Not reliable. Have installed battery system.
Control /Detecting Equipment: Metal detectors only (for passenger work).

Location:	Adequate.
Infrastructure:	Lack of own office is considered by local staff to be detrimental as in poor condition with unreliable power supply.
Human Resources:	Adequate.
Equipment:	No equipment with particular problem of inability to copy railway consignment notes.
Procedures:	None.
Performance:	Whilst clearance times are adequate, trains can be delayed by 2-7 days because of problems within the rail network.
Other:	None.

- 1) Improvements in office facilities by either refurbishing existing offices, based on long term lease arrangement or provision of own facilities.
- 2) Provision of office equipment, especially copier, telephone and possibly a fax.

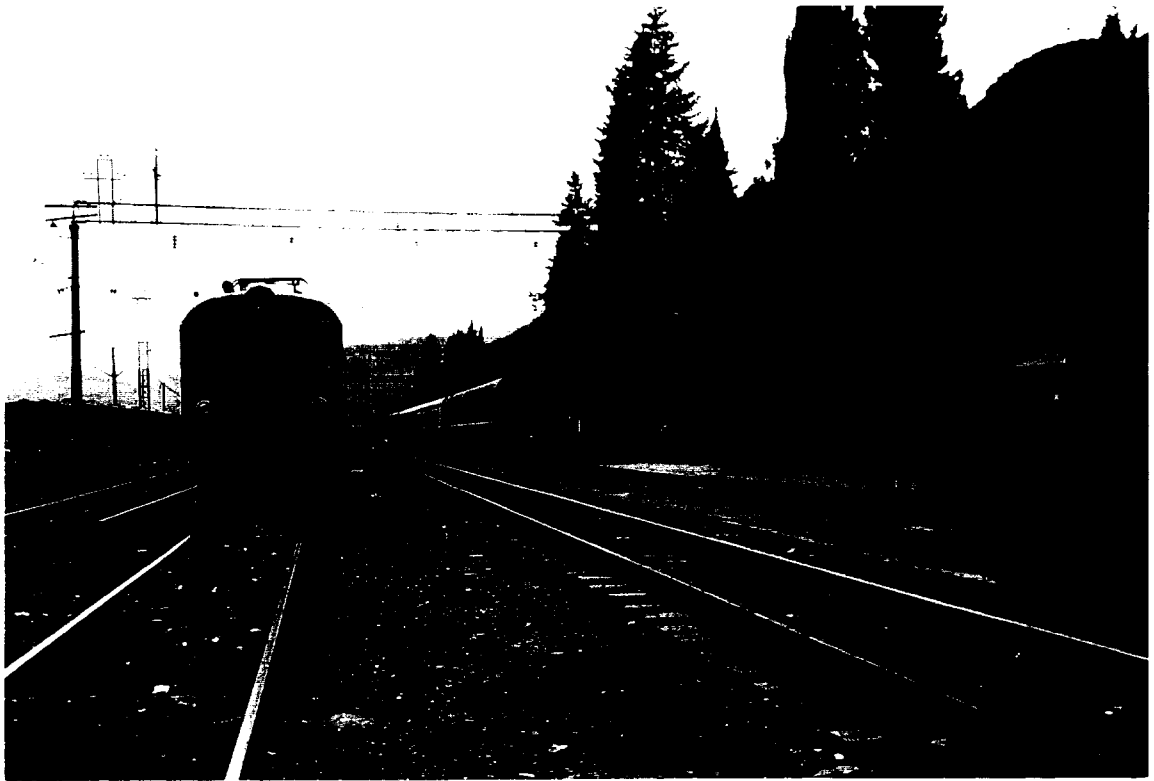
ARMENIA - Ayrum

Buildings No and Condition: Single temporary building in poor condition.

Site Access: Road from Vanadzor includes 2km tunnel and road in variable condition with surface damage. It is very exposed in winter, so subject to temporary closure in bad weather.

Adjacent Road Conditions: Road passable with care but potholing and loss of surfacing. Conditions on the Georgian side are more difficult, with steep narrow mountain roads.

- 1) Provision of new border facilities with office and communication equipment.
- 2) Some hostel facilities requested for stranded drivers in winter.

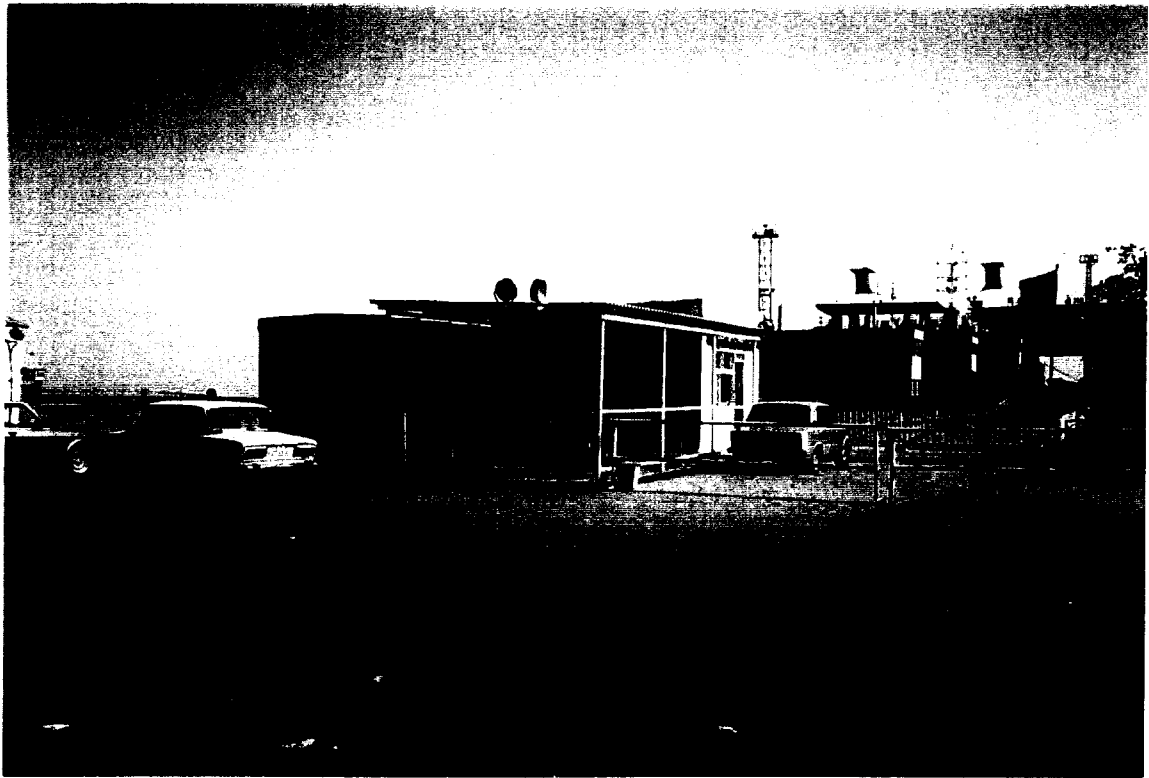
AZERBAIJAN - Baku

Buildings No and Condition: Single building with 4 rooms and hallway including canteen and rest room. Structure in moderate condition.

Adjacent Road/Rail Conditions: Road from Baku in reasonable condition.

- 1) Provision of more modern office facilities or up-grading of the existing structure.
- 2) Supply of improved communications with telephone communication to Baku and regional offices.
- 3) Provision of additional detection equipment.
- 4) Supply of portable generator for winter usage.

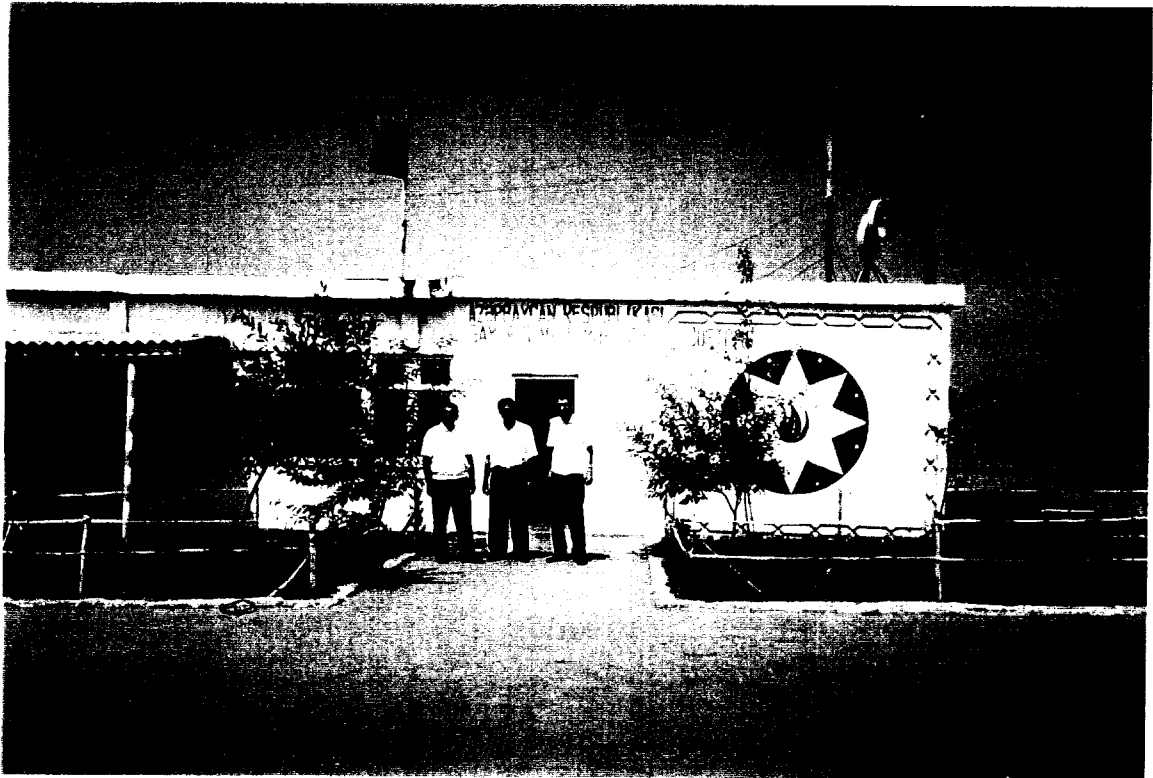
AZERBAIJAN - Samur

General Description:	Main rail border to the north. Indications were that this border is technically closed due to conflict in Chetchnia. Current movements have dropped from ten trains per day to only one but limited traffic is still moving despite the problems.
Buildings No and Condition:	Temporary building with 2 rooms positioned at end of passenger platform. Office in poor condition.
Parking Areas:	Adequate sidings.
Site Access:	Reasonable along platform on station.
Site Security:	Provided by Border Guard.
Adjacent Road/Rail Conditions:	Rail network indicated as being in reasonable order but some infrastructure problems resulting in speed limits.
Bonded Warehousing:	None.

Location:	Adequate, but remote position at end of platform.
Infrastructure:	Building in poor condition.
Human Resources:	Adequate.
Equipment:	Shortage of technical equipment, particularly communications and detection.
Procedures:	Adequate.
Performance:	Adequate.
Other:	Public access to sidings presents cargo security concerns.

- 1) Provision of a modern office building or unit.
- 2) Supply of an improved communication system.
- 3) Provision of additional detection equipment.
- 4) Supply of a printer for computer.
