TRACECA - Project
Rail Maintenance Central Asia:
Infrastructure (TNREG 9310)

**Traffic Census on the Pontoon Bridge
near Chardzhev (Turkmenistan)
July and August 1996**

Report about the Results

**Deutsche Eisenbahn-Consulting GmbH
Regional Department Europe/ CIS/Mediterranean**

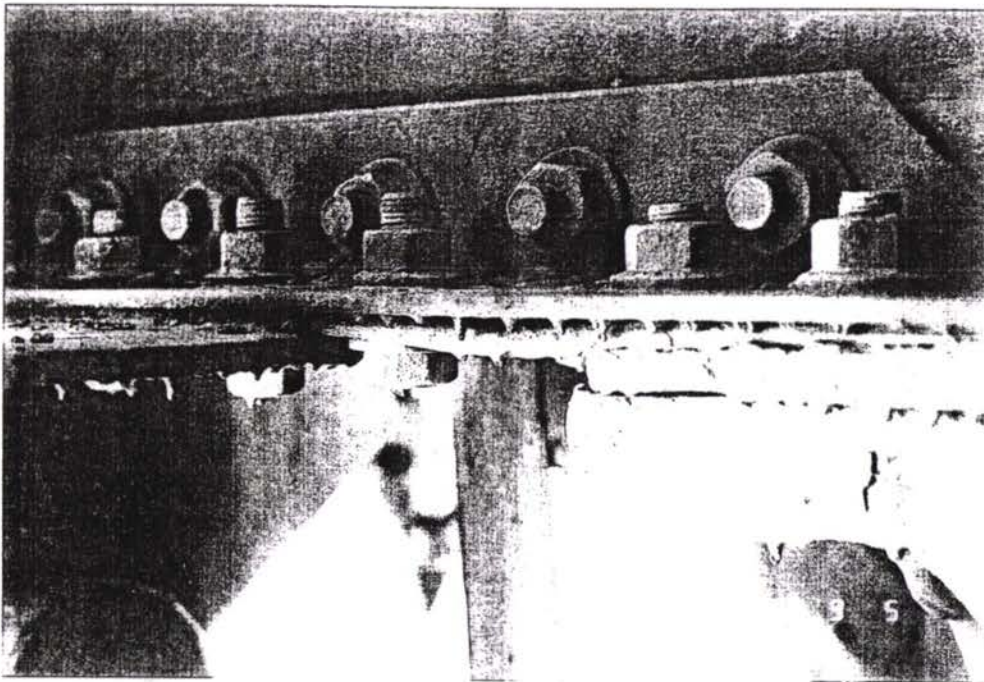
Strengthening of some structure elements (as the connection longitudinal to cross girder) is executed with angles which are bolted or with welded bars and gussets (photo F1-11 to -13). Such action evidently should improve defects as warping or torsion of angles or plates (photo F1-11).

F1-11 Span 3
Cross girder strengthening, as per 80%
of all cross girders

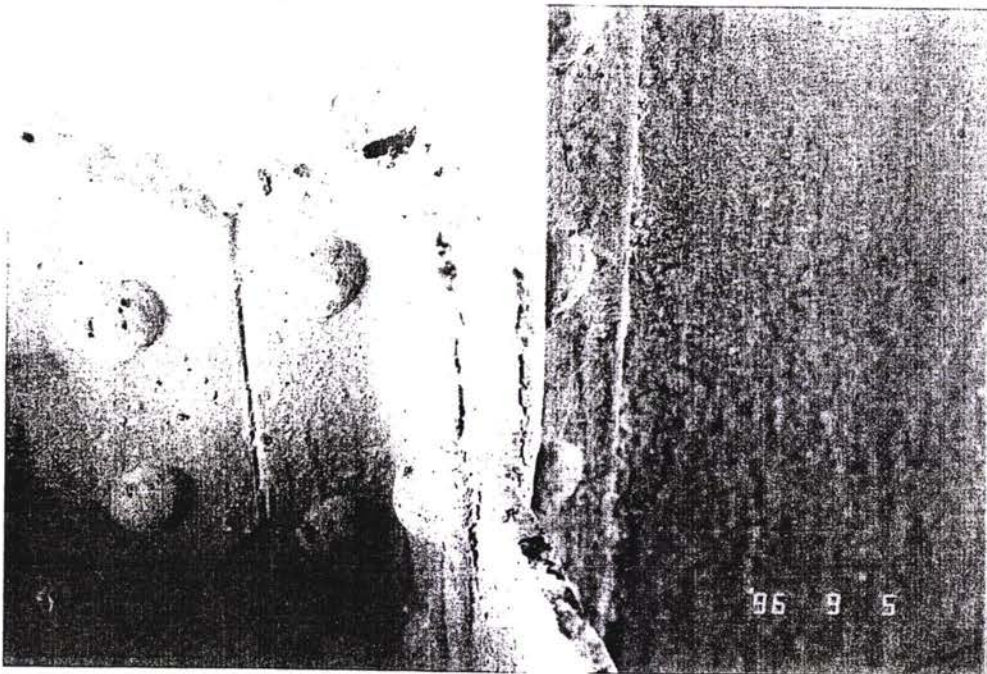
F1-21 Span 3
Corroded longitud.
girder

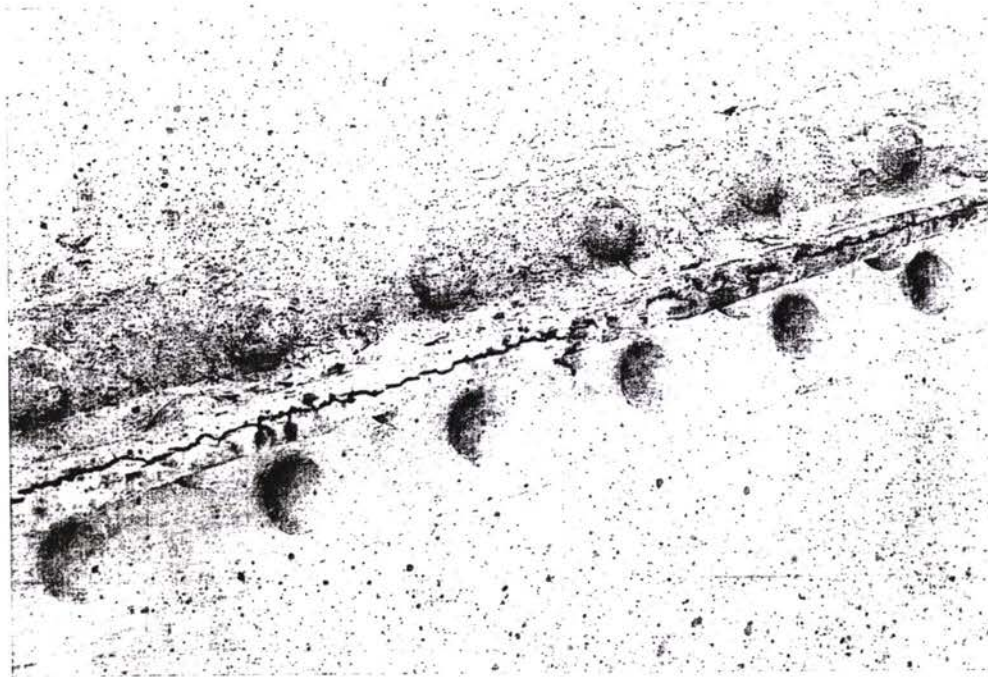
F1-25 Span 3
UC joint to cross
bracing

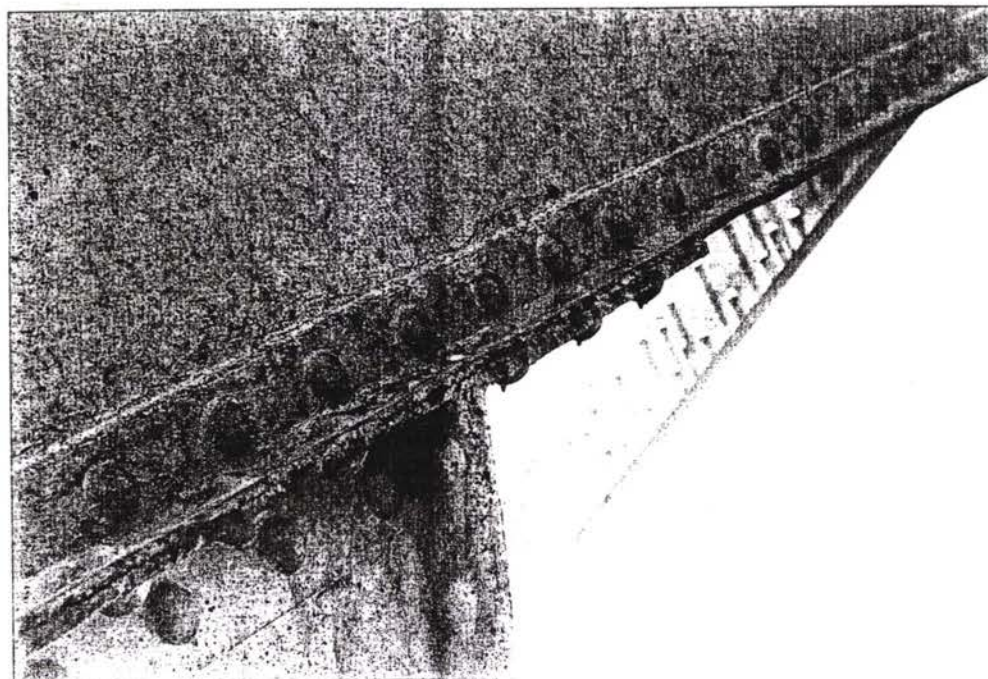
Very frequent signs of corrosion can be seen (except of the UC which is in good state but coating is full of cracks): photo F1-09, -10, -26 to -29, F2-01. The present painting consists of a special grout of unknown consistency and is full of cracks and not very resistible. Behind this coating very often the steel is rusty. Sometimes the special grout or cement is used to fill wide gaps (photo F1-22).

F1-26 Span 3
UC strengthening
angle corrosion

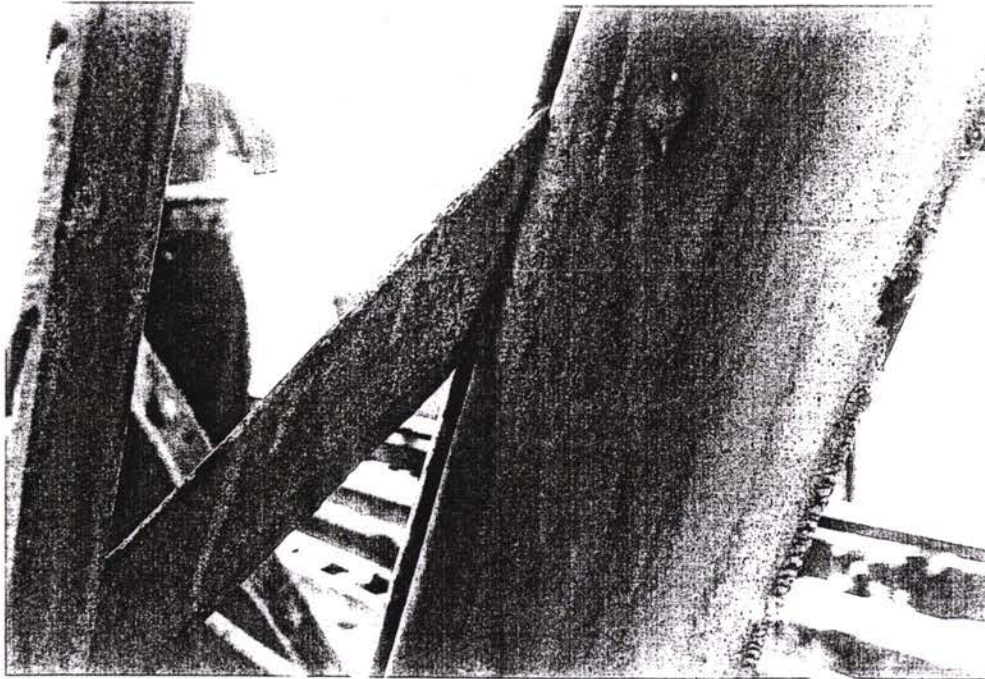
F1-27 Span 3
UC strengthening
angle corrosion

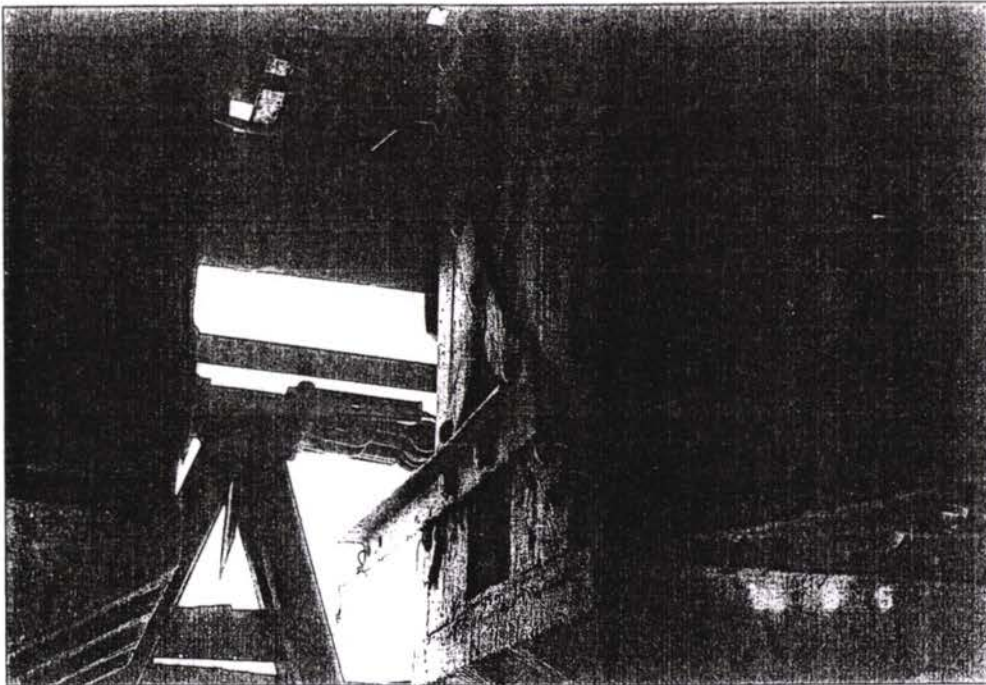
F2-02 Span 3
End cross girder
at movable bearing

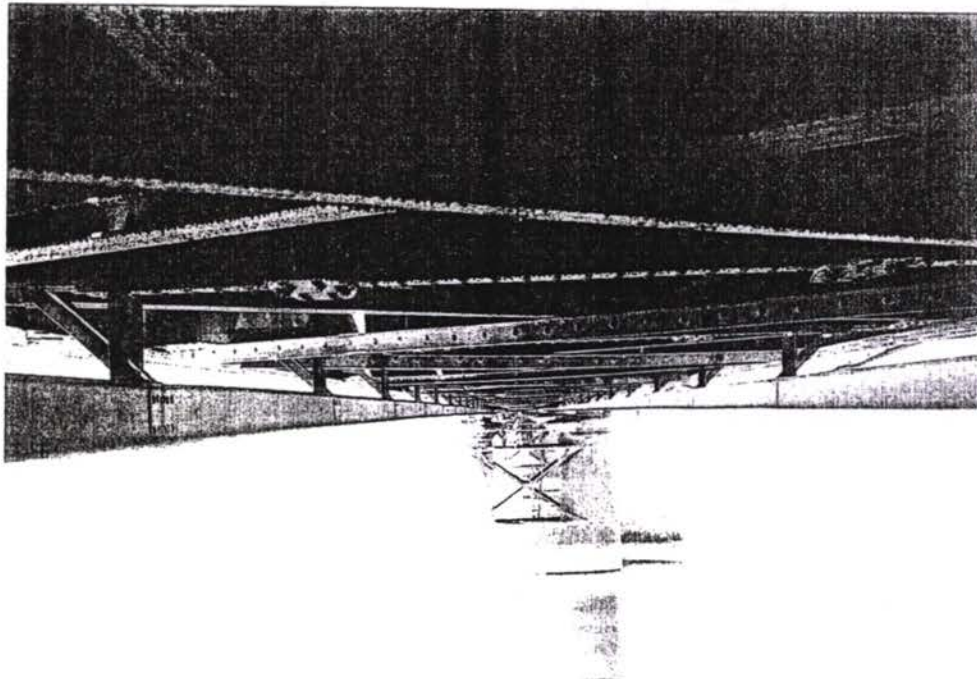
F2-03 Span 3
Bearing
(flashlight defect)

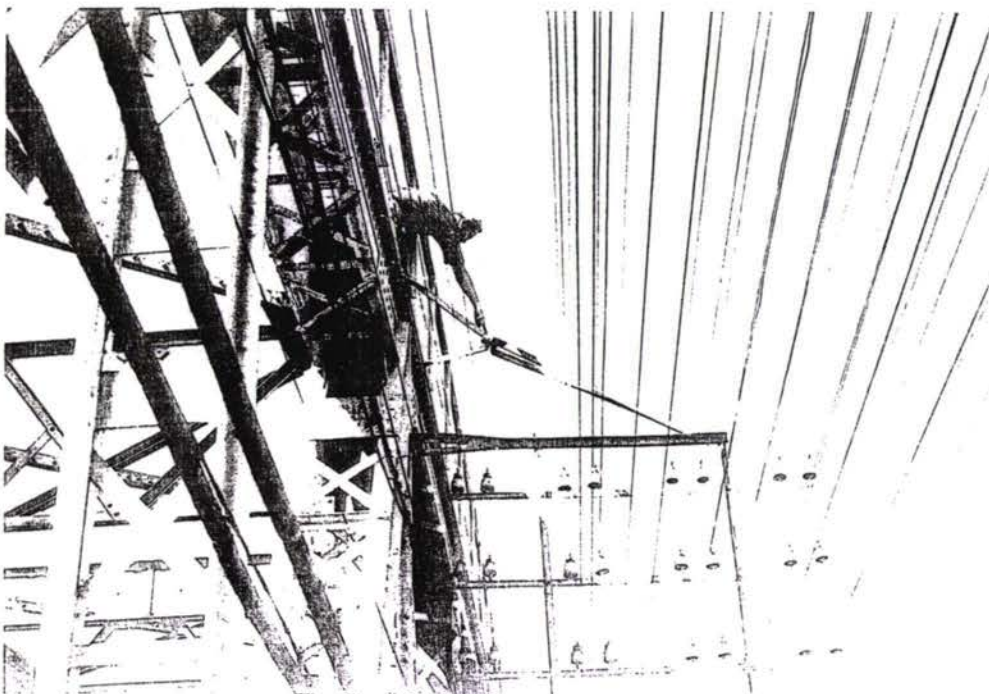
In many cases the angle which carries the inspection car rails are cracked or deformed heavily (photo F2-07, F6-13, -14 of other span). The supporting angle of the telephone console is loose also.

F2-07 Span 3
Cracked angle of
inspection car rail

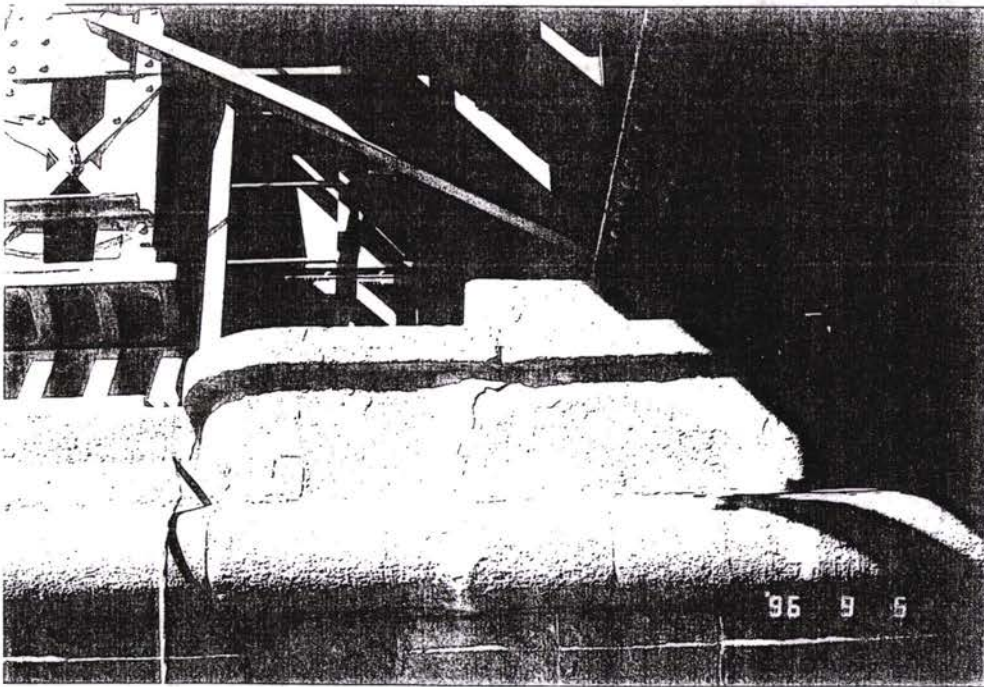
F2-11 Span 1
Fixed bearing of
span 1 DS

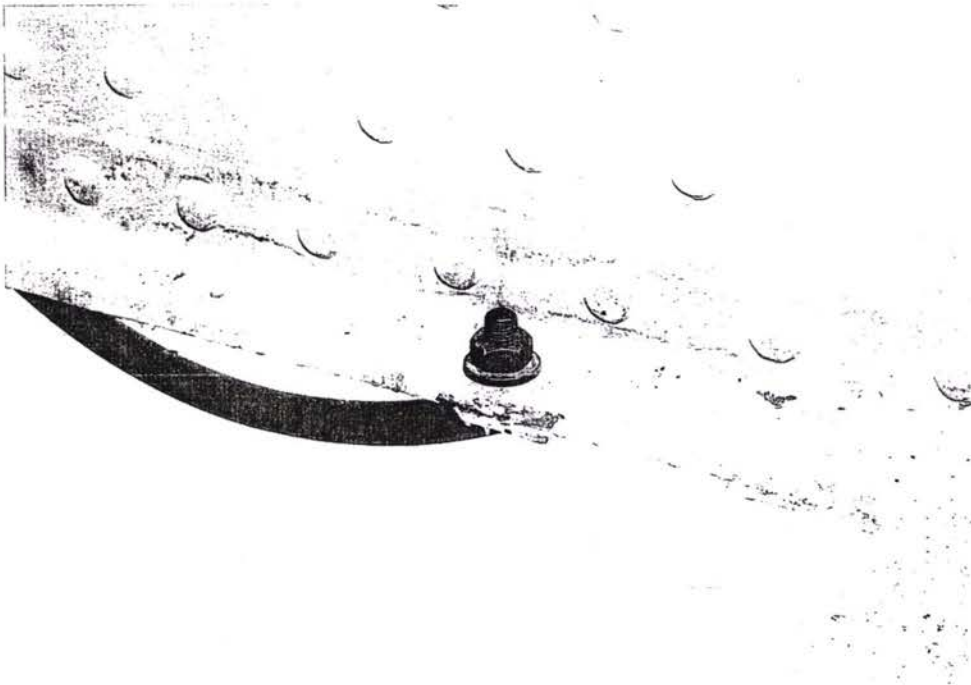
F4-02 Span 23
Deformed diagonal
bracing

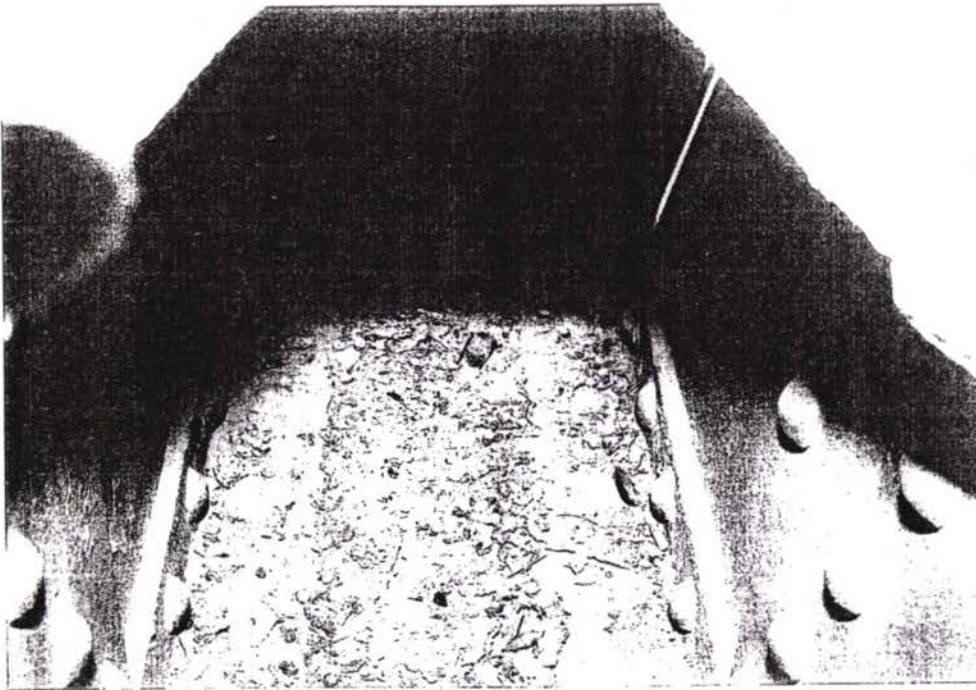
F4-14 Span 23
Completion of longit.
girders, cross girder

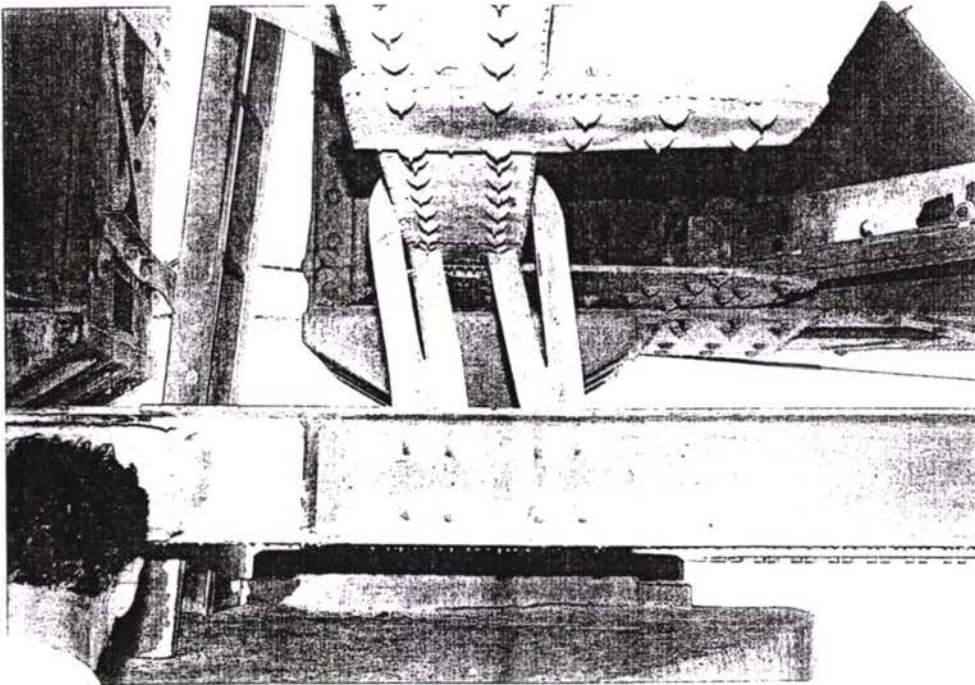
F4-15 Span 23
Corrosion of LC

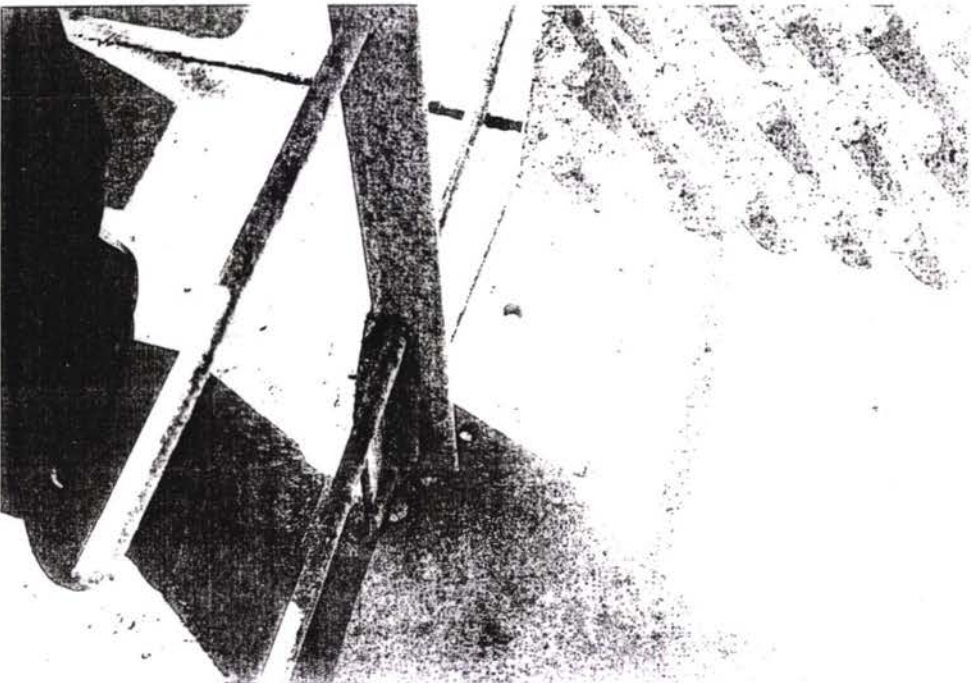
F4-20 Span 23
Cut off railing
support

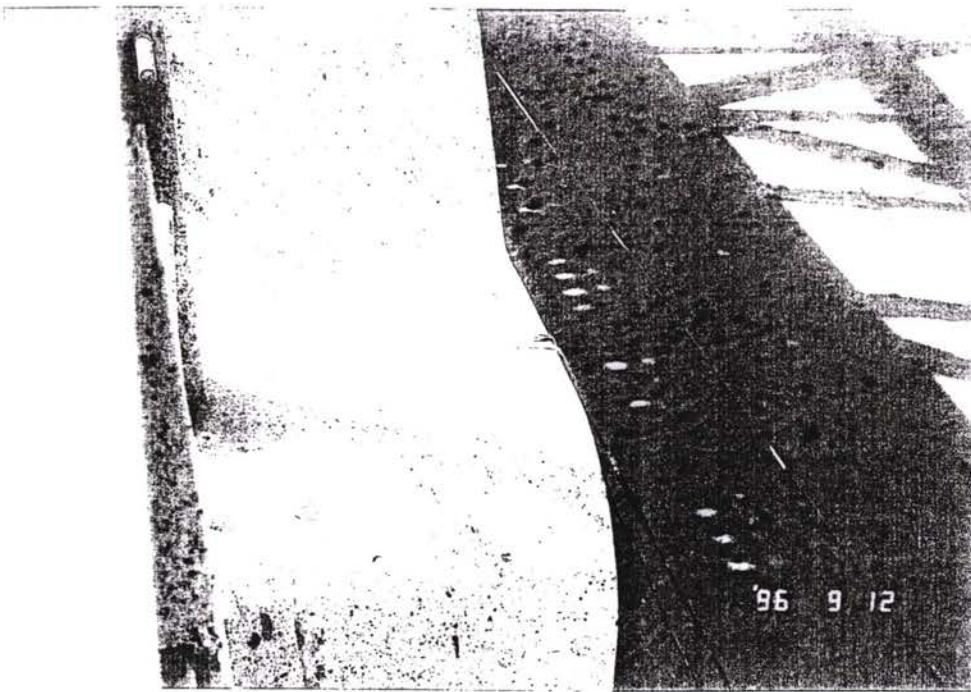
F4-21 Span 23
Missing rivet at
end circle

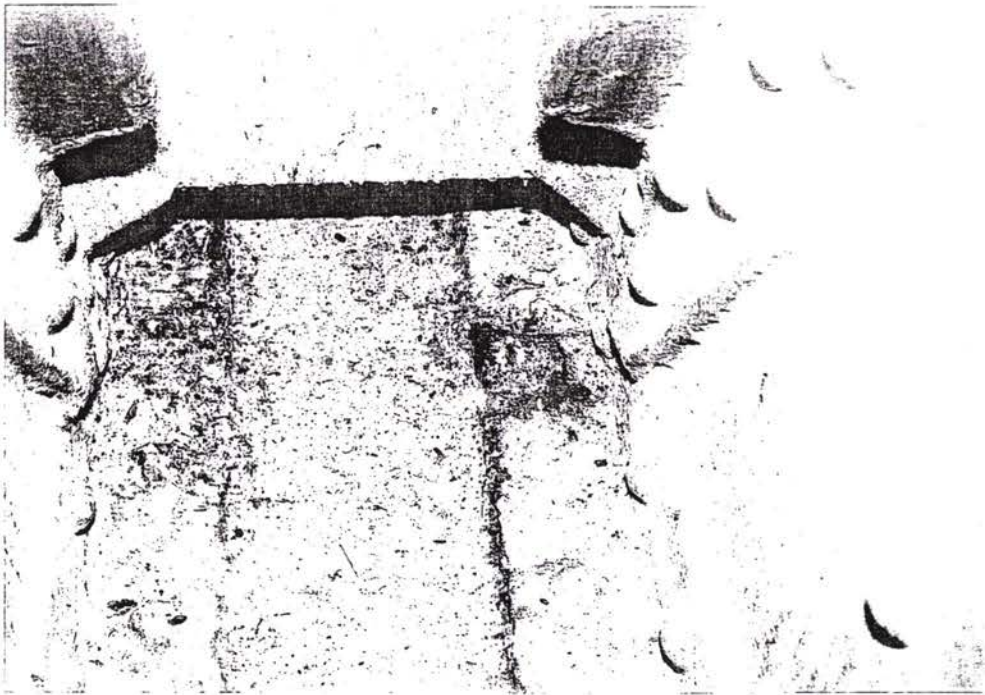
Corrosion exists at every vertical to LC connection and at cross girders and diaphragms (photo F4-24, -25).

F4-25 Span 23
Missing rivet and
corrosion at cross
girder

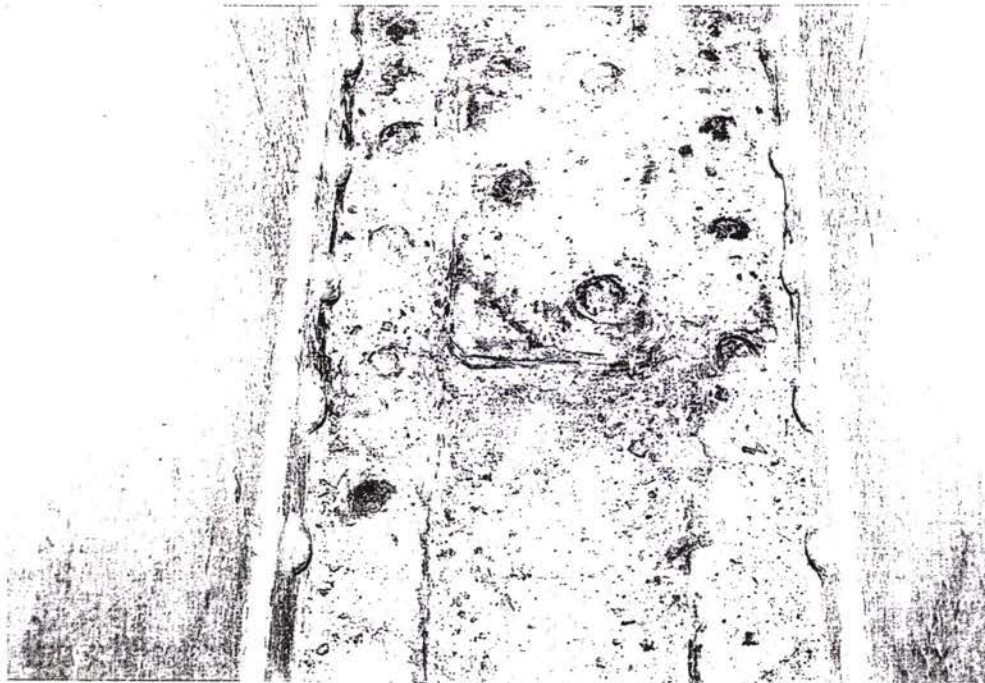
F4-26 Span 23
LC corrosion and
warping

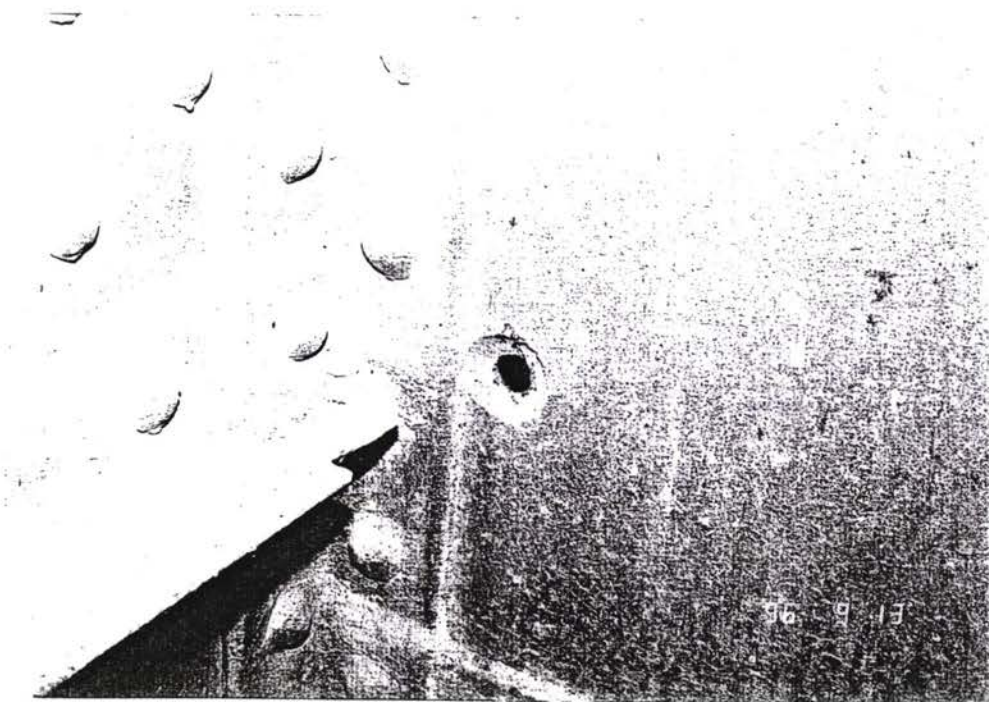
F4-29 Span 23
Lower wind bracing
newly strengthened,
corrosion

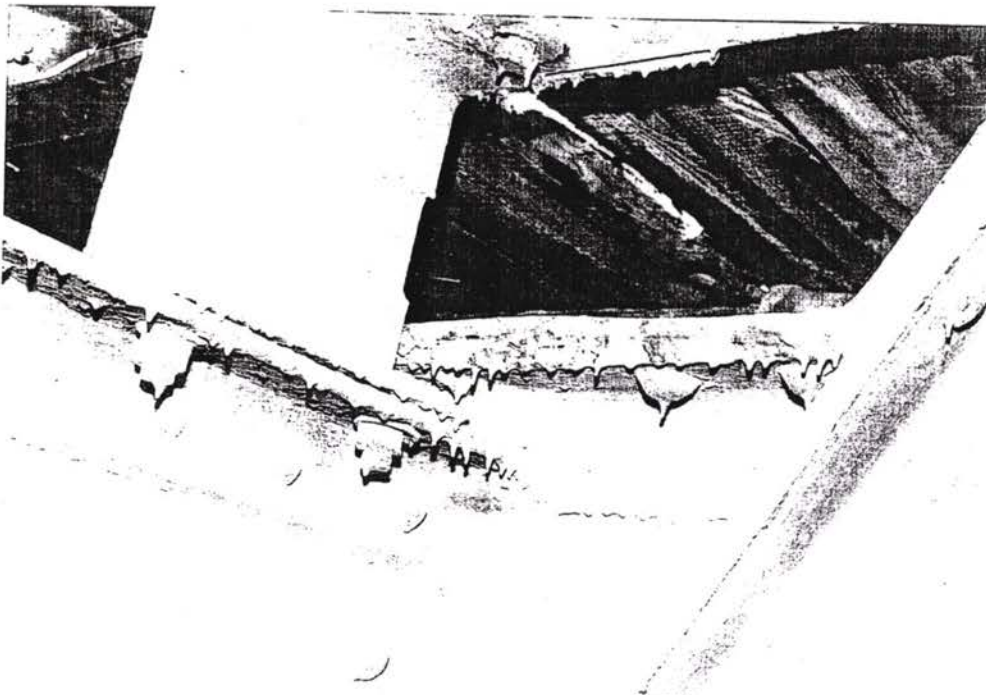
F4-30 Span 23
Cross diaphragm,
hole without rivet or
bolt

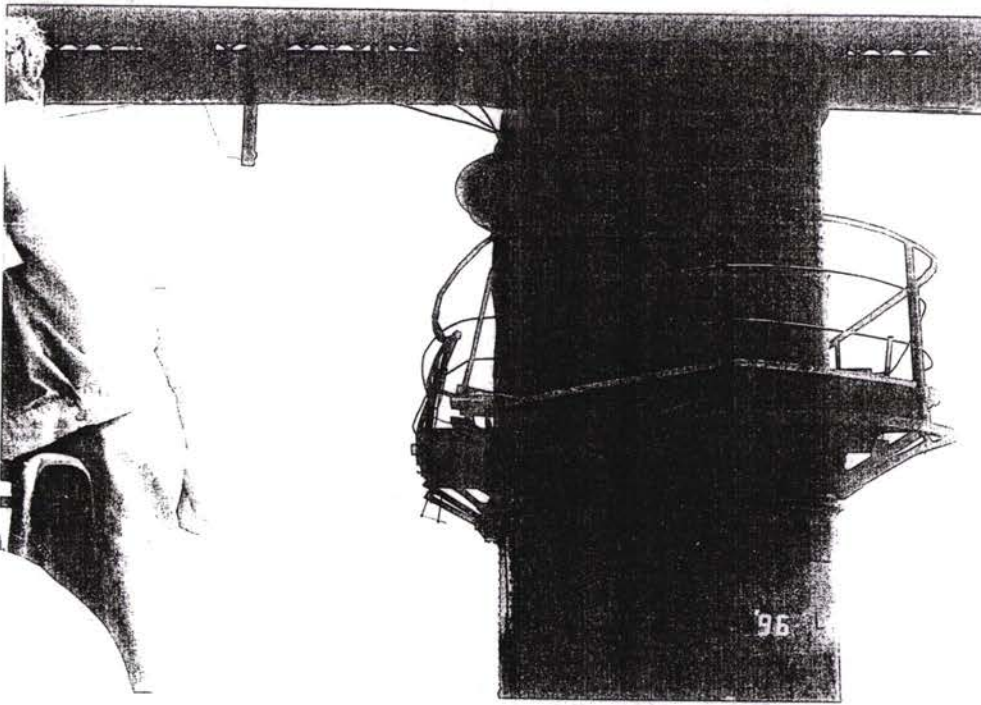
Plate cladding of the piers 15 mm thick is on some spots totally bitten due to corrosion and there strengthened with plates (photo F4-32 to -34). Pier 24 was hit by a ship which damaged and bent the cladding (photo F4-36, -37).

F4-34 Pier 25
Pier 25 corrosion

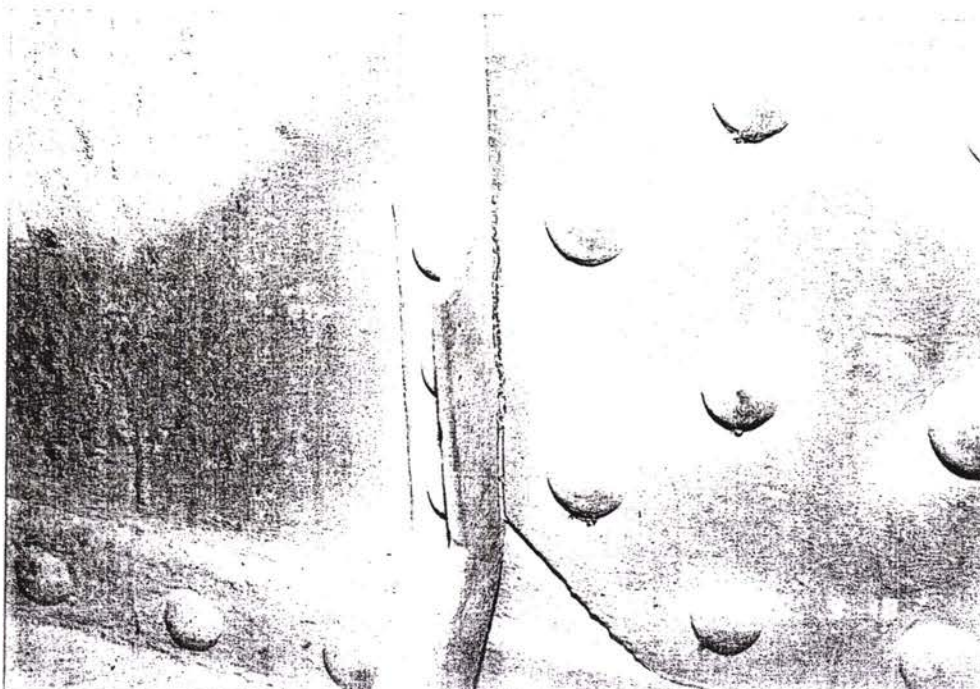
Corrosion is visible at various locations especially below rail level (photo F6-01, -02, -03, -05, -06, -07, -09, -11, -12, -15, -17, -32), but also at the diagonals where narrow gaps filled with special cement exist (photo F6-20, -24, -27, -30, -37). Rust has puffed up the angle legs due to volume extension and effects proceeding of corrosion (photo F6-32, -34, -35).

F6-01 Span 13
Corrosion at lower
wind bracing, behind
special cement

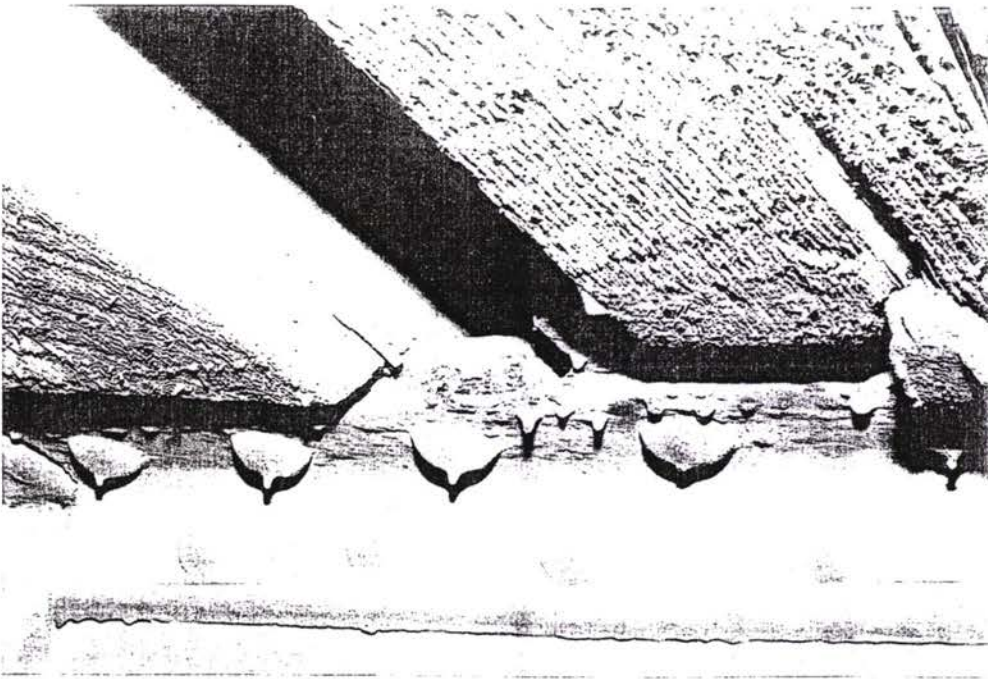
F6-07 Span 13
LC node corrosion

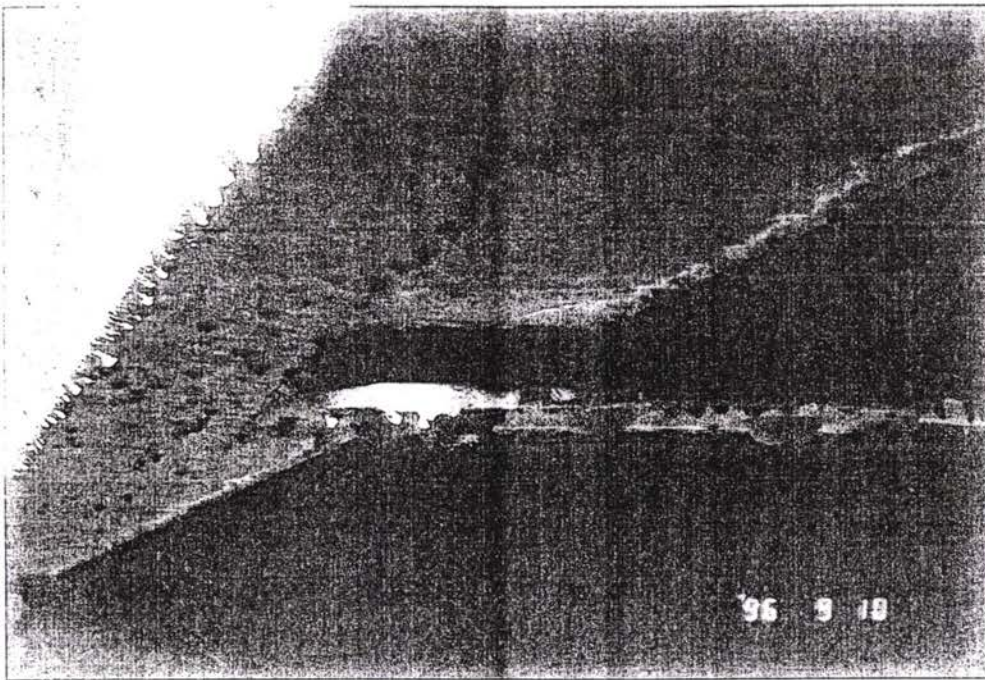
F6-09 Span 13
Longitudinal girder
corrosion in chink in
cross girder

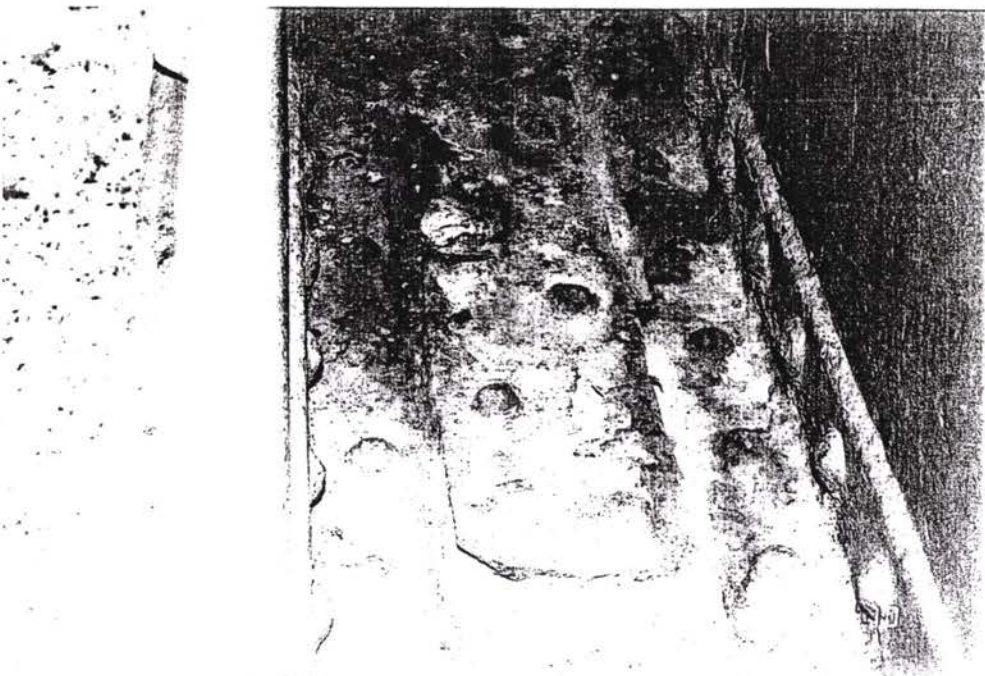
LC heavy pitting (localized corrosion) due to acid influence is shown on photo F6-11, -12. The suspension angle of the inspection rail is broken (photo F6-13, -14).

F6-11 Span 13
LC US node, rivet
head and plate
missing

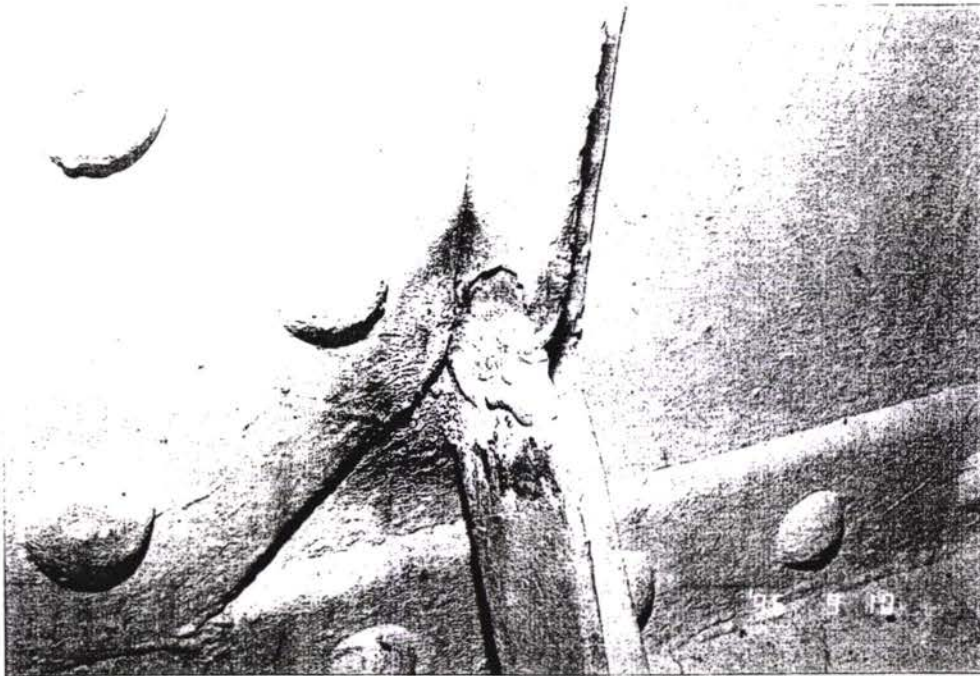
F6-13 Span 13
Broken inspection
rail support

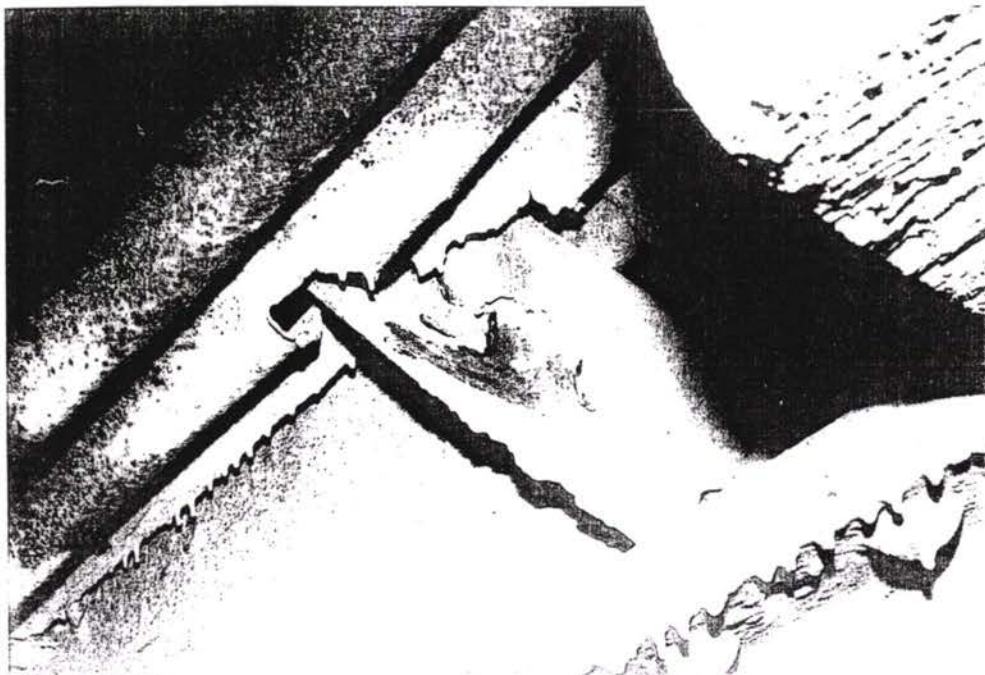
F6-14 Span 13
As F6-13

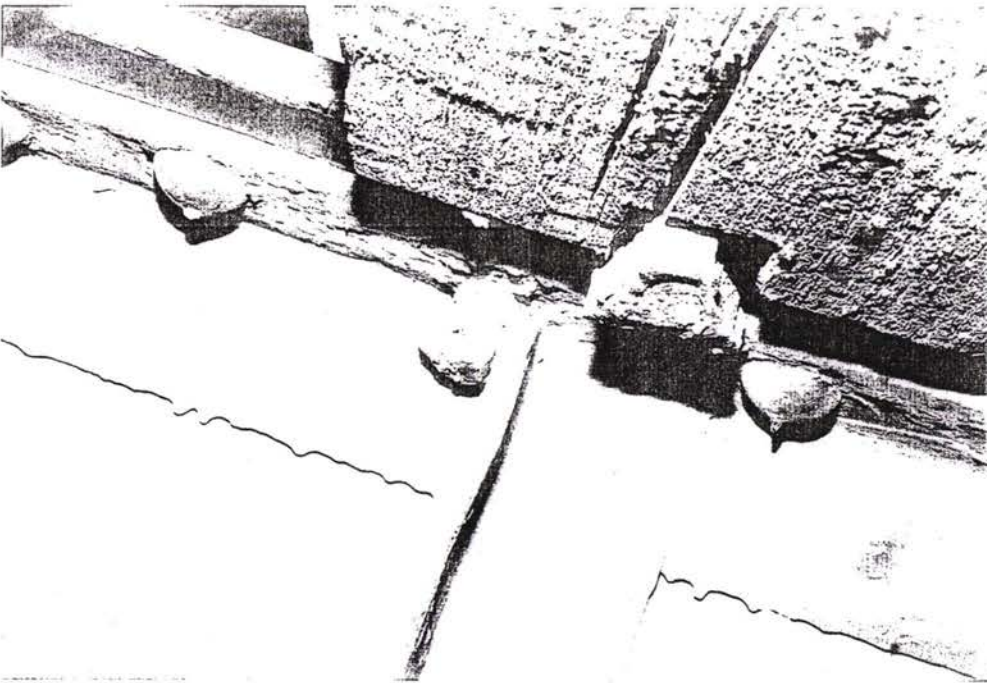
F6-15 Span 13
Longitudinal girders
upper flange corrosion

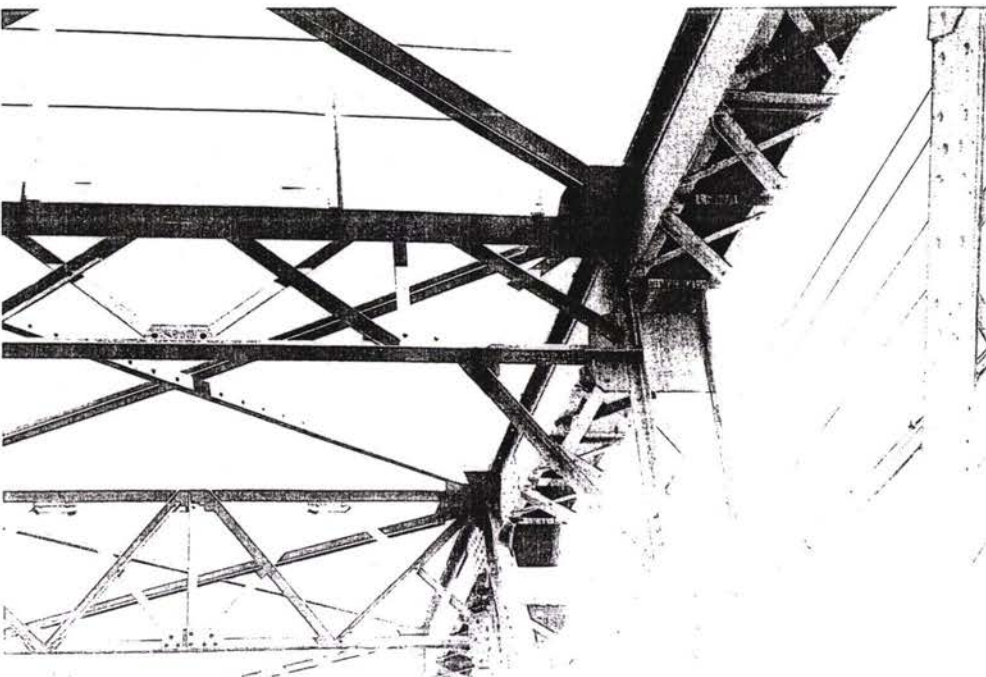
F6-17 Span 13
LC US corrosion

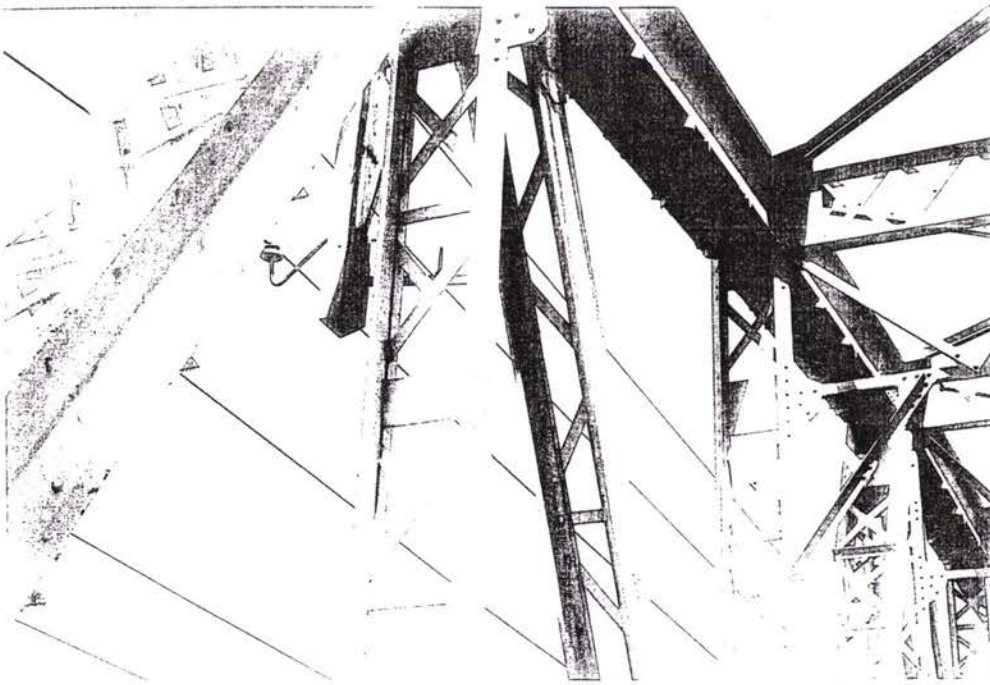
F6-18 Span 13
Bracing angle out
of axis

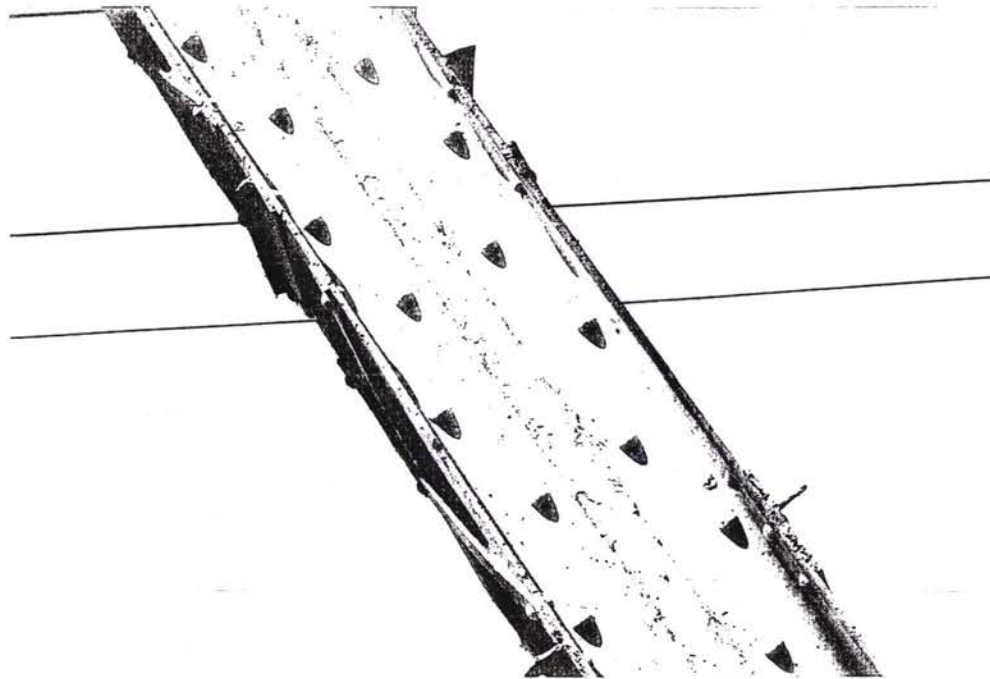
F6-19 Span 13
Bracing angle cut
off, not replaced

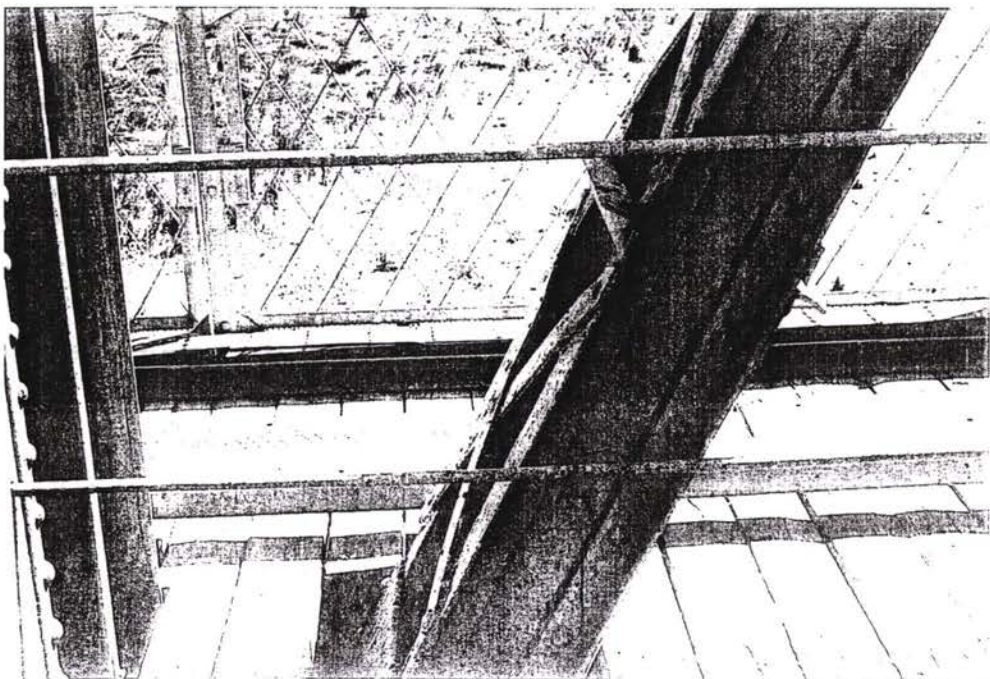
F6-20 Span 13
Corrosion behind
special cement of
diagonal

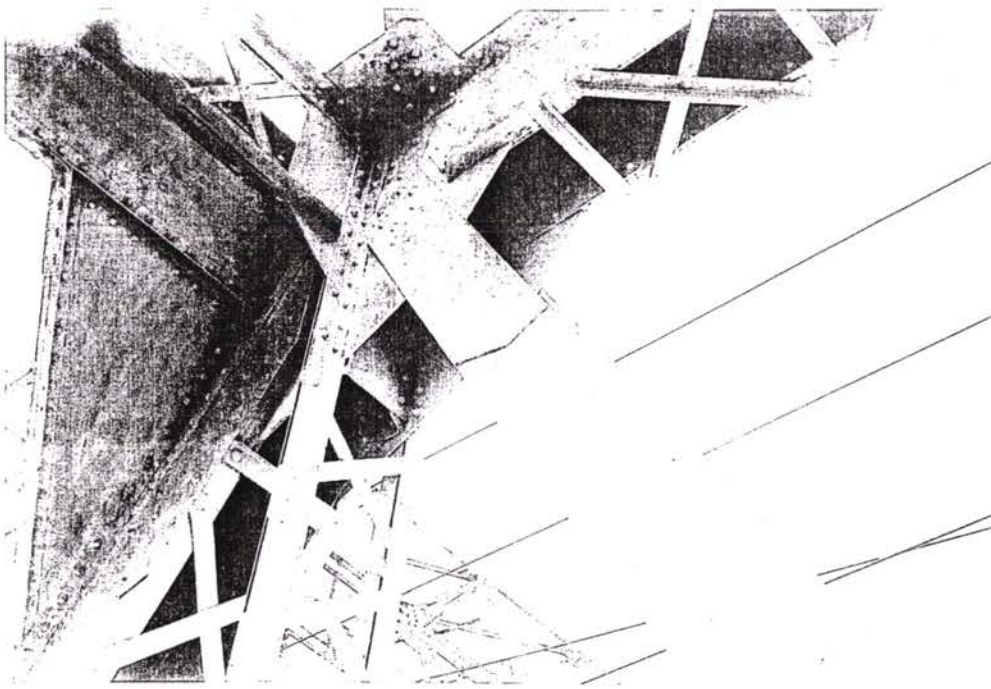
F6-27 Span 13
Detail of the
joint

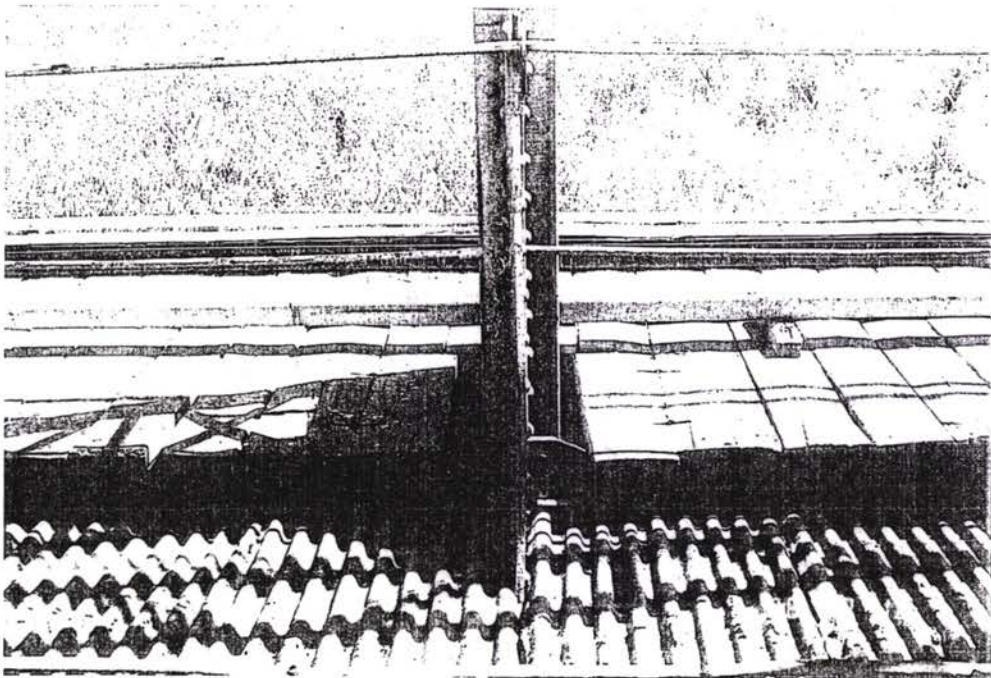
F6-28 Span 13
UC node 1 missing
rivet

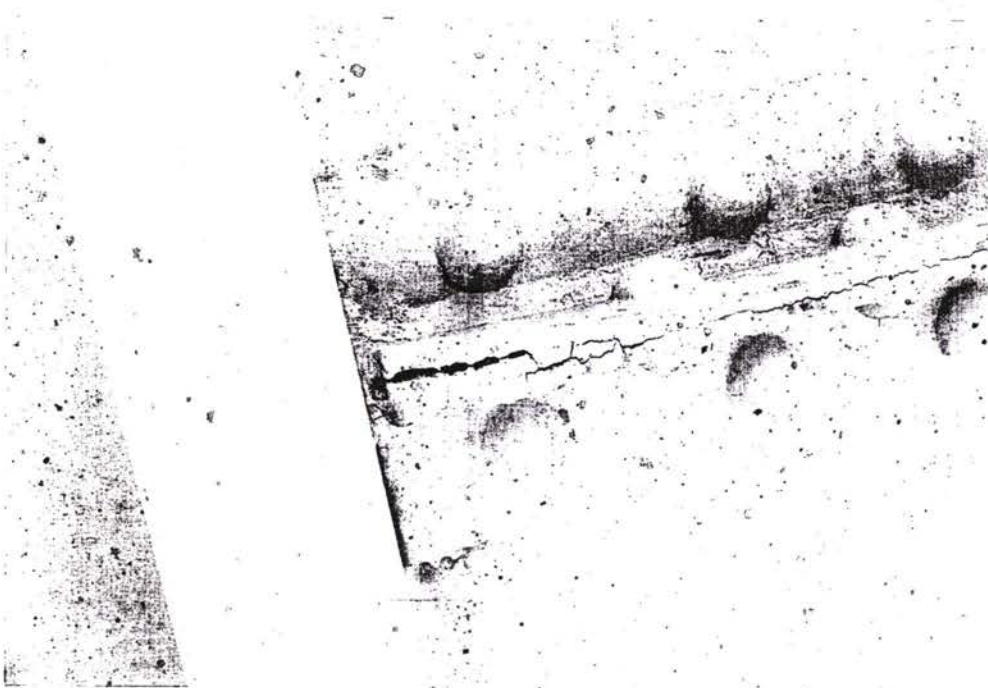
F6-32 Span 13
LC DS angle
puffed up by corros.
