TRACECA - Project
Rail Maintenance Central Asia:
Infrastructure (TNREG 9310)

**Traffic Census on the Pontoon Bridge
near Chardzhev (Turkmenistan)
July and August 1996**

Report about the Results

**Deutsche Eisenbahn-Consulting GmbH
Regional Department Europe/ CIS/Mediterranean**

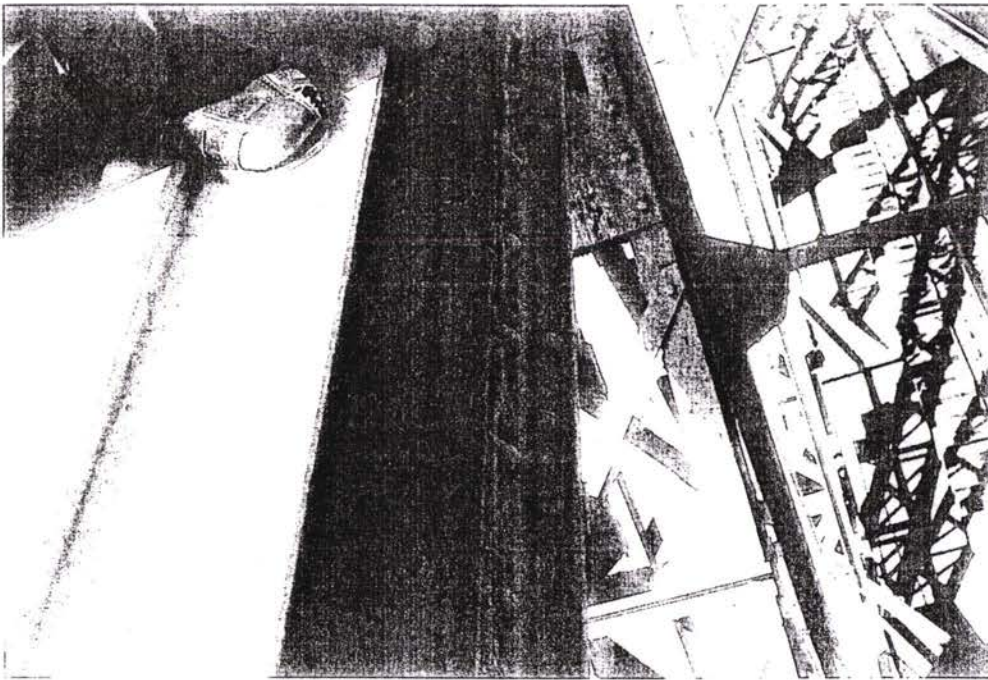
Corrosion is visible at various locations especially below rail level (photo F6-01, -02, -03, -05, -06, -07, -09, -11, -12, -15, -17, -32), but also at the diagonals where narrow gaps filled with special cement exist (photo F6-20, -24, -27, -30, -37). Rust has puffed up the angle legs due to volume extension and effects proceeding of corrosion (photo F6-32, -34, -35).

F6-34 Span 13
UC DS puffing up
between rivets

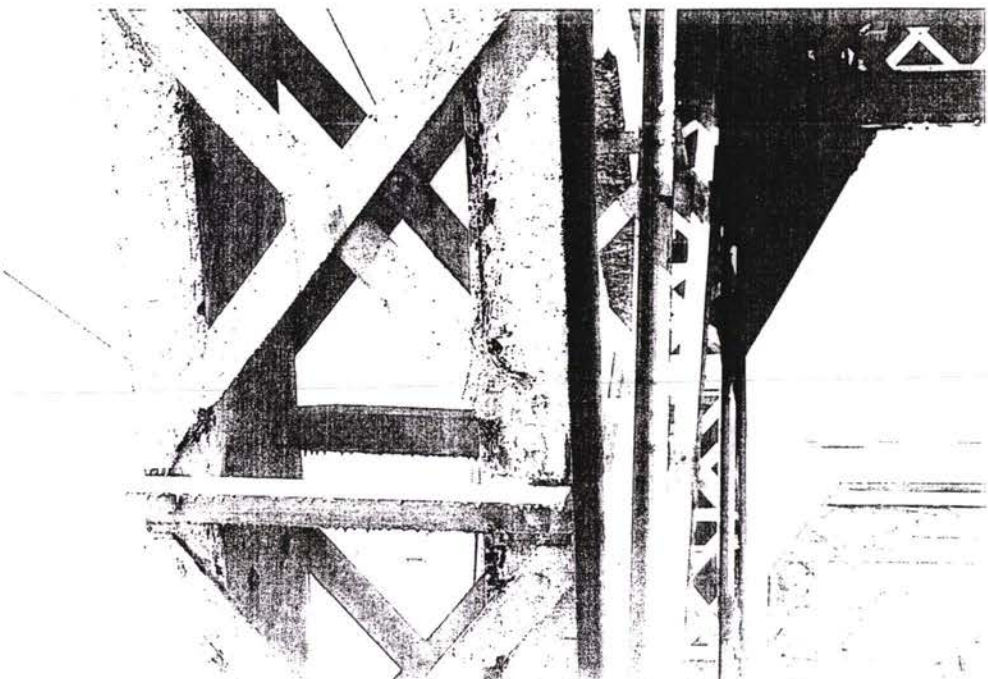
F6-37 Span 13
Corrosion of dia-
gonal

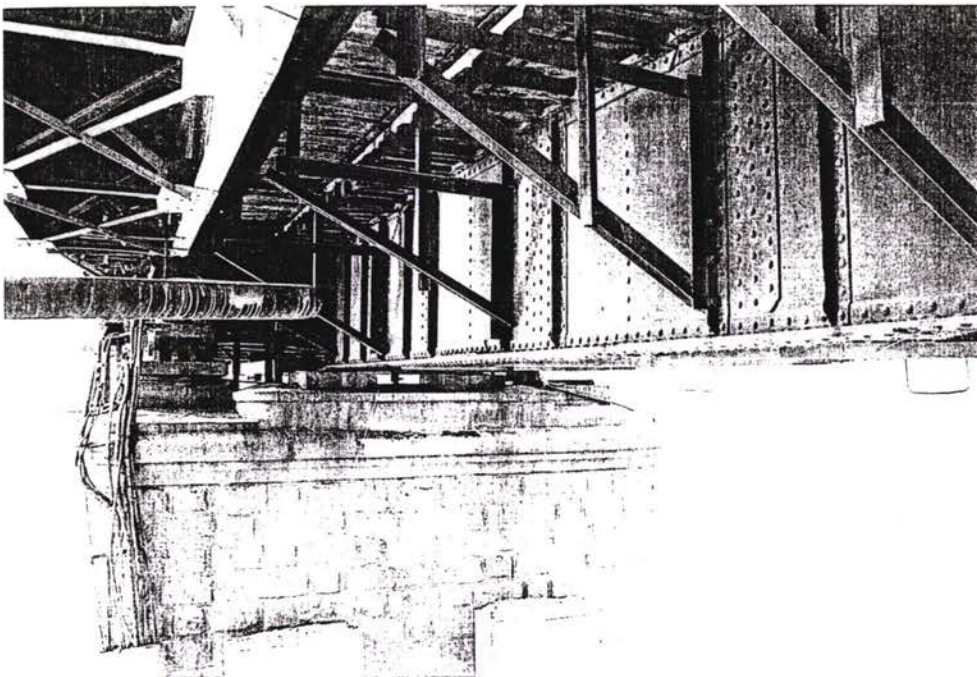
F7-07 Span 26
Bearing A1 with
cracked stone

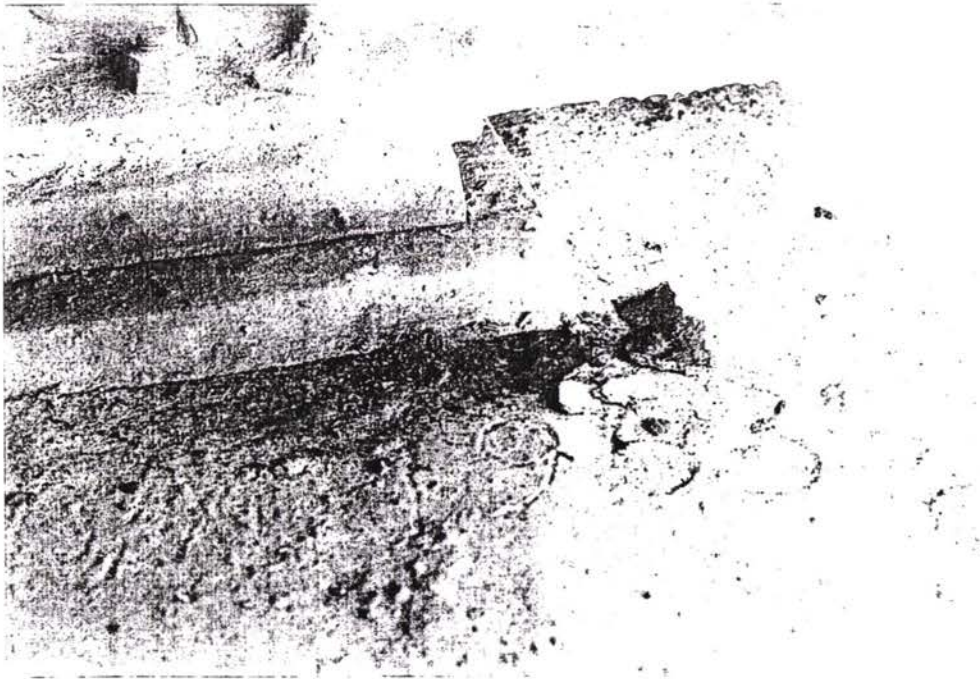
F7-11 Span 26
Main girder from DS

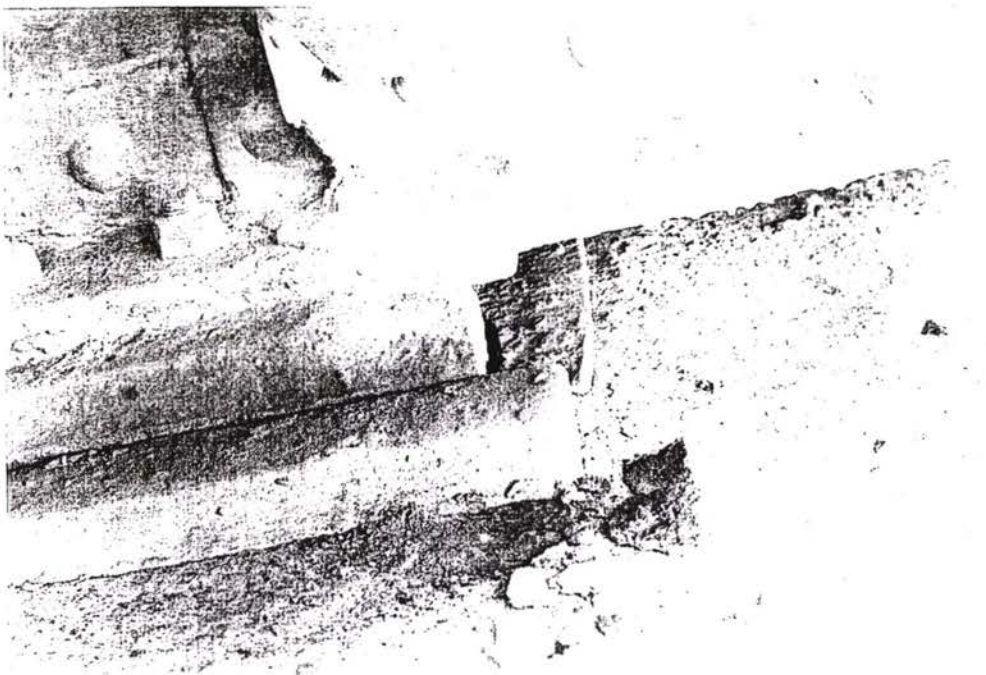
B2: (photo F7-12, -13, -14, -17, -18, -20). The concrete block has cracks and chippings. Between upper and lower bearing plate a 7 mm lining plate is inserted, which can be easily moved. Vertical free motion is possible (photo F7-20). The concrete base has no connection to the stone below.

F7-13 Span 26
Bearing B2 -
water channel

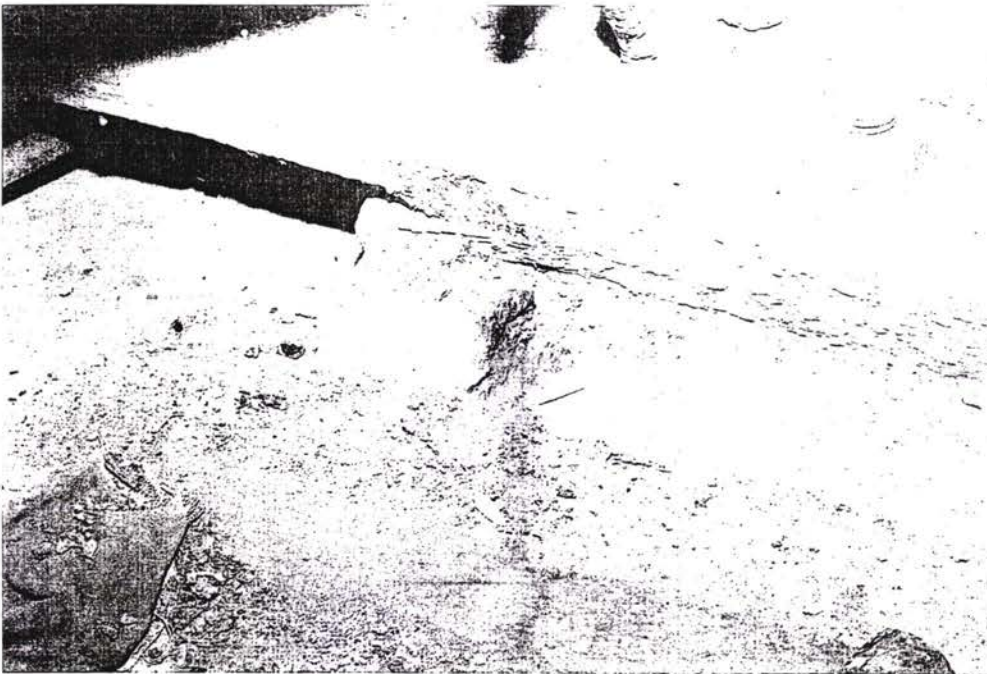
F7-23 Span 26
Welded fixing angle
for sleepers

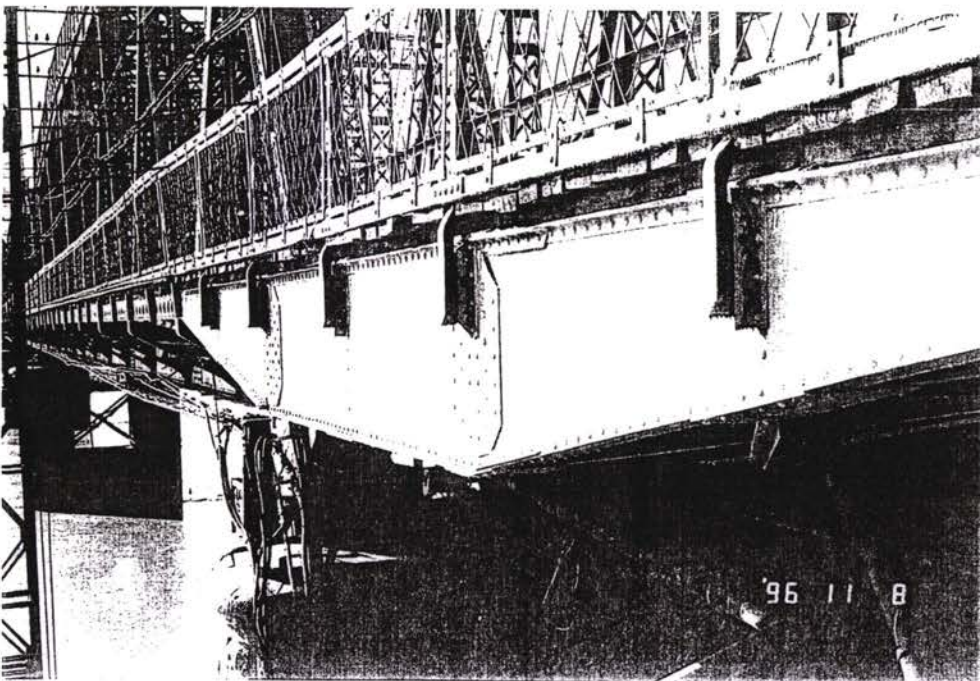
B1: (photo F7-22, -24). Lower plate is cracked. Vertical free motion together with concrete base 1,5 mm. Water channel behind the bearings has to be cleaned.

F7-24 Span 26
Bearing B1 -
cracked lower plate

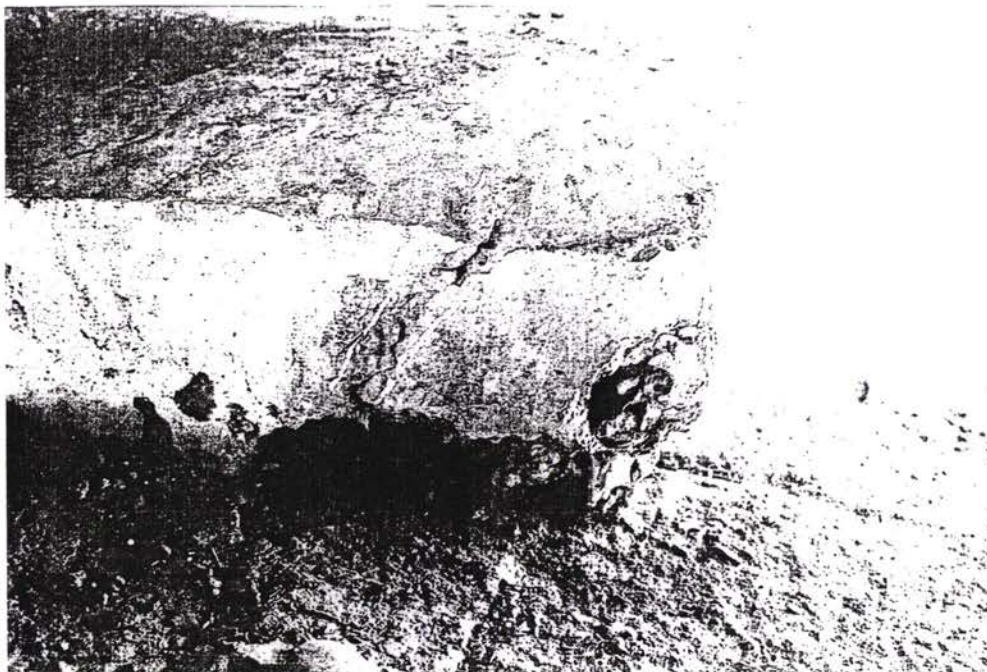
F7-29 Span 25
As F7-28,
other side

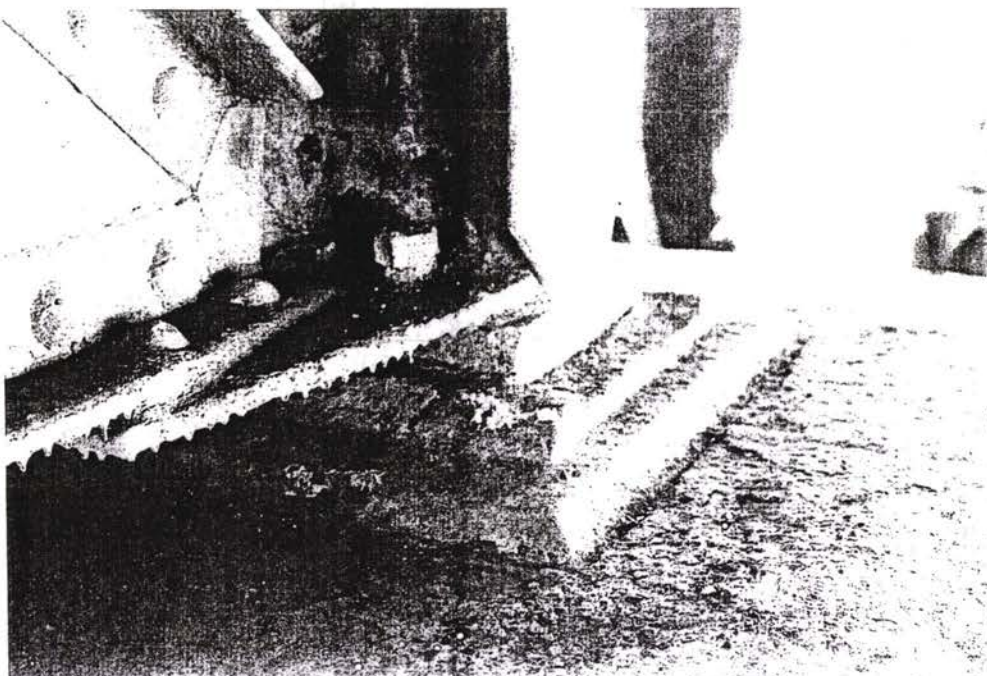
A1: (photo F7-30, -32, F8-00). Should be fixed bearing but concrete base moves on the stone (vertical movement 2 mm). Concrete base shows chippings and cracks so that the reinforcement is visible.

F7-30 Span 26
Bearing A1 - crack

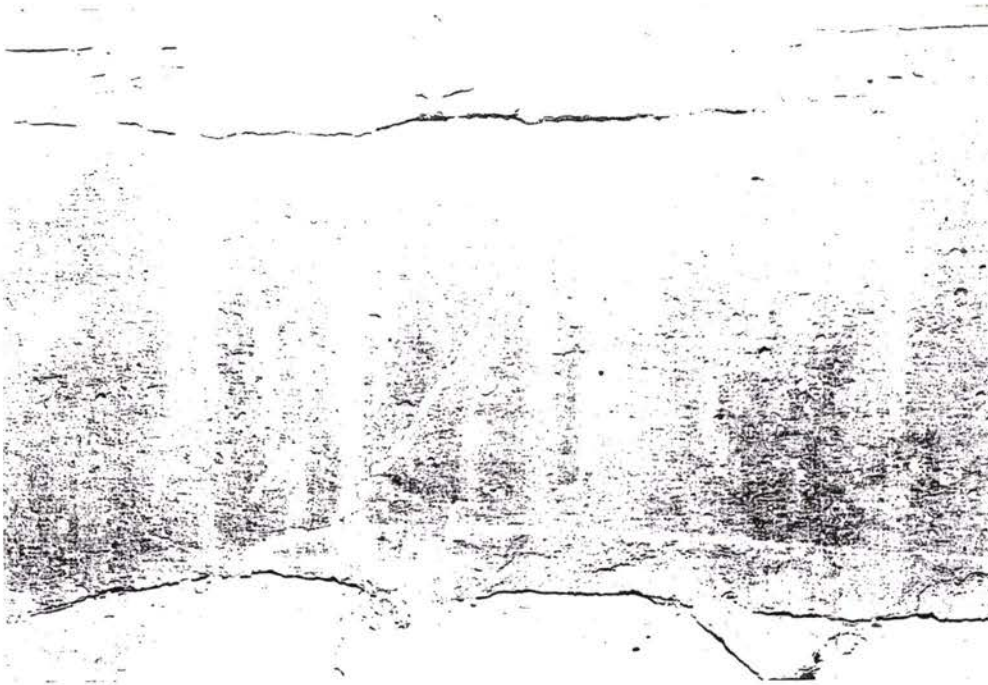
A1: (photo F8-26, -33, -34). Concrete block is loose on the stone. No cracks.

F8-26 Span 0
Bearing A1 -
vertical movement

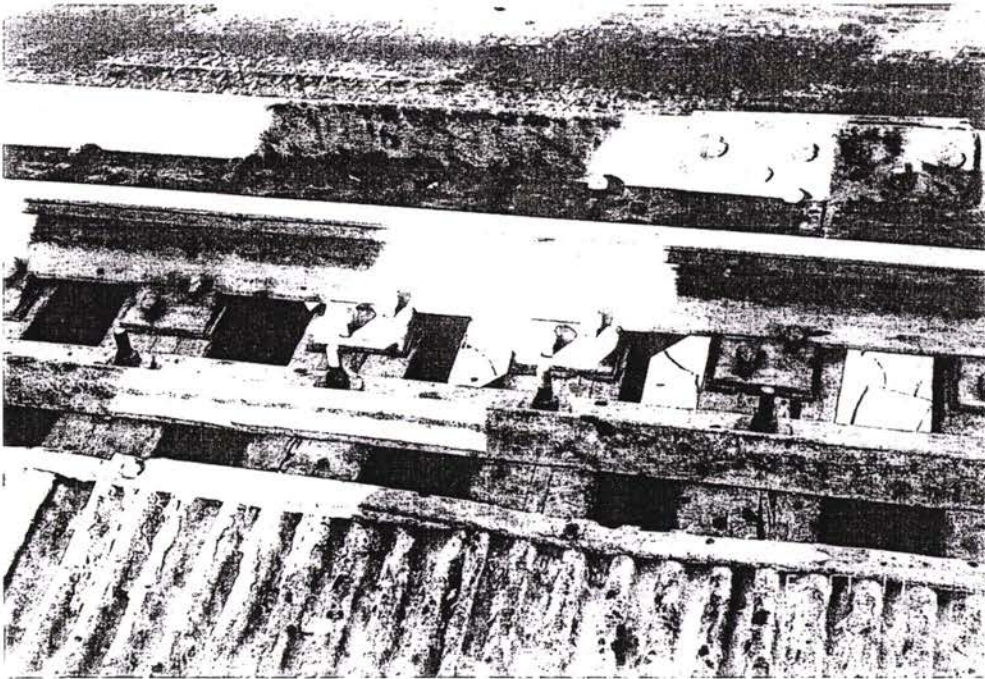
80% of the bolts to fasten the rails are loose.

F10-00
Loose rail fasteners
(nails)

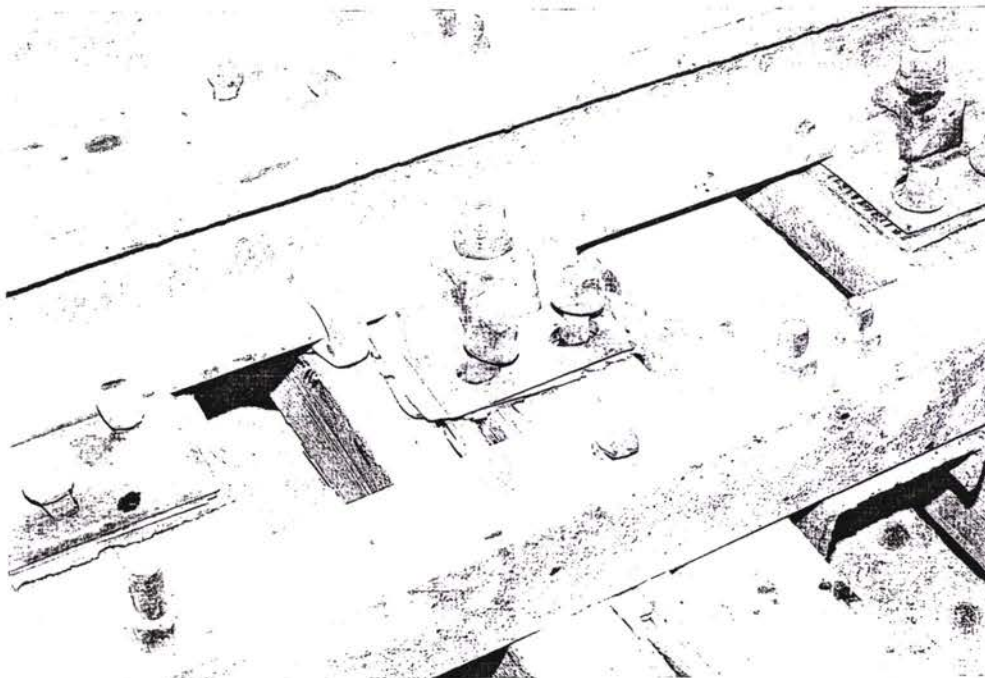
F10-05
As F10-00

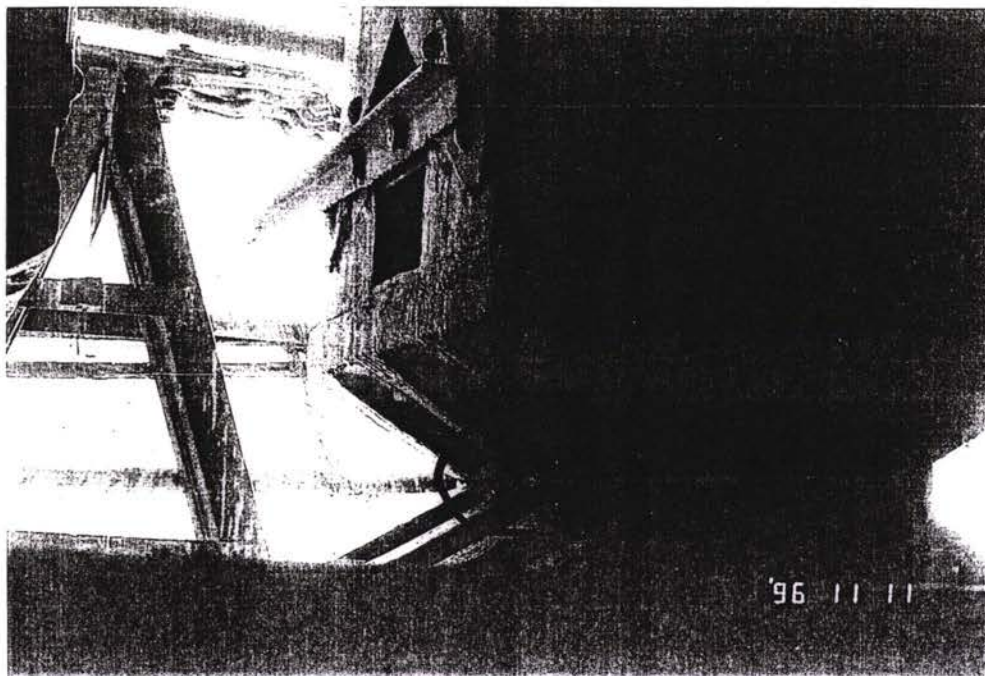
F10-01 Pier 9
Corrosion at
bearing

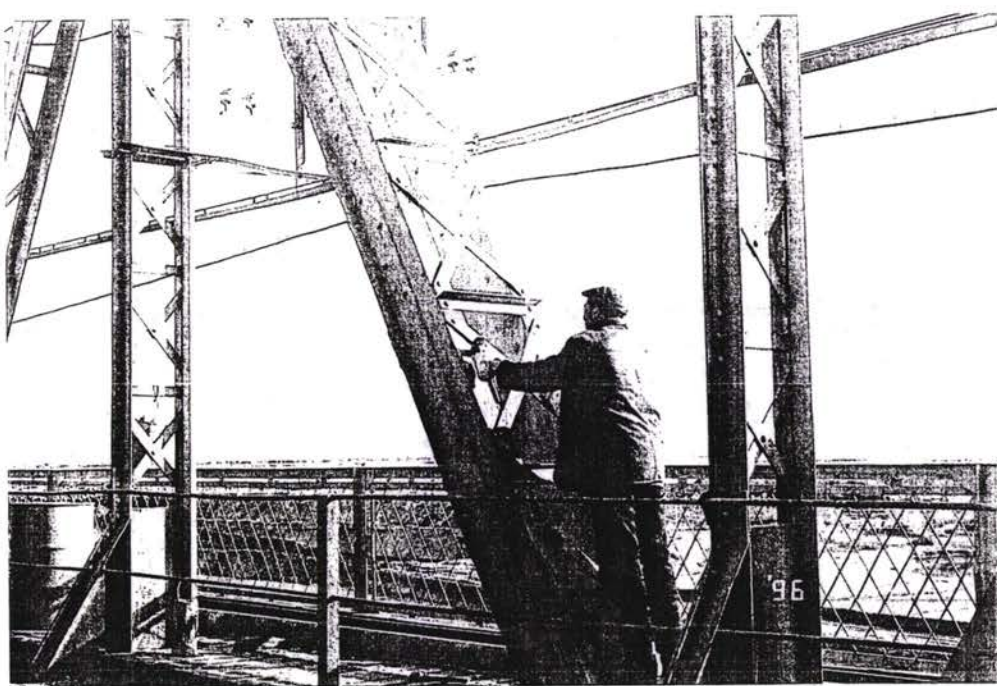
F10-07
Derusting
method with hammer

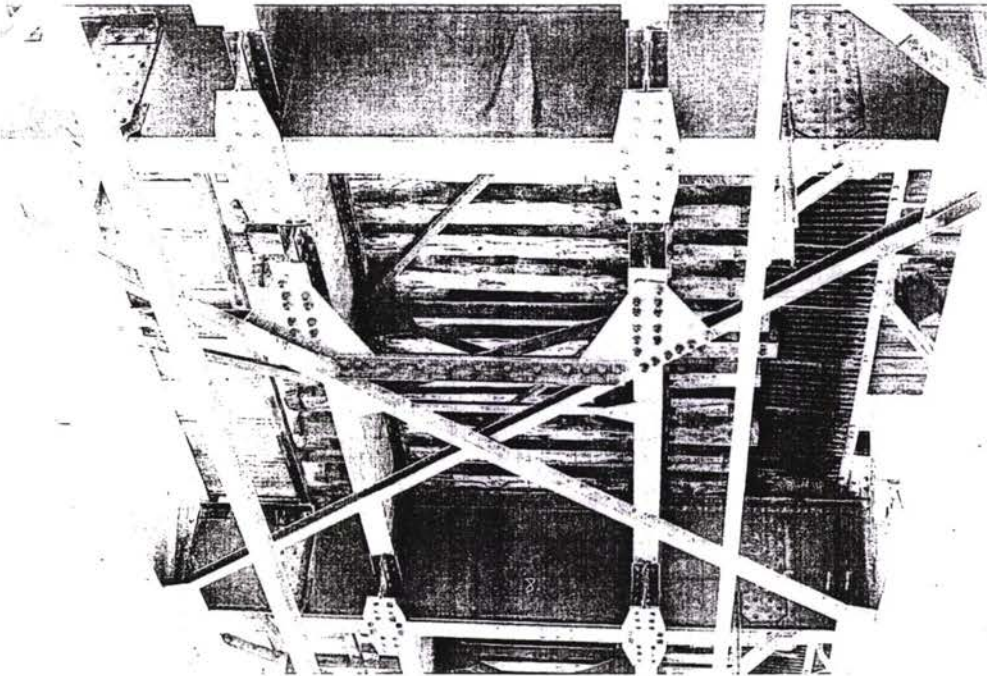
F10-15 Pier 8
DS cracks

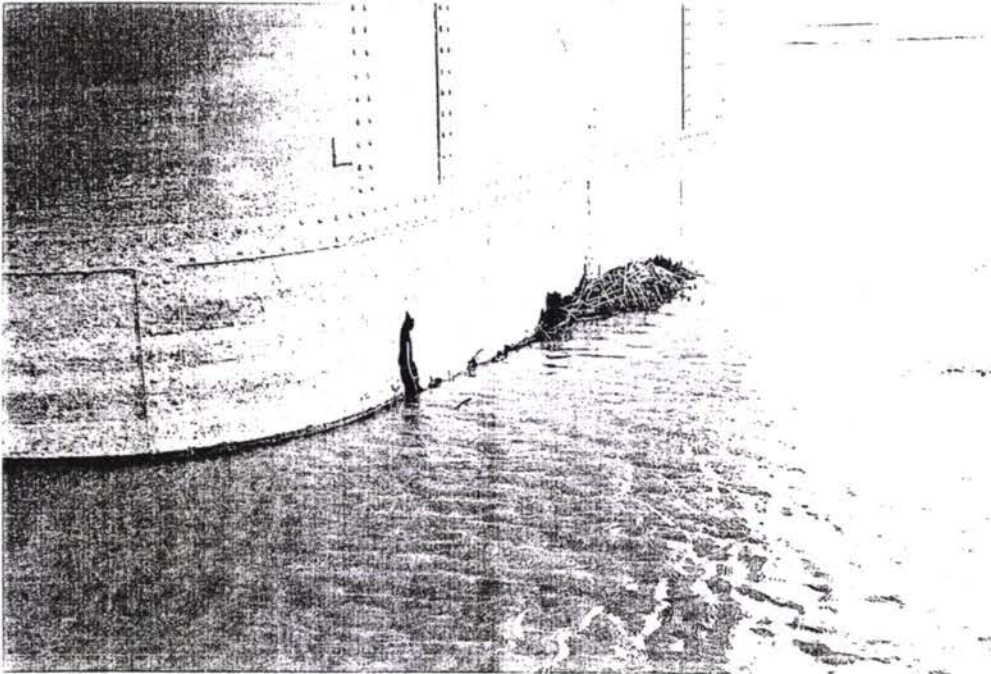
F10-21 Pier 13
Hole (not closed)
in the steel shell

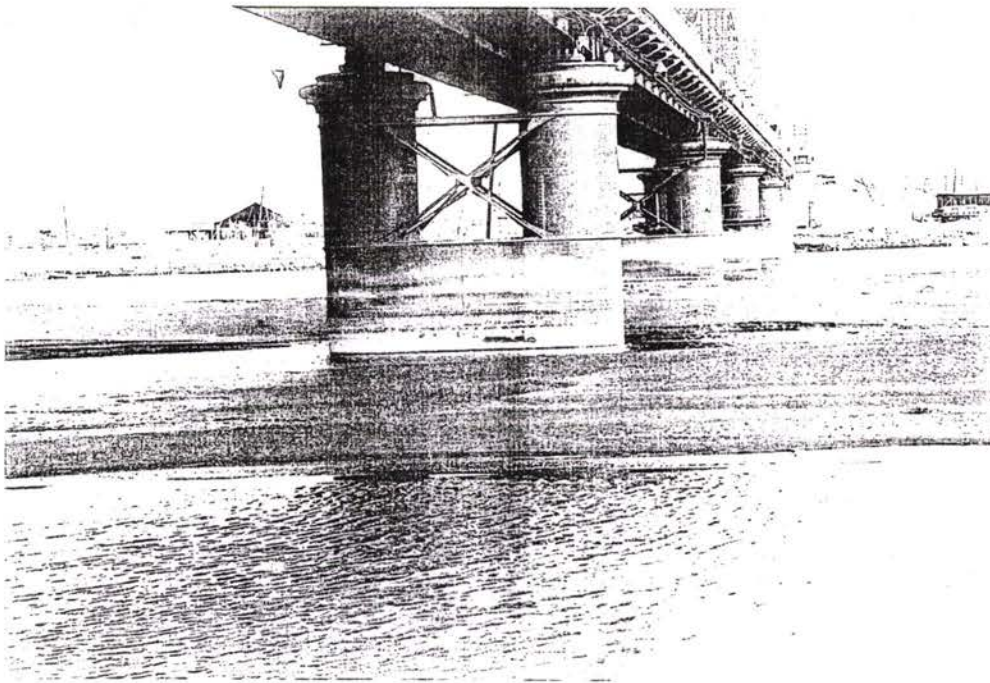
Bottom: Access possible, water ditch. Very heavy corrosion inside and outside. Hole at water level 2,5 m long (photo F10-22, -23).

F10-23 Pier 19
As F10-22

Especially the state of the piers which are situated in the main water flow have to be kept under supervision regarding inclination and vibration signs. The heavy leaks at water level should be repaired to prevent sudden break down in a low water level periode.
