Feasibility Study of New Terminal
Facilities of the Georgian Ports Plan

Survey of the railway installations in the port of Poti

Annex 9

Review of Present Facilities under Railway Engineering Aspects

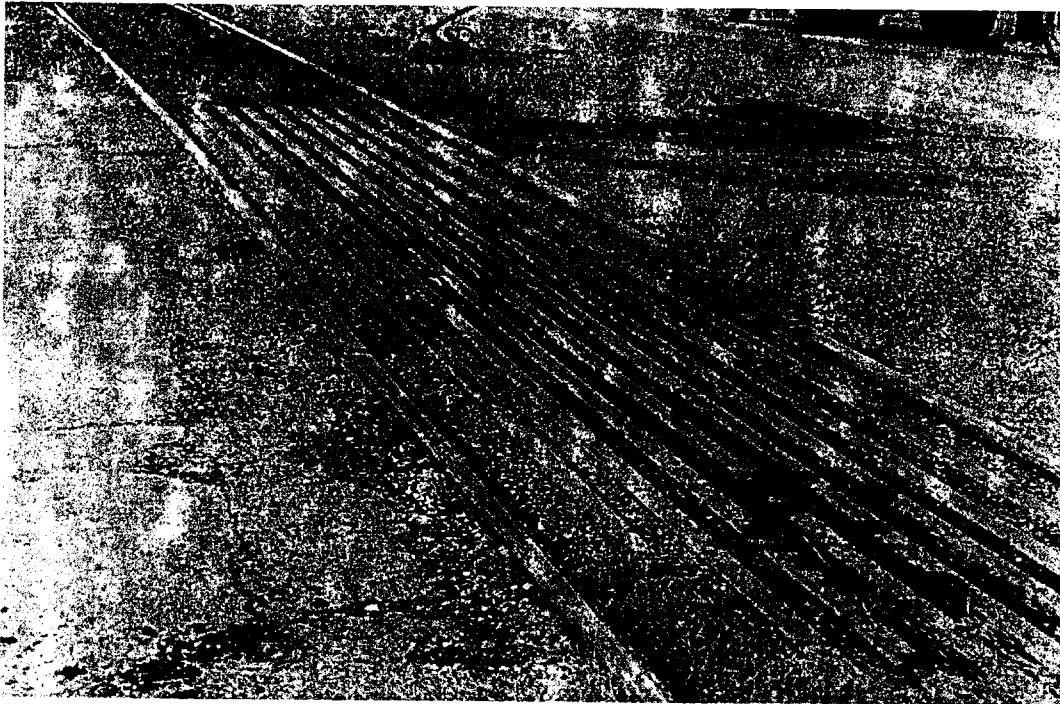
Railcrossing / Железнодорожный переезд № 08

General condition

Access roads: Asphalt, very worn out.

General Condition: Fair

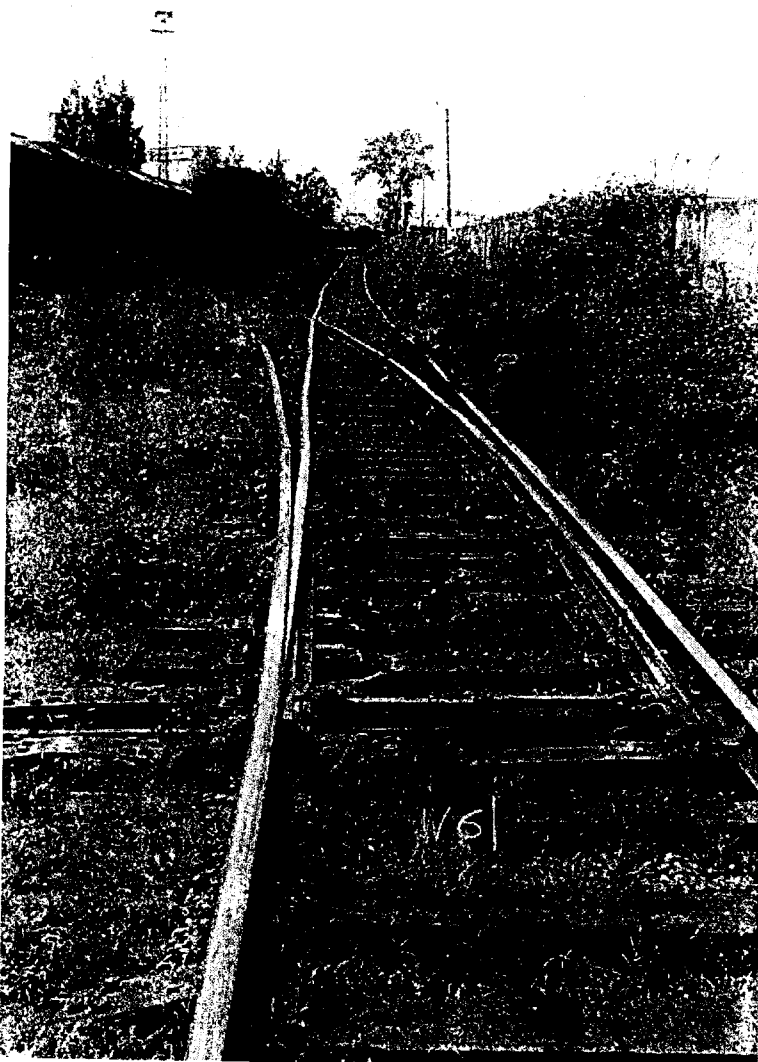
N° 06

General Condition

The switch is partly filled up to half the height of the sleepers, partly the sleepers are entirely bare. The whole area is overgrown. The sleepers are partly rotten. The base plate of the frog part is nailed, the fastening of the frog part loose and the rail joints are not stable, they are moving up and down during a pass over. The rails are worn out.

General condition: Poor.

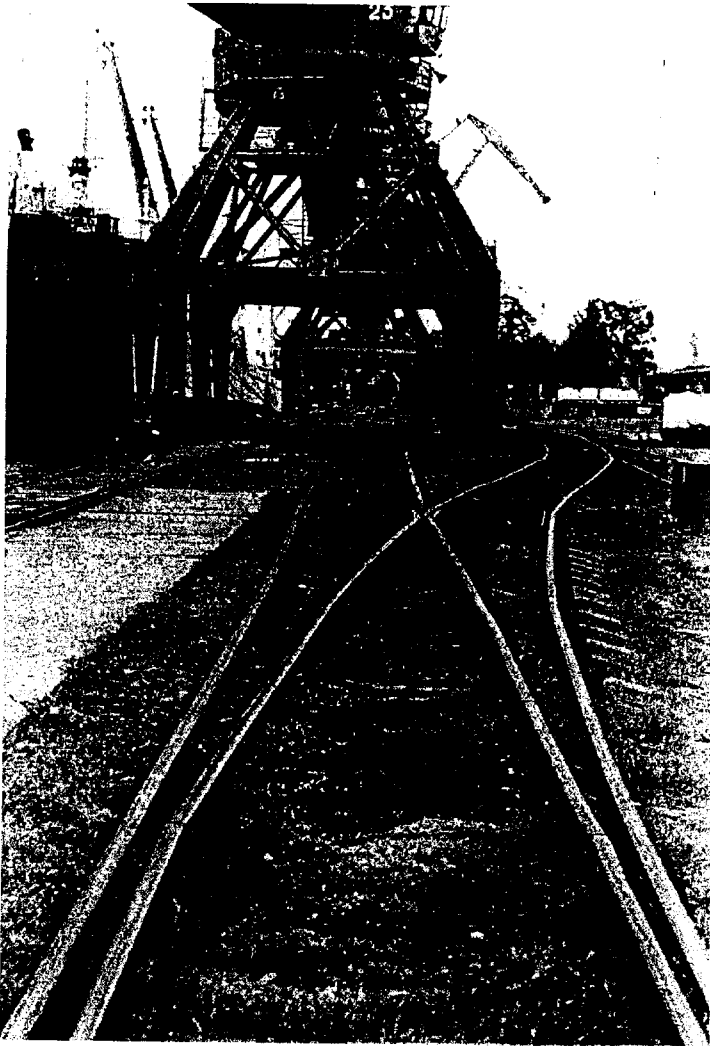
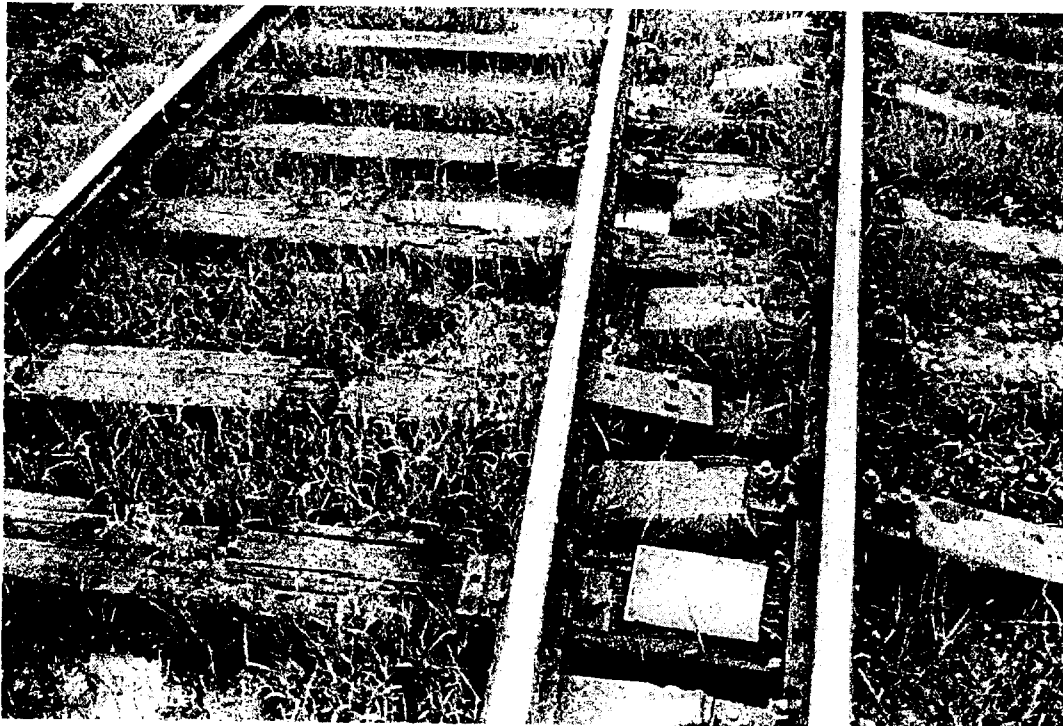
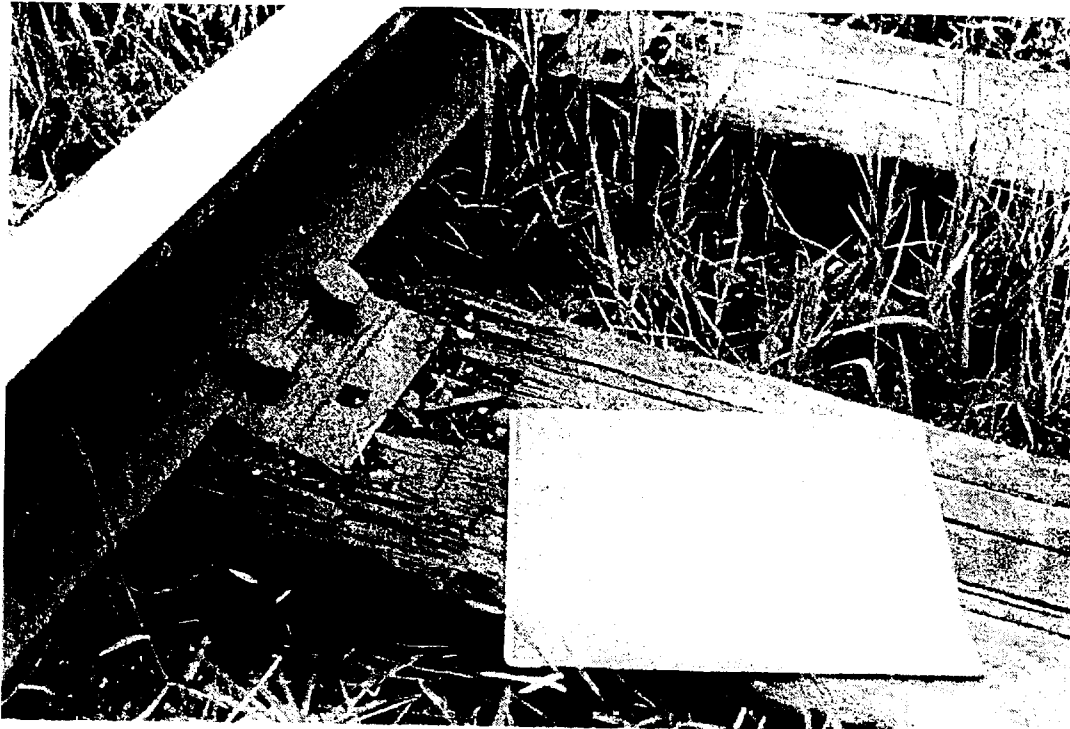
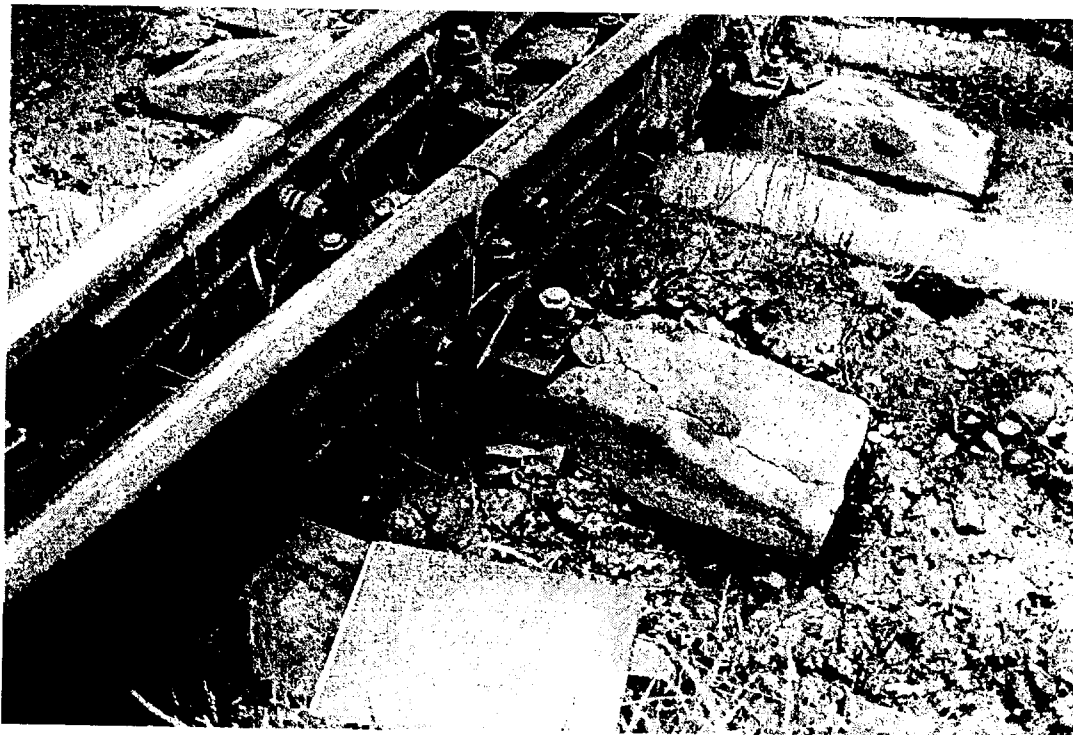
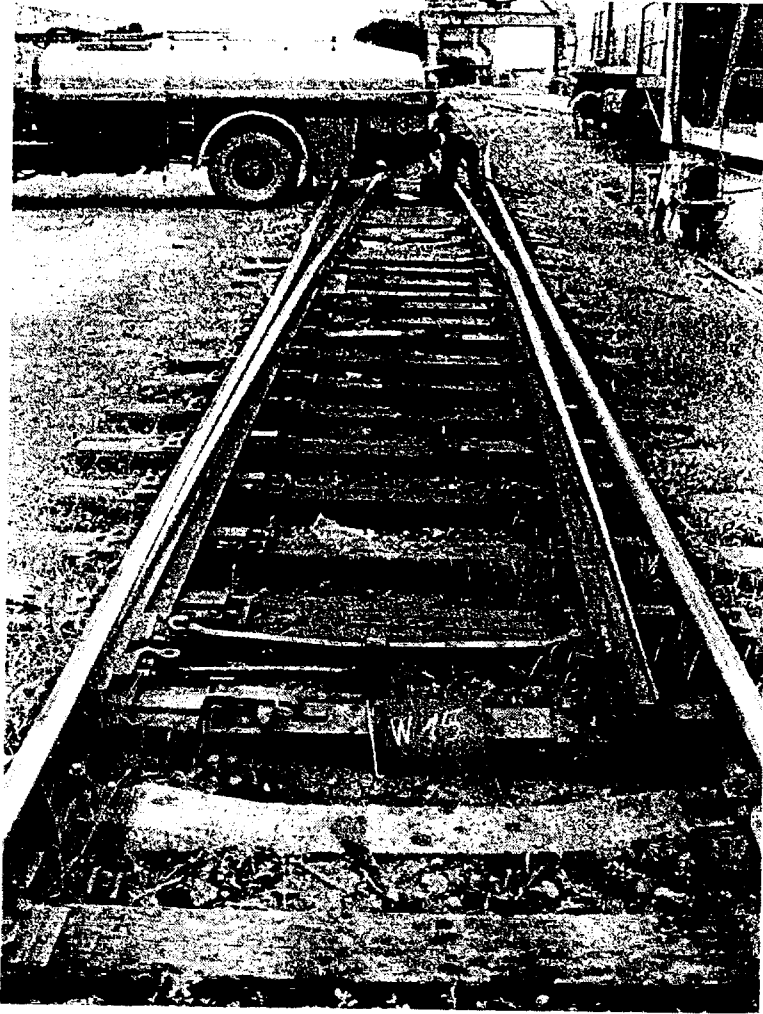
N° 15

General Condition

The switch is filled up to the half of the height of the sleepers with ballast. The sleepers are overgrown with grass. The bedding is very humid, partly due to stagnant water. Due to the lack of long sleepers and the use of normal sleepers in the central and frog parts of each switch, in the central part the sleepers are located almost side by side. The central and frog part areas as well as the rail joints are heavily moving up and down during a pass over. Nails and rail-fittings are loose. The concrete sleepers are partly torn. Single sleepers are destroyed.

General condition: Poor.

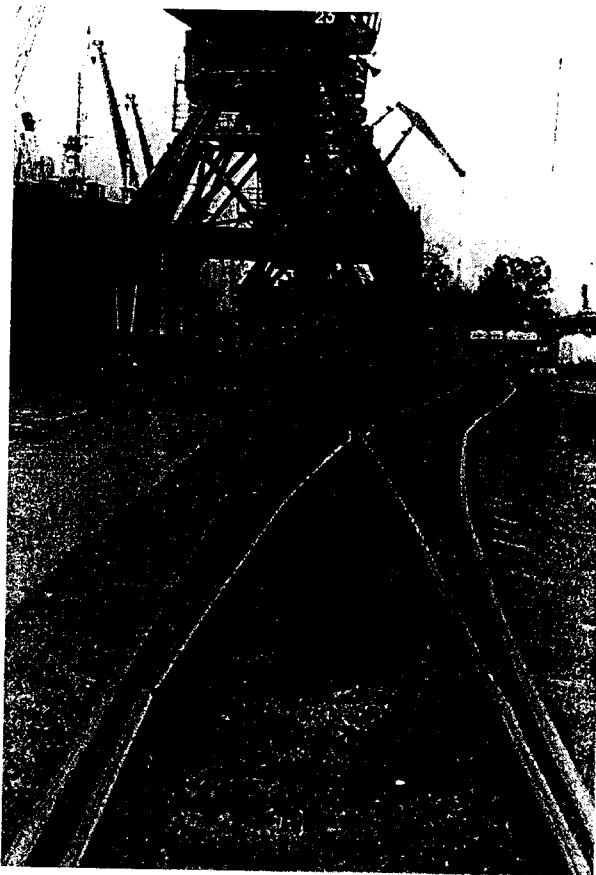
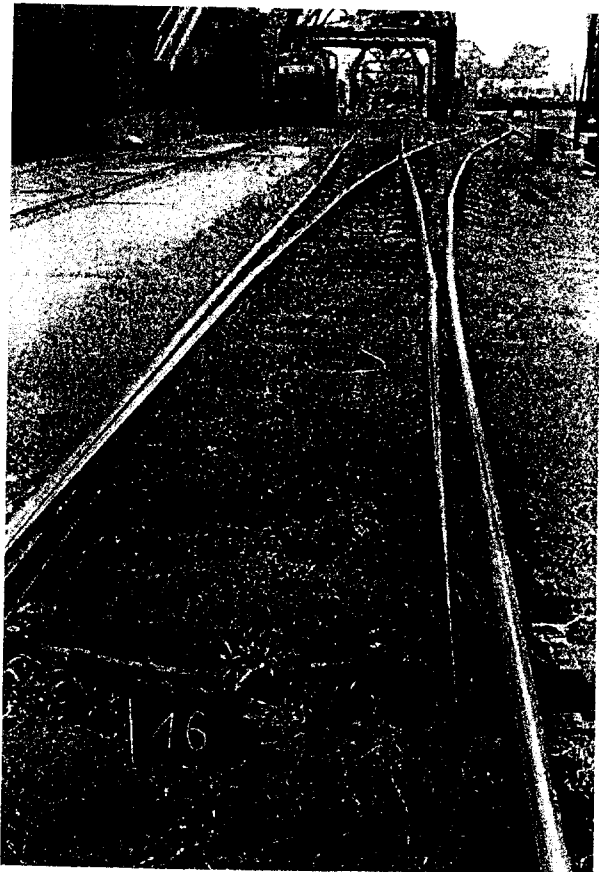
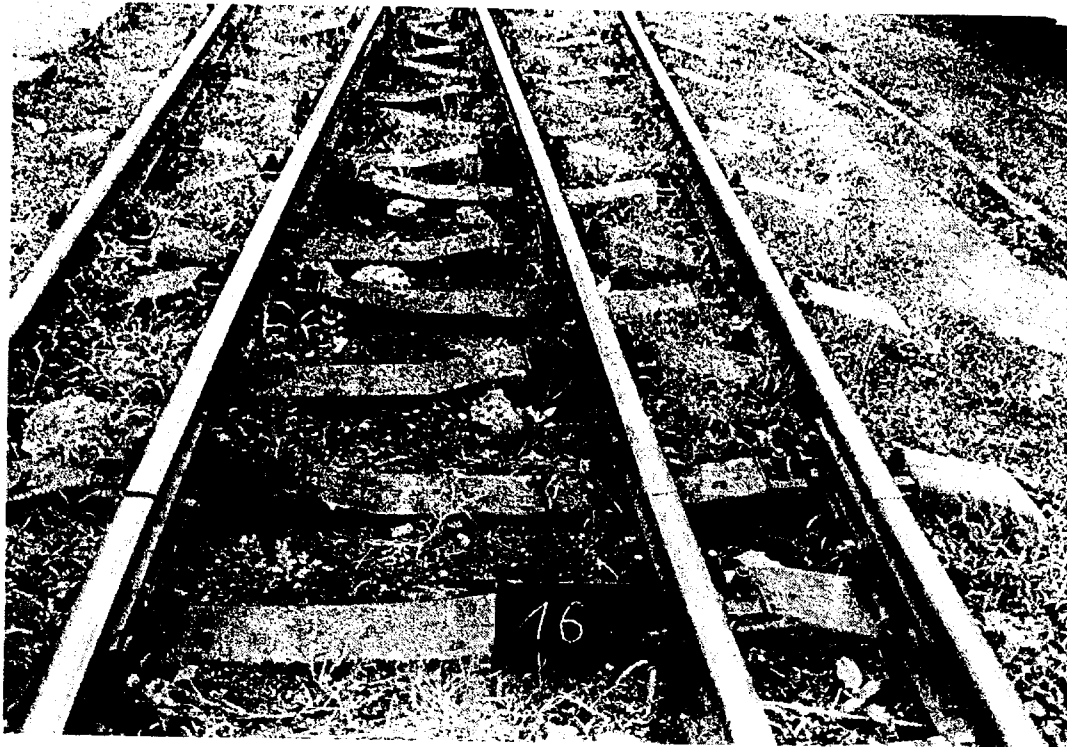
Switch / Стрелка N° 16

General Condition

The switch is filled up to the half of the height of the sleepers with ballast. The sleepers are overgrown with grass. The bedding is very humid. Due to the lack of long sleepers and the use of normal sleepers in the central and frog parts of each switch, in the central part the sleepers are located almost side by side. Nails and rail-fittings are loose. The concrete sleepers are partly torn.

General condition: Poor

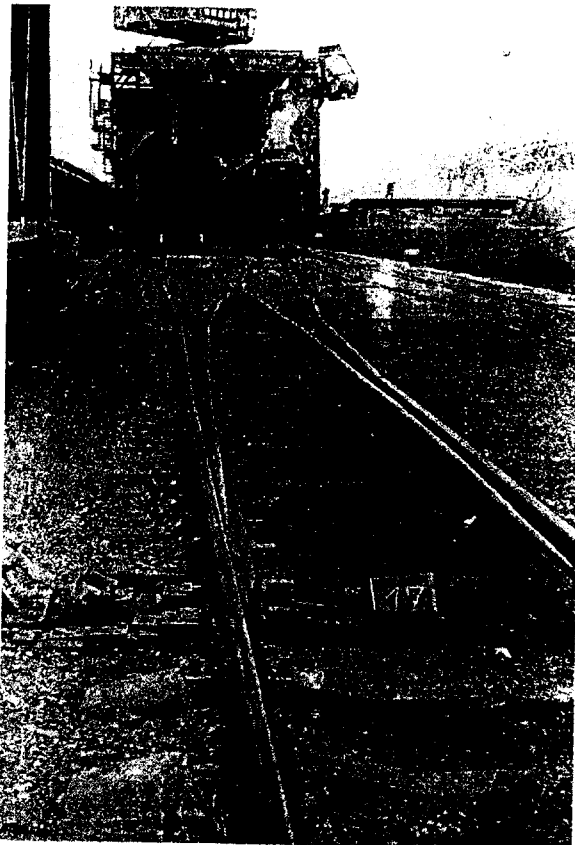
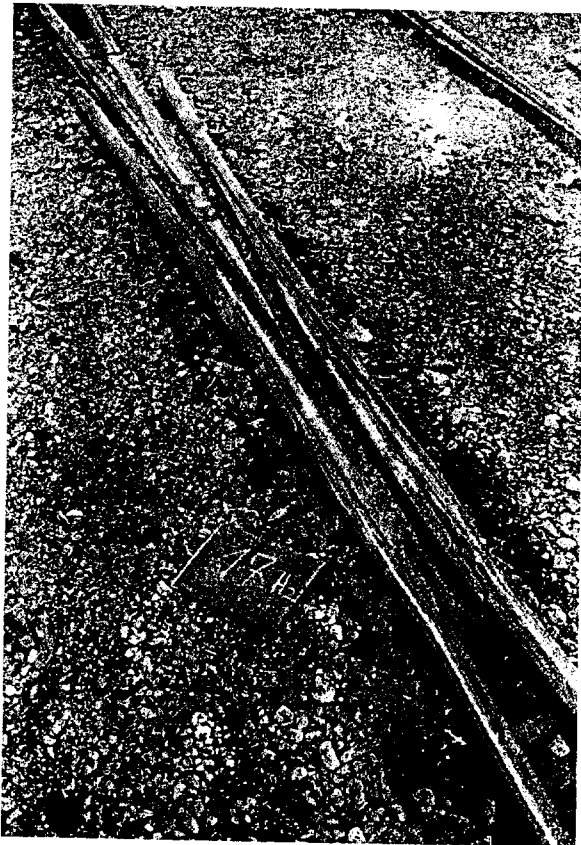
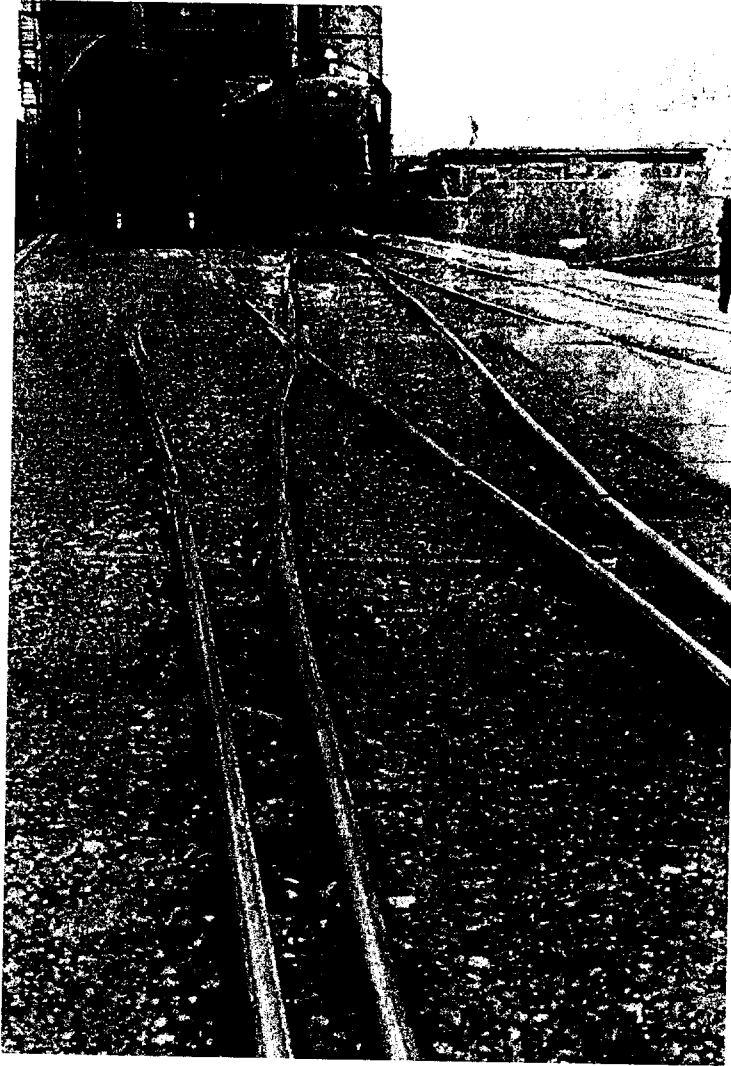
Switch / Стрелка N° 17

General Condition

The switch is filled up to the top of the sleepers with ballast. Due to the lack of long sleepers and the use of normal sleepers in the central and frog parts of each switch, in the central part the sleepers are located almost side by side. The central and frog part areas as well as the rail joints are moving up and down during a pass over. Nails and rail-fittings are loose.

General condition: Poor.

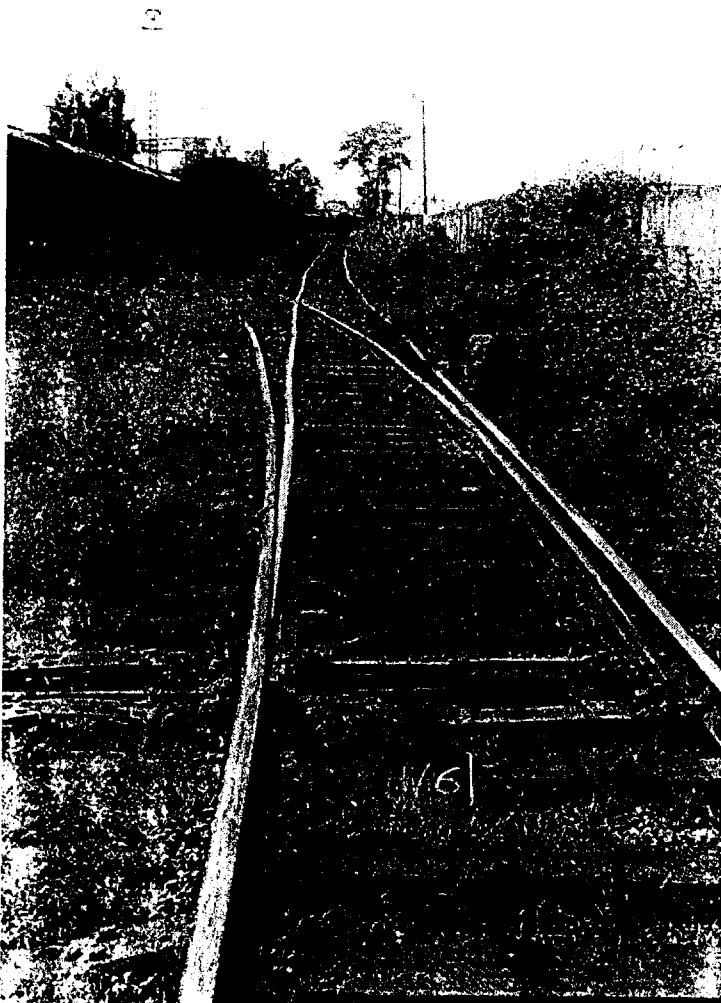
Track / рейльсовый путь N° 05

General Condition

The track is covered up to half of the height of the sleepers in the area between switch W03 to switch W06 the remaining part is covered up to the top of the sleepers. The whole area is very overgrown with grass. The fastenings of the rails are mainly loose. The rails are partly worn into the contact area of the sleepers. The track bends. The surfaces of the rails are worn out. In the area in front of switch 06 the sleepers are old and have mainly moved into a diagonal position, they have different distances from 70 cm to 110 cm.

General condition: Poor.

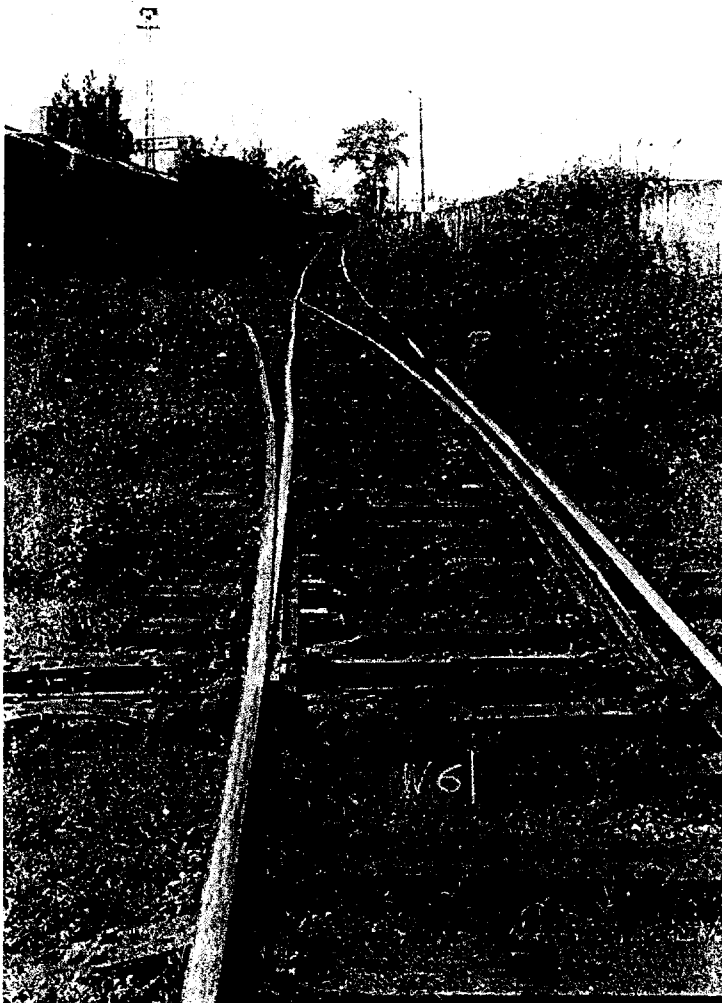
Track / рейльсовый путь N° 06

General Condition

The track is covered up to the top of the sleepers. The area is very overgrown with grass. The fastenings of the rails are mainly loose. The rails are partly worn into the contact area of the sleepers. The track bends. The surfaces of the rails are worn out. The track is highly frequented. About 140 m before the termination point there is a weigh-bridge which is used to weigh the outgoing loaded carriages.

General condition: Poor.

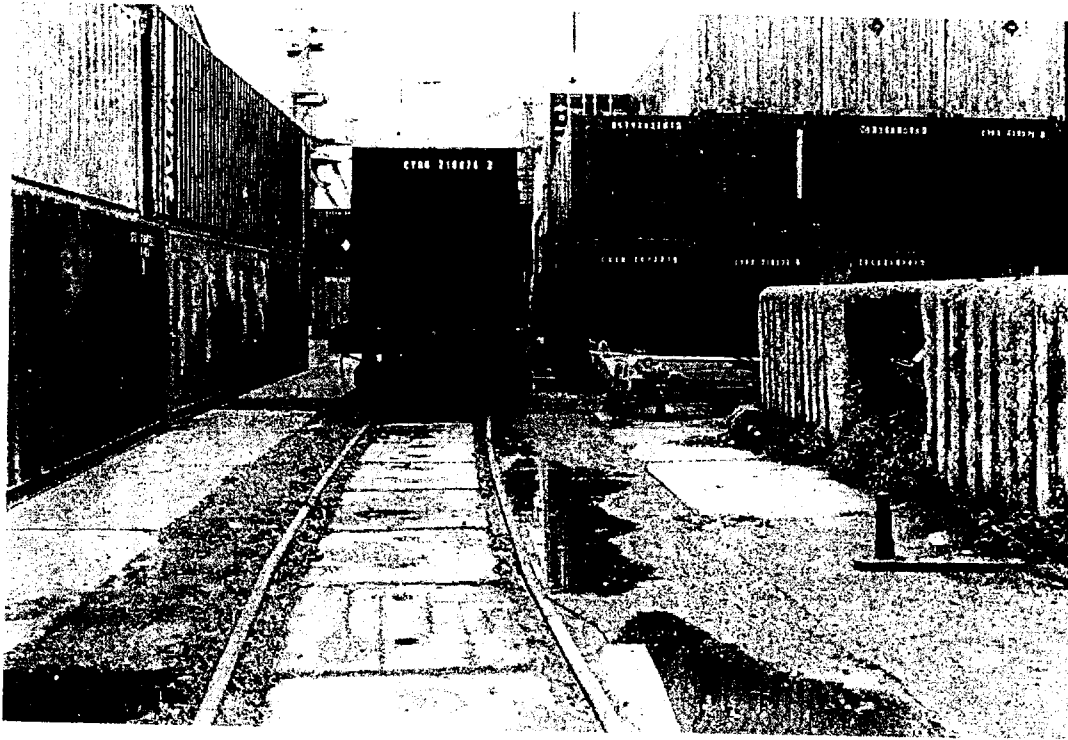
Track / рейсовый путь N° 07

General Condition

The track is covered up to the top of the sleepers. Behind switch 12 the track is entirely bare on the ground, it is overgrown with grass. The bedding is humid, due to stagnant water. The rails joints are not stable, they are moving up and down during a pass over. The lugs are attached to the rail-ends with one screw only, they are partly loose. Because of this the rail joints are partly acute-angled in the curve. Behind the gate the track is placed on concrete plates and passable, it has the same level as the crane sleepers.

General condition: Fair.

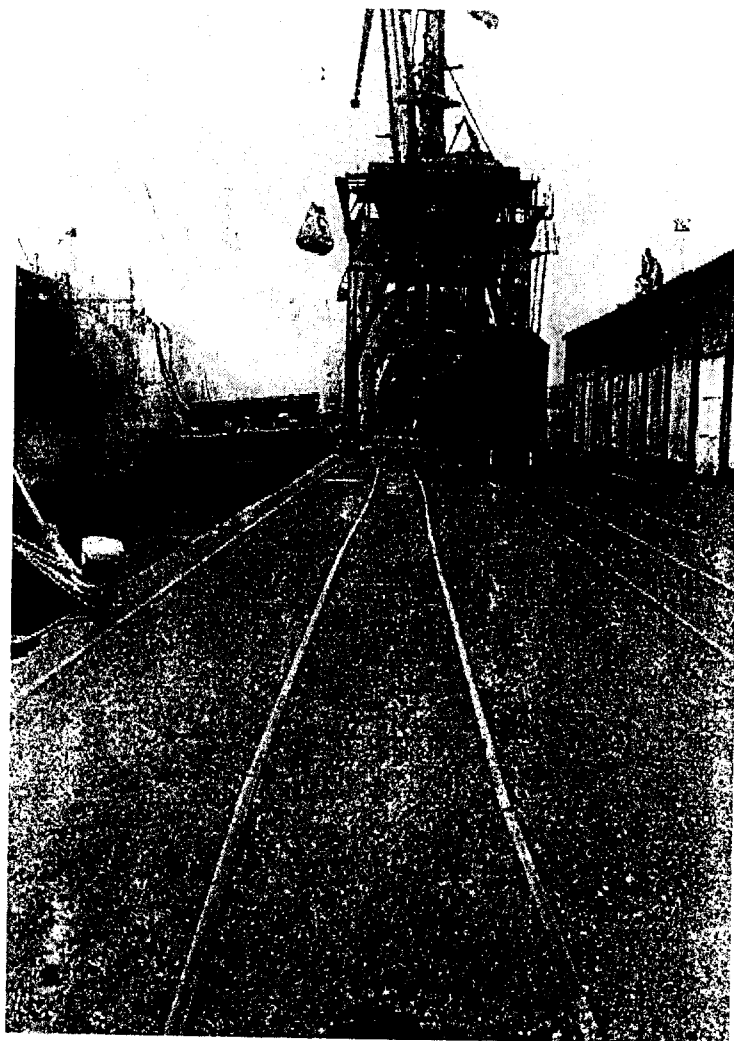
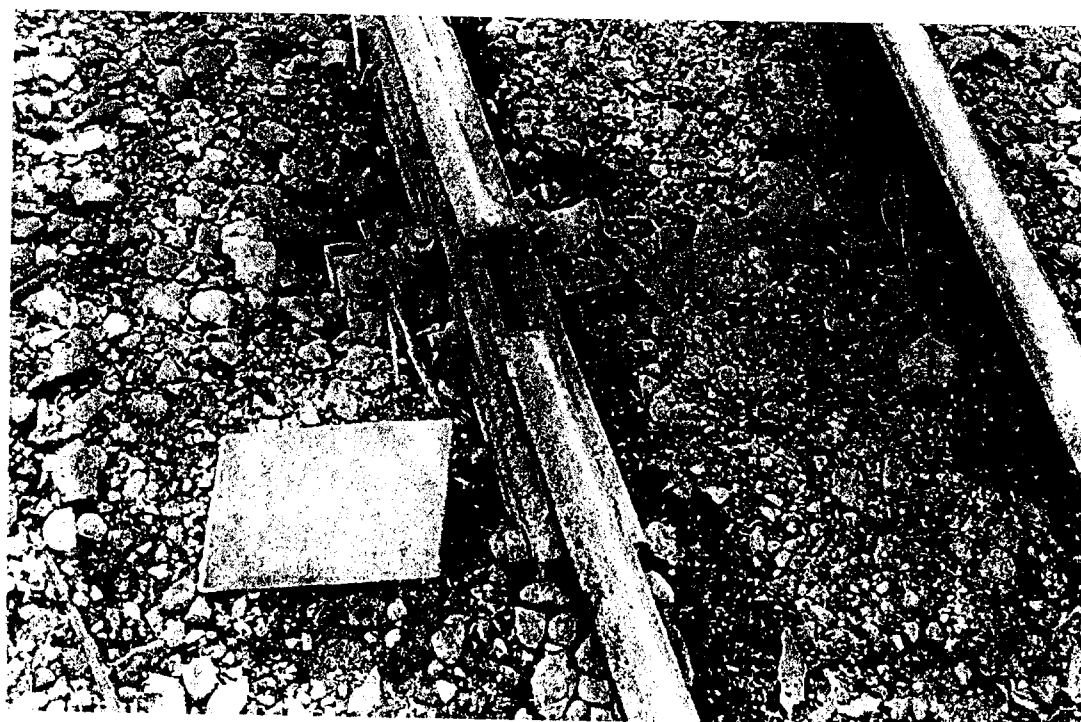
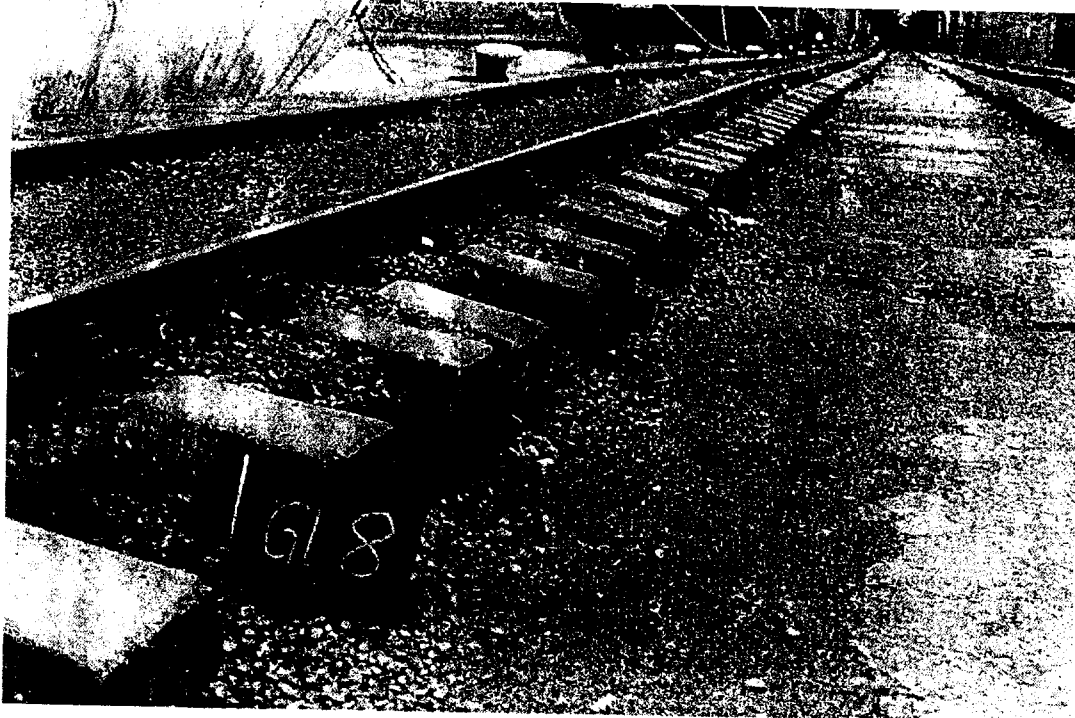
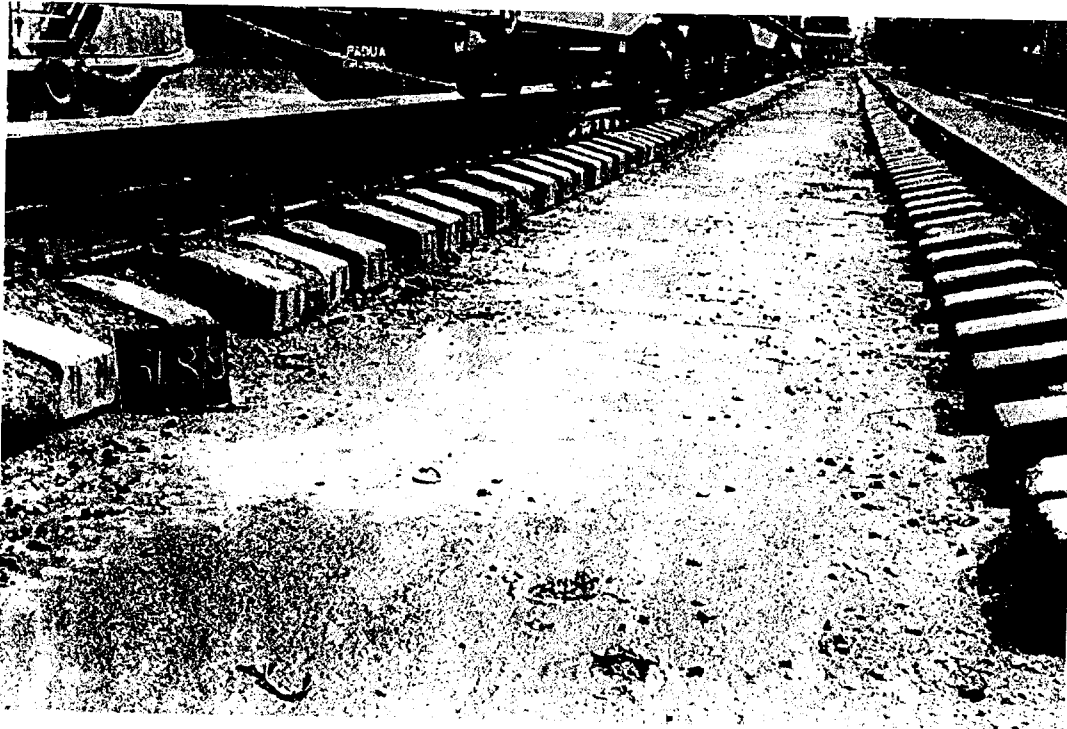
Track / рейсовый путь N° 08

General Condition

Due to the construction of the quay-wall (continuous concrete plate) the track is entirely bare upon this plate of concrete on a 5 cm thick layer of fine ballast. The bays of the sleepers have different sizes from 30 cm to 120 cm and are filled with a mixture of lean concrete and ballast. The filling at the head of the sleepers is missing, therefore the track is not stable in that direction. The difference of the top of the crane rails and the level of the railroad is 35 - 40 cm.

General condition: Fair - Poor.

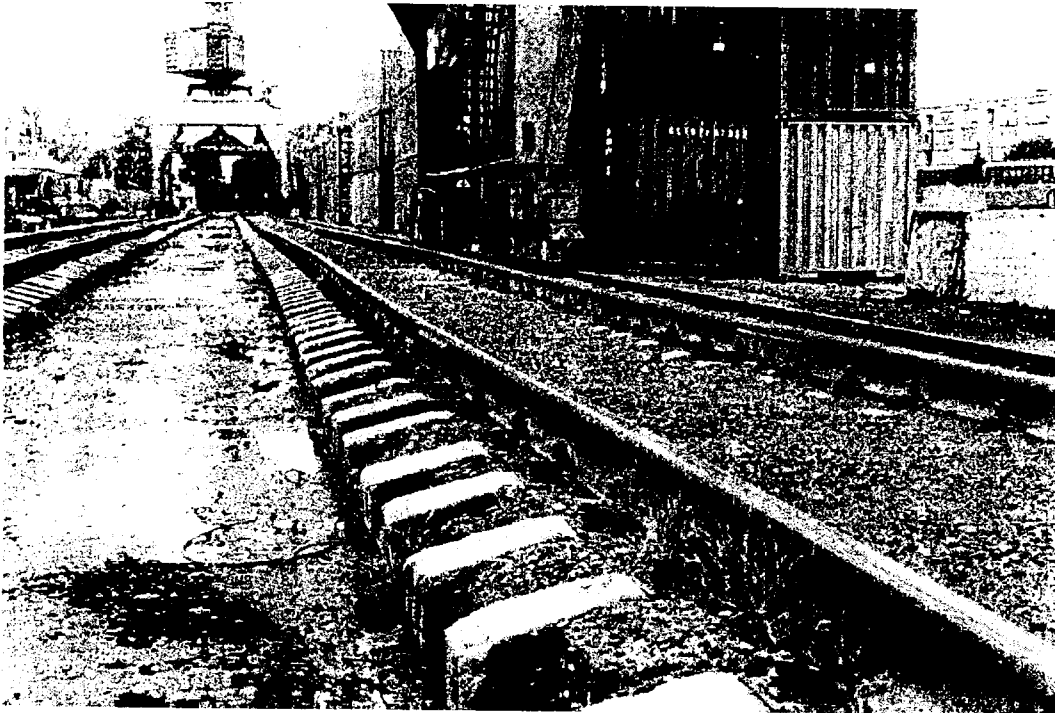
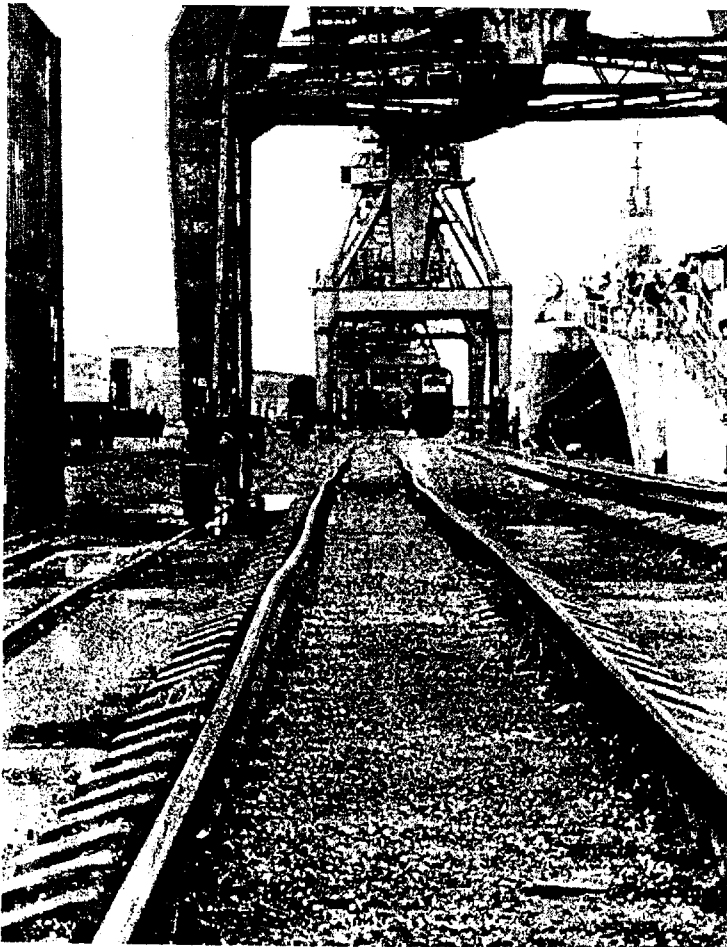
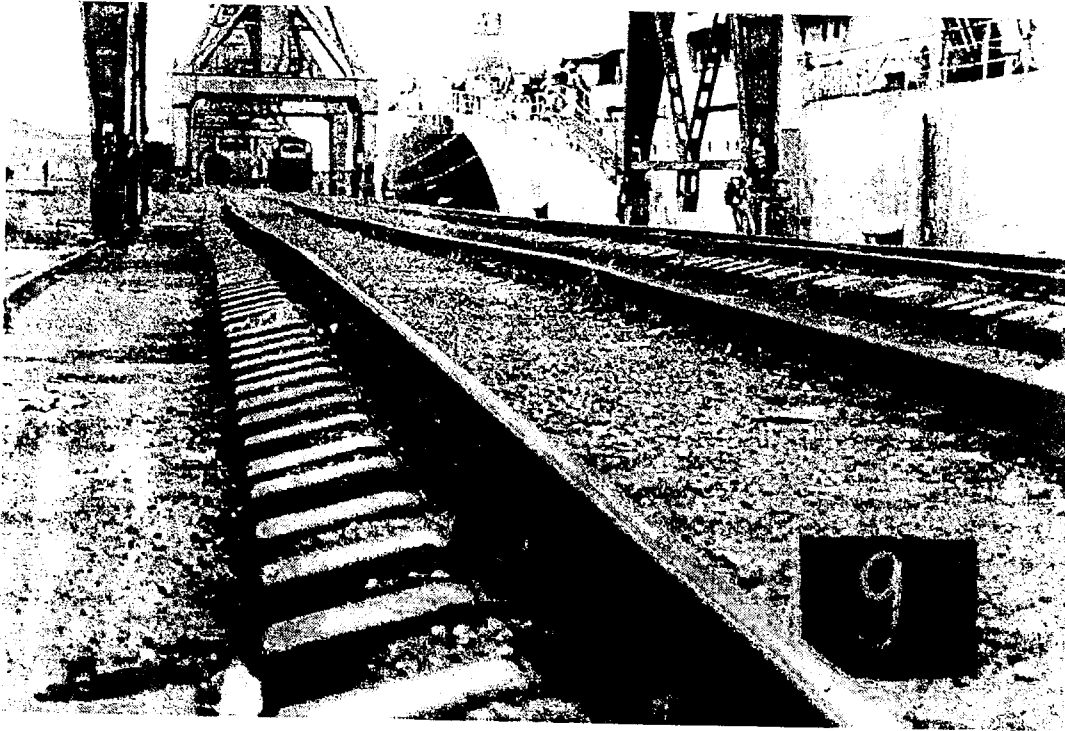
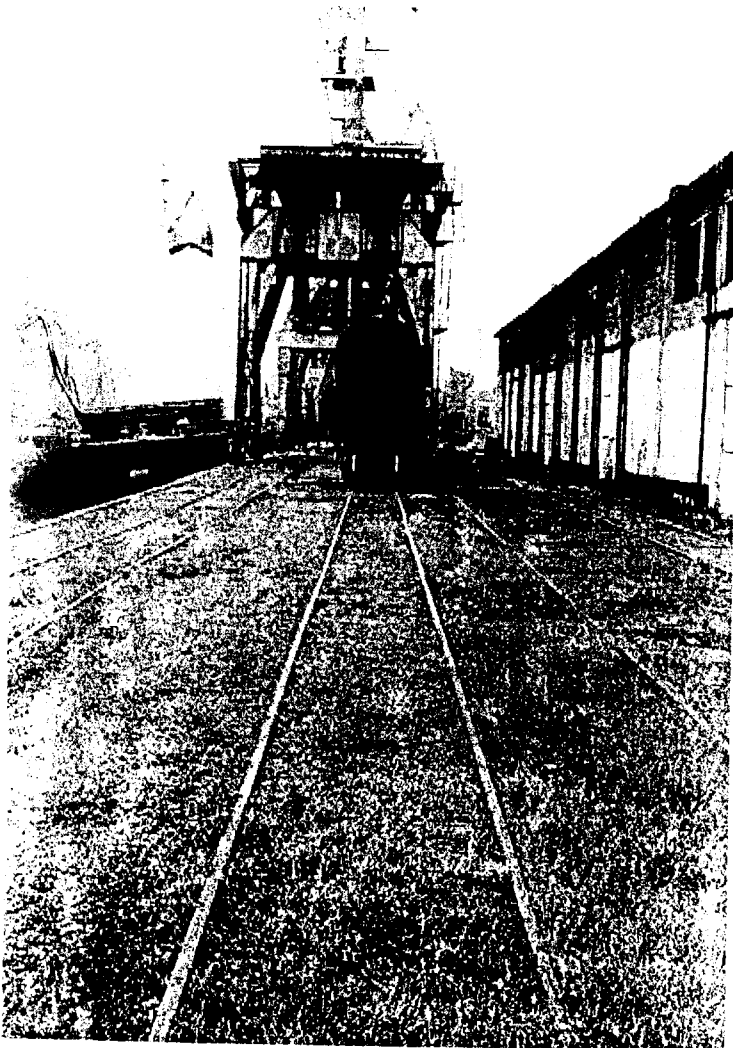
Track / рейсовый путь № 00

General Condition

Due to the construction of the quay-wall (continuous concrete plate) the track is entirely bare upon this plate of concrete on a 5 cm thick layer of fine ballast. The bays of the sleepers have different sizes from 30 cm to 120 cm and are filled with a mixture of lean concrete and ballast. The filling at the head of the sleepers is missing, therefore the track is not stable in that direction. The difference of the top of the crane rails and the level of the railroad is 35 - 40 cm.

General condition: Fair - Poor.

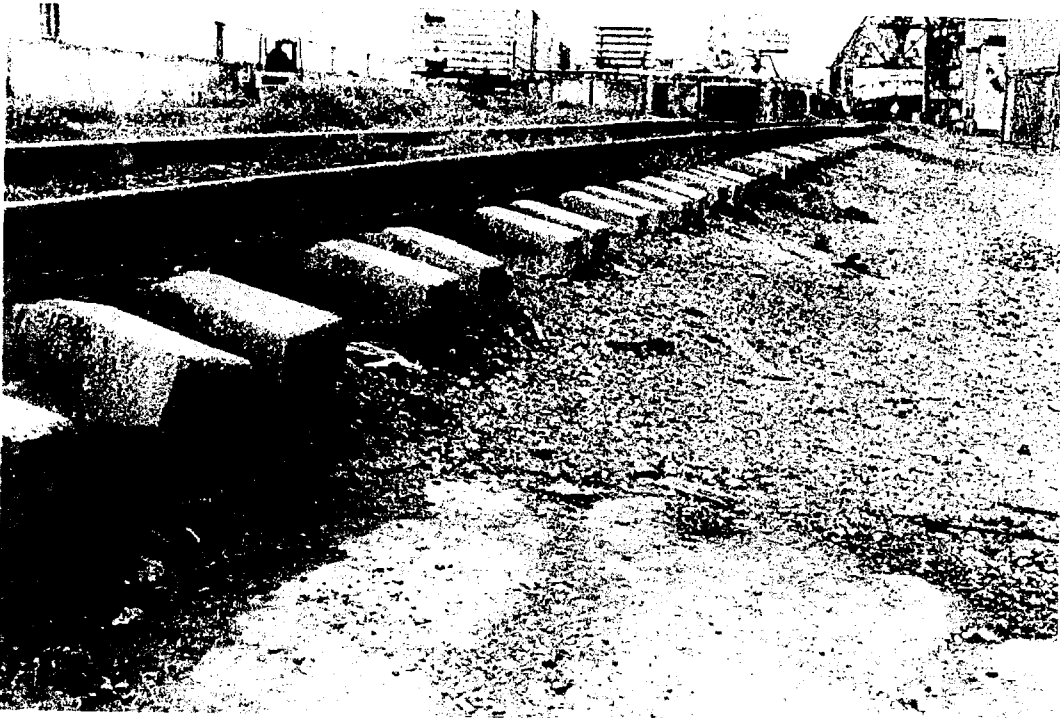
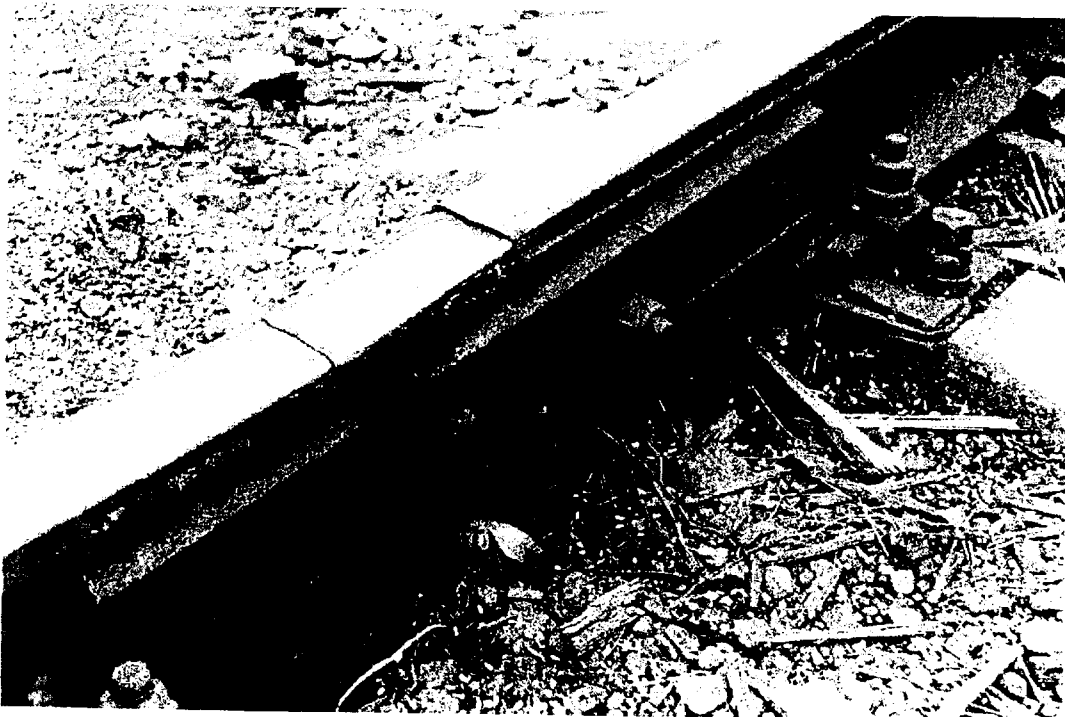
Track / рейльсовый путь № 11

General Condition

Area behind switch W14, right branch: The track is partly covered up to half of the height of the sleepers. At the head of the sleepers the bedding is partly missing. The sleepers are uneven, some of them are tipped over. The rail joints are not stable, they are heavily moving up and down during a pass over. In the area of the ramp the fastenings of the rails are partly torn out of the sleepers.

The track runs parallel to the loading road. The surface water from the road is running into the track. It is overgrown with grass. Due to the humid ground the rail joints are not stable, they are heavily moving up and down during a pass over. The screws of the lugs do not fit tight.

The track is covered up to the top of the head of the rails. Its level is a bit higher than the level of the crane rail.

General condition: Poor.

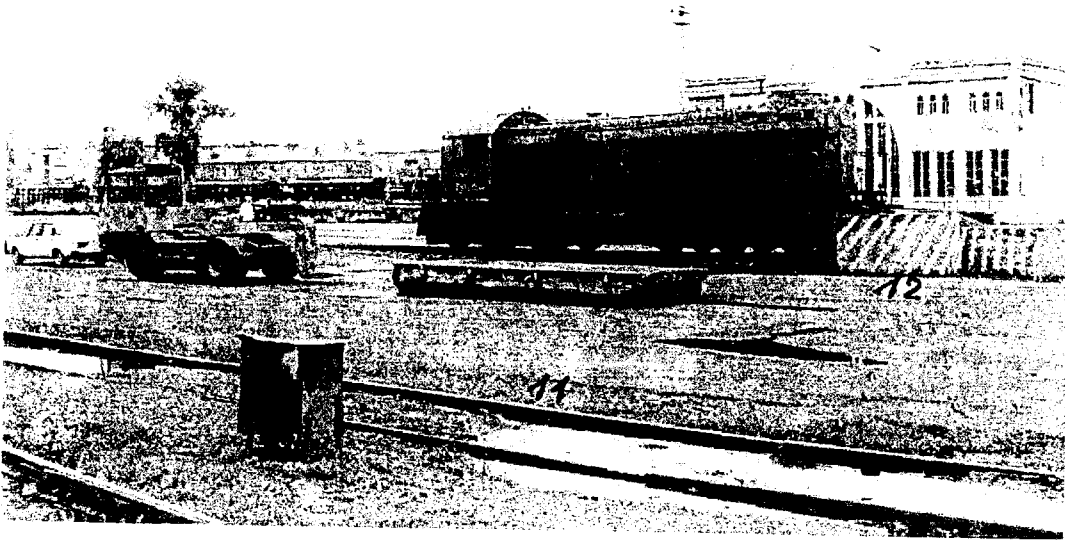
Track / рейсовый путь № 12

General Condition

The track is covered up to the top of the sleepers. The track is very overgrown with grass. The rail joints are not stable. The fastenings of the rails are loose. The side running street drains into the track.

General condition: Poor.

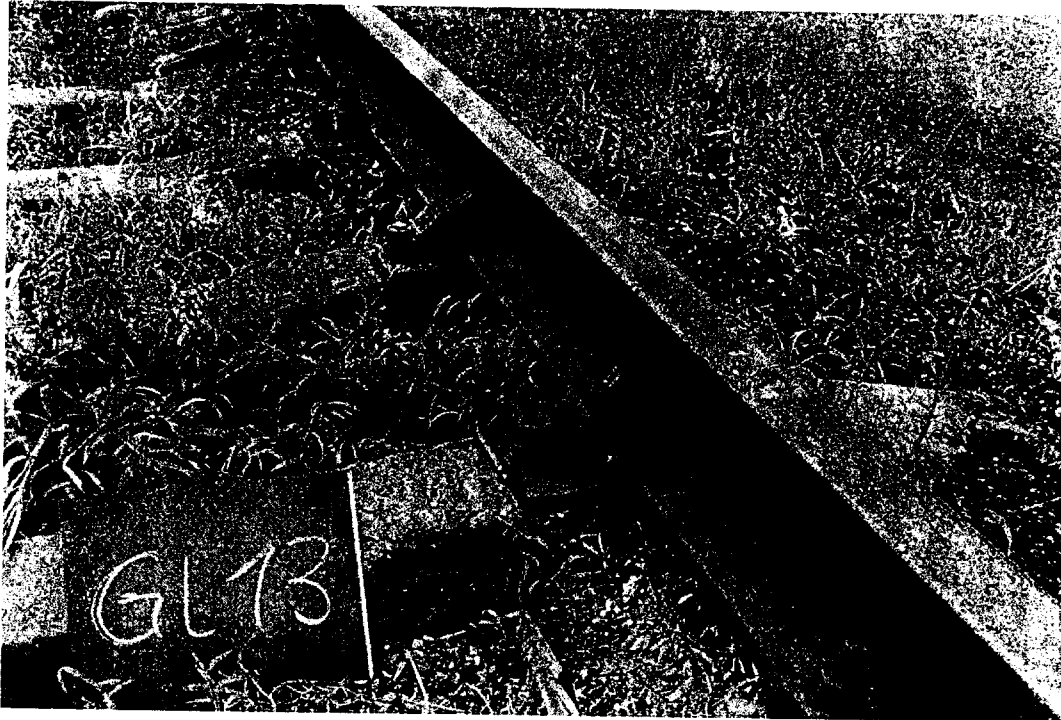
Track / рейльсовый путь N° 13

General Condition

The track is covered up to half of the height of the sleepers. The track is very overgrown with grass. The rail joints are not stable. The fastenings of the rails are loose. The side running street drains into the track. Ongoing from the central area there is a track ramp on the right side.

General condition: Poor.

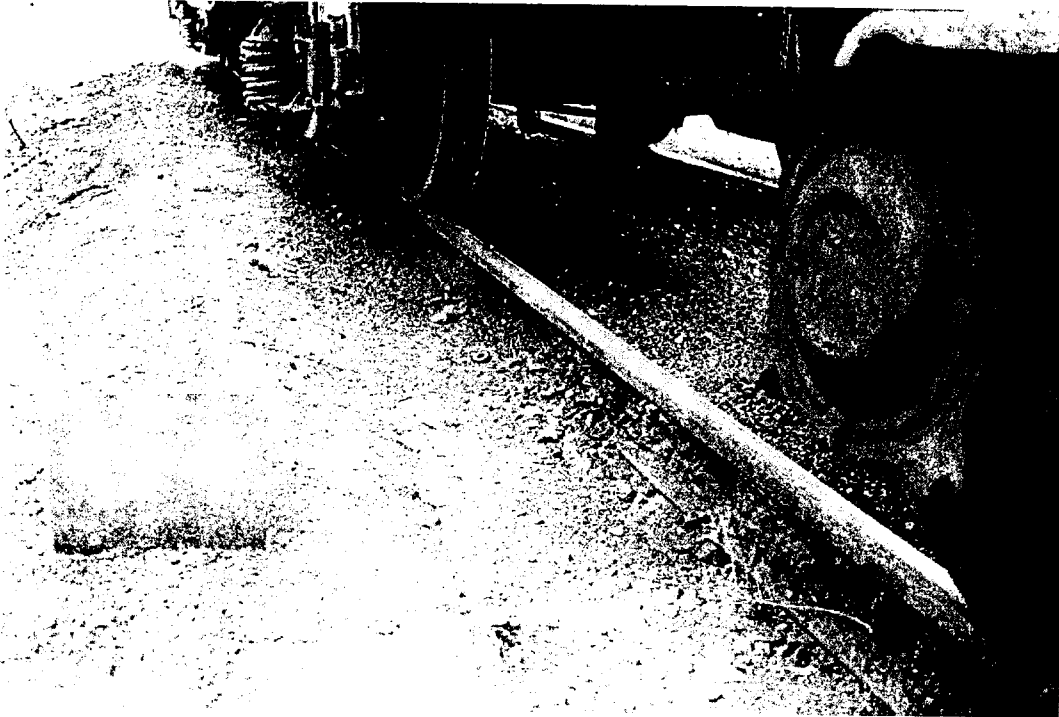
Track / рейсовый путь № 17

General Condition

General condition: Poor.
