Feasibility Study of New Terminal
Facilities of the Georgian Ports Plan

Survey of the railway installations in the port of Poti

Annex 9

Review of Present Facilities under Railway Engineering Aspects

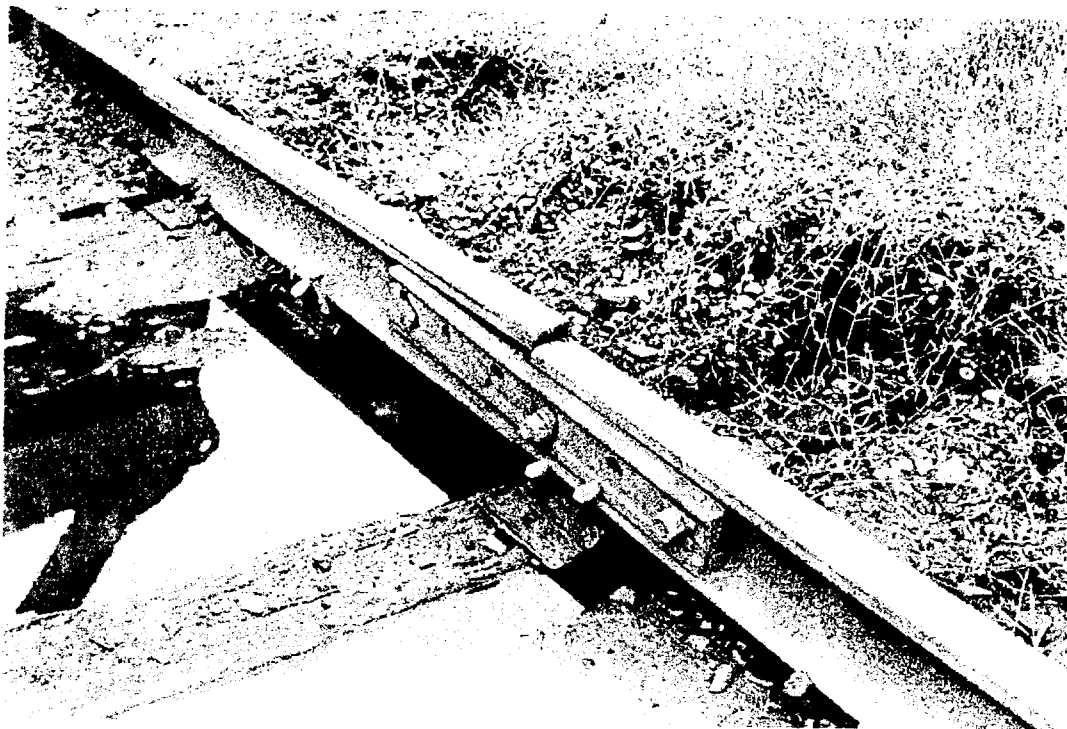
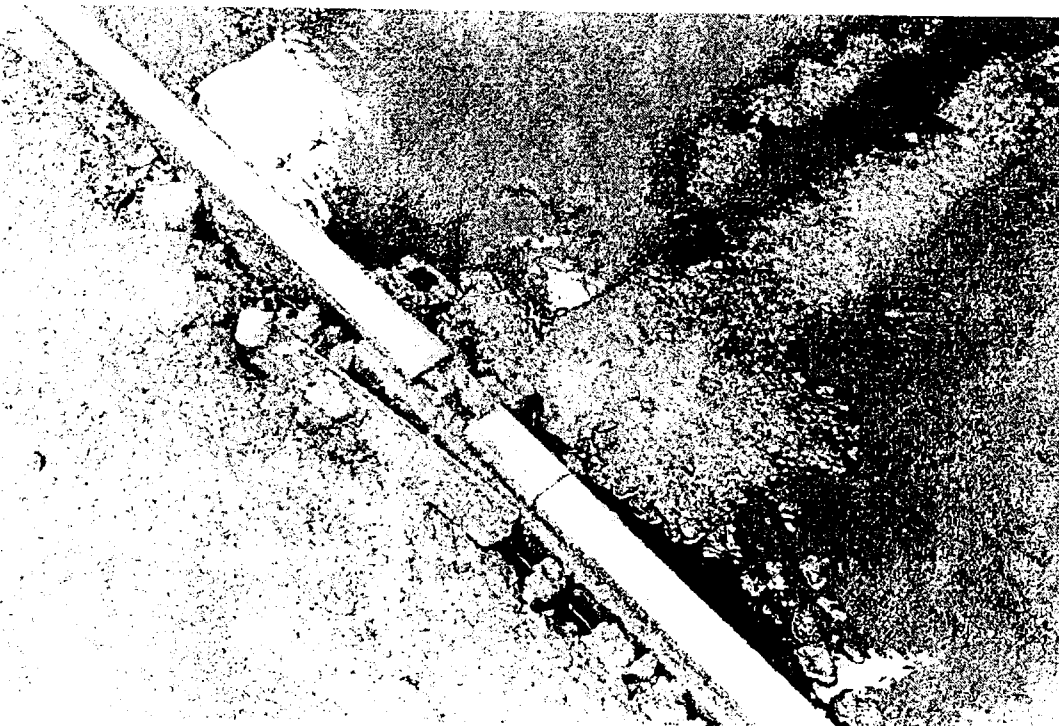
Track / рейльсовый путь N° 28

General Condition

General condition: Fair.
