Feasibility Study of New Terminal
Facilities of the Georgian Ports Plan
Survey of the railway installations in the port of Batumi
Annex 10
30 October 1997

Volume III - Annex 10

Review of Present Facilities under Railway Engineering Aspects

1 Survey of the railway installations in the port of Batumi

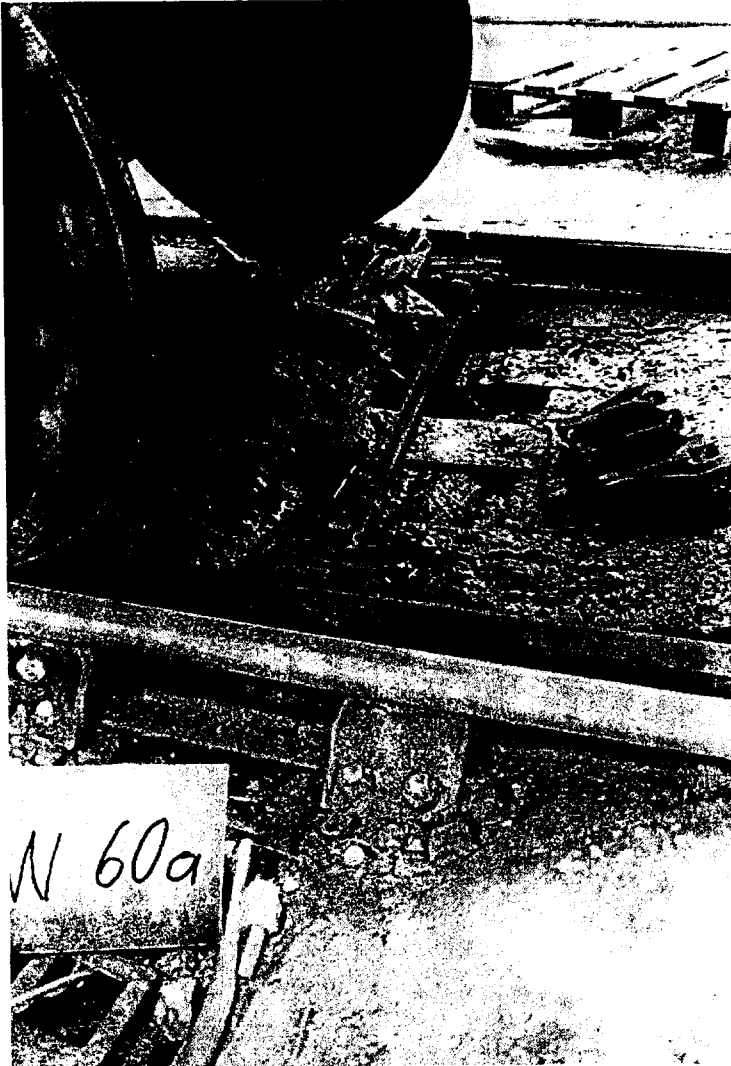
Switch / Стрелка N° 60a

The switch is covered up to the top of the head of the rails with asphalt, the parallel area is covered with asphalt as well. The frog part area and the rail joints are moving up and down during a pass over. As a consequence the surface fastening is partly broken. There is stagnant water in this area. The channel of the switch is silted. Due to traffic the stretcher rod bends. To avoid further bending it was under laid by plates.

General condition: Fair

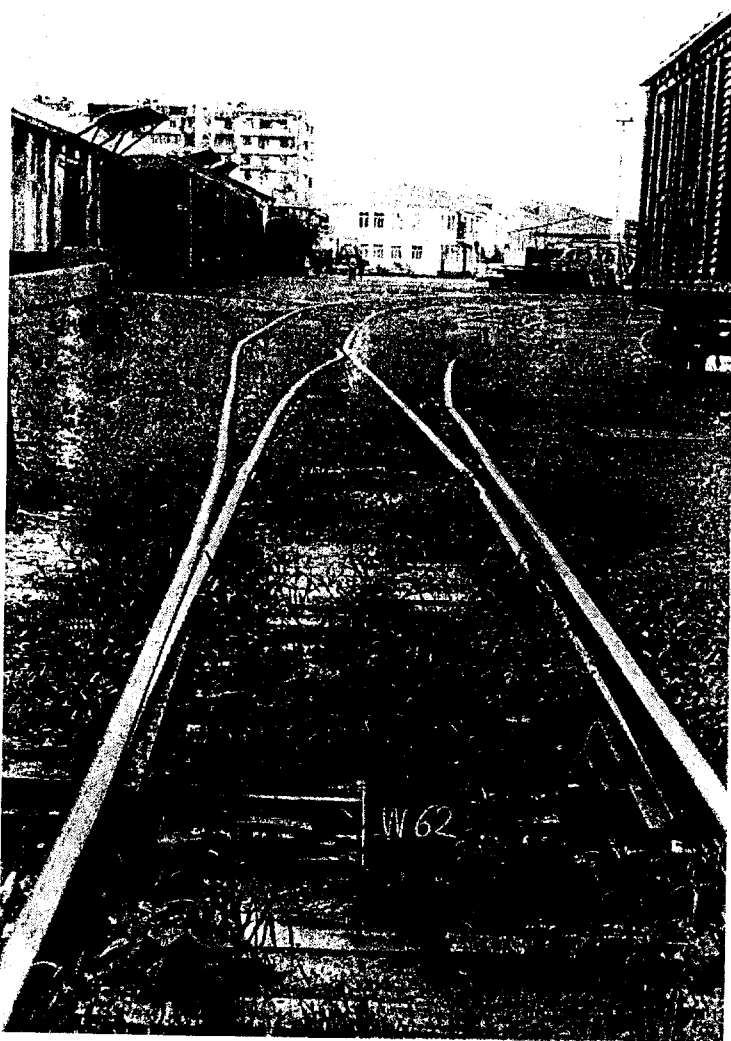
Switch / Стрелка N° 62

The switch turned into a switch with an external arch. It is filled up to the top of the sleepers and overgrown with cabbage. The switch blade lies in the water and is silted. The support holders of the stock rails on the right side are missing. All fastenings are loose. The gauge is supported by holders of flat bar iron. The central sleepers are partly supported by plates. In the frog part area the guard rails are loose. The top of the frog part gets stroked. The switch blade as well as the frog part areas are heavily moving up and down during a pass over. The screwing of the lugs are loose. The joints are acute in the arch.

General condition: Poor.

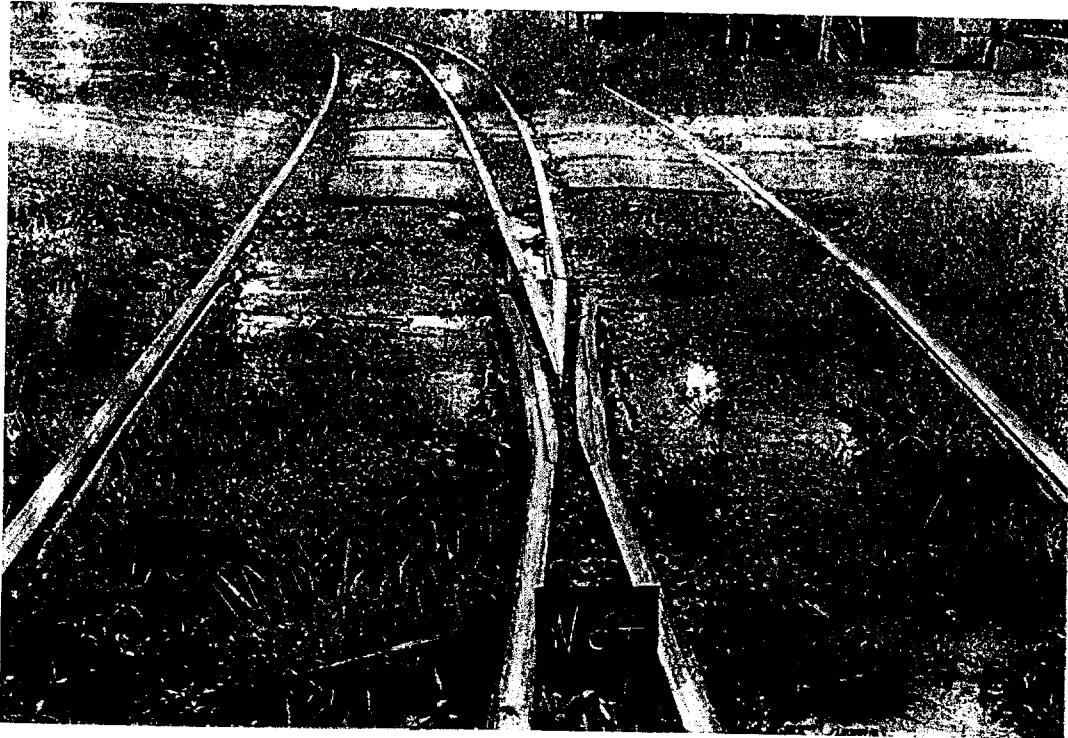
Switch / Стрелка N° 64

The switch is filled up to the top of the sleepers, it is overgrown with grass. At the central and the frog part areas the rails of the switch lie on long through line sleepers. The slide chairs are nailed and the stock rails bolted. All fastenings are loose. At the branch rails the gauge is supported by holders of flat bar iron. There is water in the central and the frog part areas. These areas as well as the joints are moving up and down during a pass over. The bedding is silted. The screwing of the lugs are loose. The joints are acute in the arch. Behind the frog part the track on the right side bends very much to the left side.

General condition: Poor.

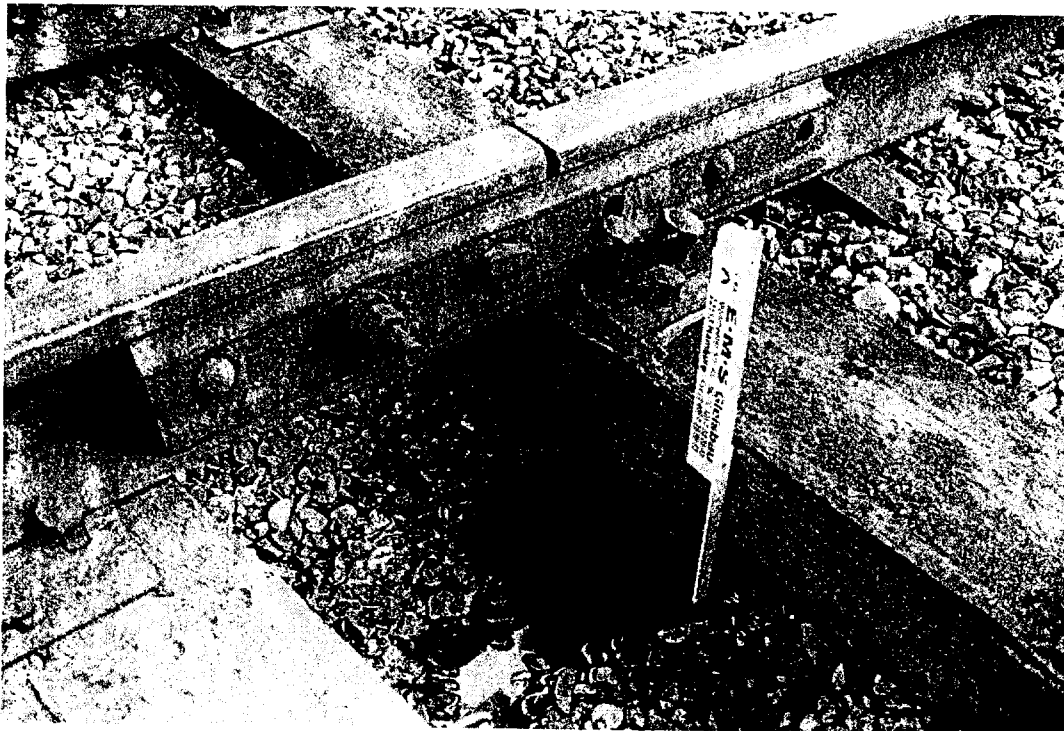
Switch / Стрелка N° 64a

The switch was repaired short time ago. The bedding of the switch is uneven. At the internal rails of the central part the bedding is missing. Under the sleepers lies 10 cm bedding up to the concrete quay plate. The fastenings of the nails are partly loose, as well as the screwing of the lugs and the supporting brackets of the stock rails. To keep the gauge running straight holders are installed as support. The guard rails are loose therefore the top of the frog part gets stroked. There is water under the switch. At the blade area draining takes place through an outlet leading directly into the water of the port. The joints are considerable stable. In the central and the frog part areas there are long sleepers. The gradient of the switches 64a and 64b does not fit to the interval of the tracks and the switches. The switch connection lies steeper and therefore bends strongly behind the frog parts of the two switches.

General condition: Fair - Good

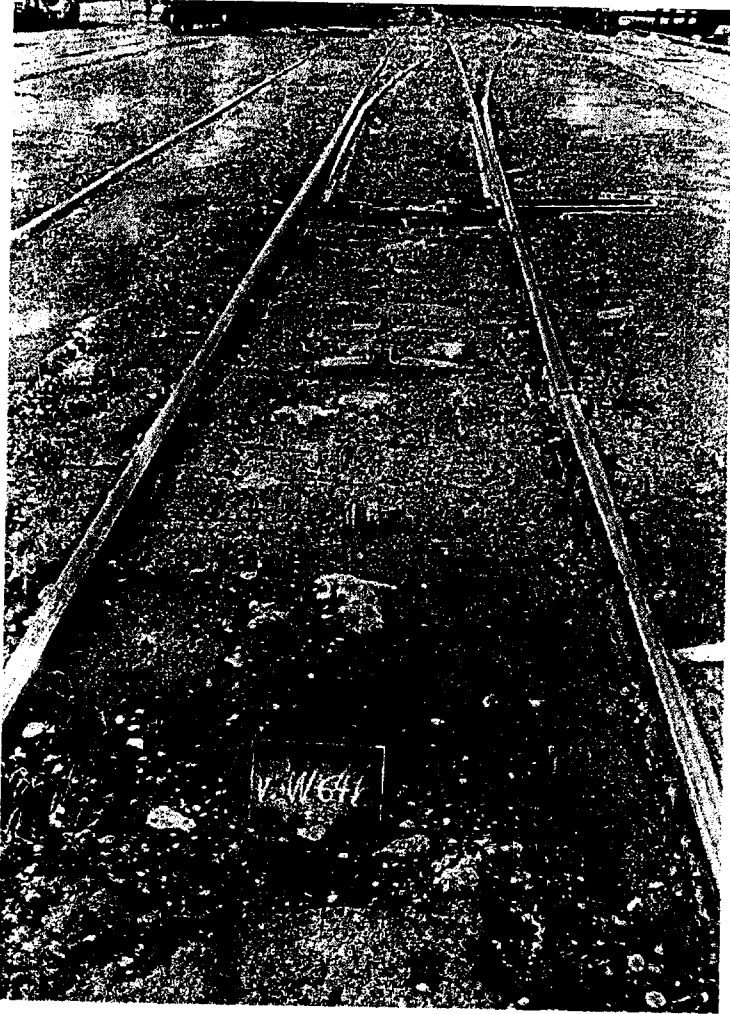
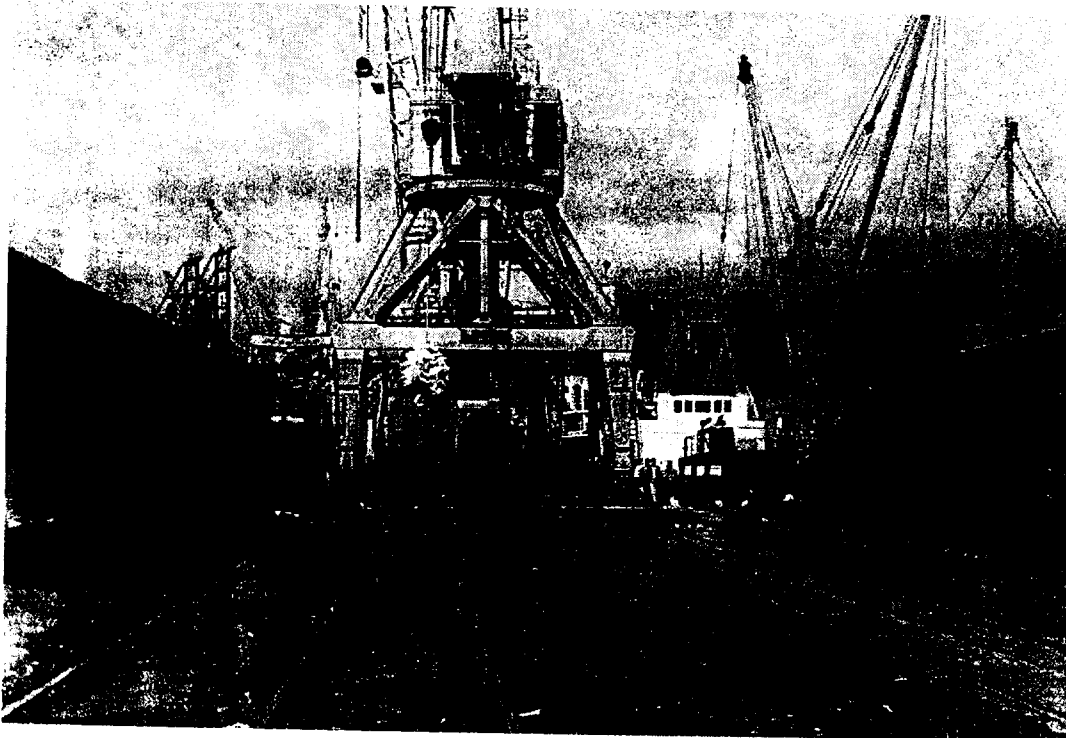
N° 64b

The switch is filled up to the top of the rails. All fastenings are loose. There is stagnant water in the central and the frog part areas. These areas as well as the joints are heavily moving up and down during a pass over. The bedding is silted. The sleepers are partly destroyed in the areas of the joints. The guard rails are loose.

Behind the frog part the screwing of the joints are loose they are moving heavily up and down during a pass over. The bedding is silted. In the joint area the sleepers are destroyed. The gradient of the switches 64a and 64b does not fit to the interval of the tracks and the switches. The switch connection lies steeper and therefore bends strongly behind the frog parts of the two switches.

General condition: Poor.

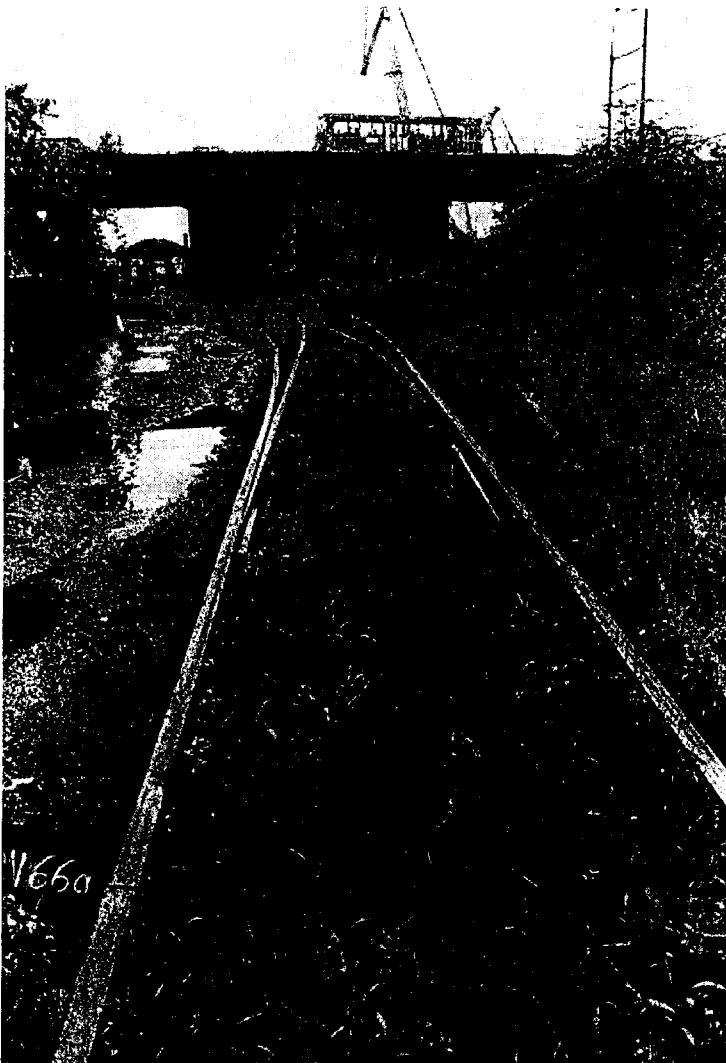
N° 66a

The switch turned into a switch with an internal arch. It is filled up to the top of the sleepers. The switch as well as the switching equipment and the rod channel lie under water and are very overgrown with cabbage. At the central and the frog part areas the rails of the switch lie on long through line sleepers. The slide chairs are nailed and the support holders of the stock rails are bolted. The top of the switch blade on the right side lies 15 cm behind the left one (standard: equal position, rectangular to the stock rails). All fastenings are loose. The gauge is supported by holders of flat bar iron. The blade and the frog part areas are moving up and down during a pass over. The screwing of the lugs are loose. The joints are acute in the arch

General condition: Poor.

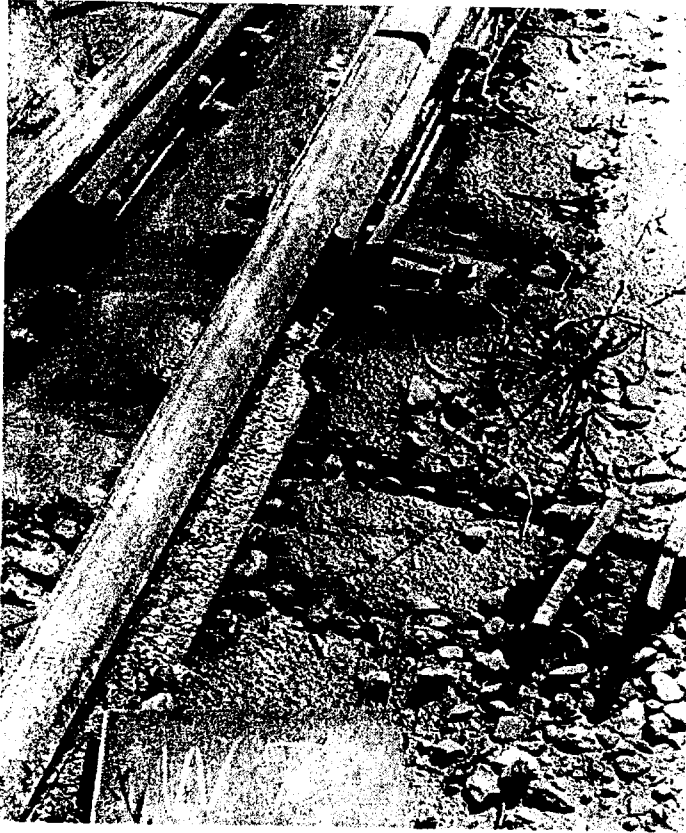
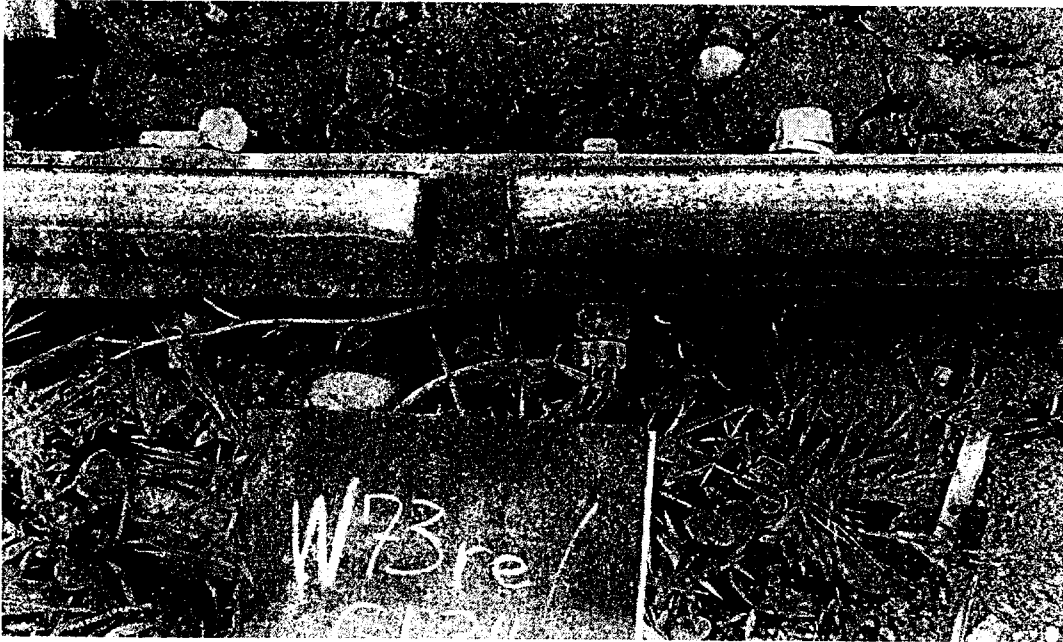
Switch / Стрелка N° 73

The switch turned into a switch with an internal arch. It is filled up to the top of the sleepers. The switch as well as the switching equipment and the rod channel lie under water and are very overgrown with cabbage. The water can not run off because the location of the switch is lower than the level of the parallel area. The central part is silted. The fastenings and the screwing are loose. The rails are worn out and have a ridge. The guard rails are loose. The top of the frog part gets stroked on the left side. The gauge is supported by holders. The screwing of the gauge holders are partly loose. The switch is heavily moving up and down during a pass over. The screwing of the lugs are lose. The joints are acute in the arch. The joint gaps are partly filled in by adapters.

General condition: Poor.

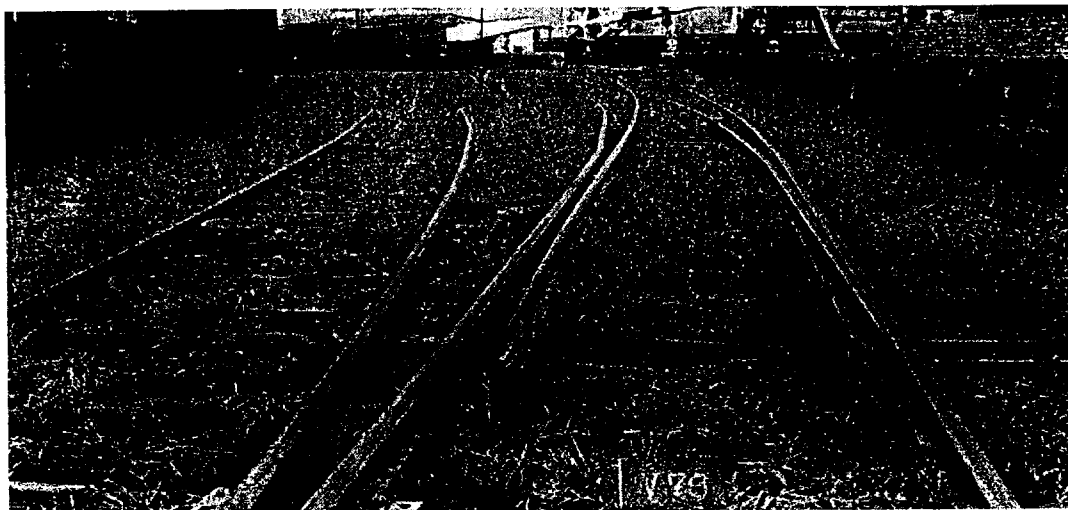
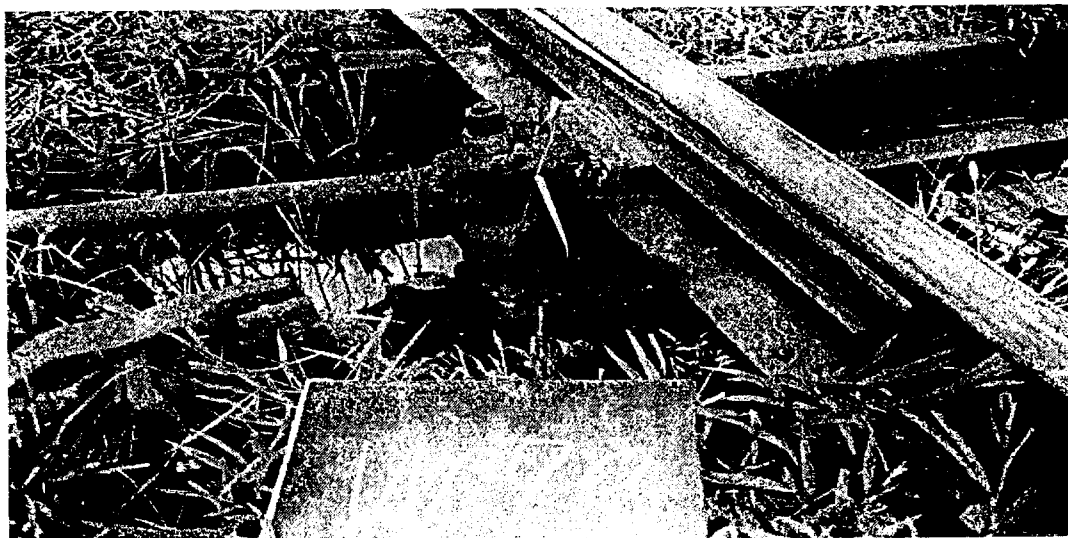
N° 79

The switch has turned into a switch with an internal arch. It is filled up to the top of the sleepers. The switch as well as the switching equipment and the rod channel lie in water and are very overgrown with cabbage. The water can not run off because the area is in-between a ramp and a wall. The slide chairs of the switch are nailed and the holders of the stock rails are attached by screws. The screws do not fit tight. The top of the switch blade at the right side is almost 25 cm in front of the left one (standard: equal position, rectangular to the stock rail). The right switch blade is broken away. The rails are worn apart and have a ridge. All fastenings are loose. In the frog part area the sleepers are partly rotten. The rails are supported by screwed-on sleepers. The top of the frog part gets stroked. The gauge is supported by holders of flat bar iron and additionally pulled-in sleepers. The screwing of the holders are partly loose. The switch is heavily moving up and down during a pass over. The screwing of the lugs are loose. The joints are acute in the arch.

General condition: Poor.

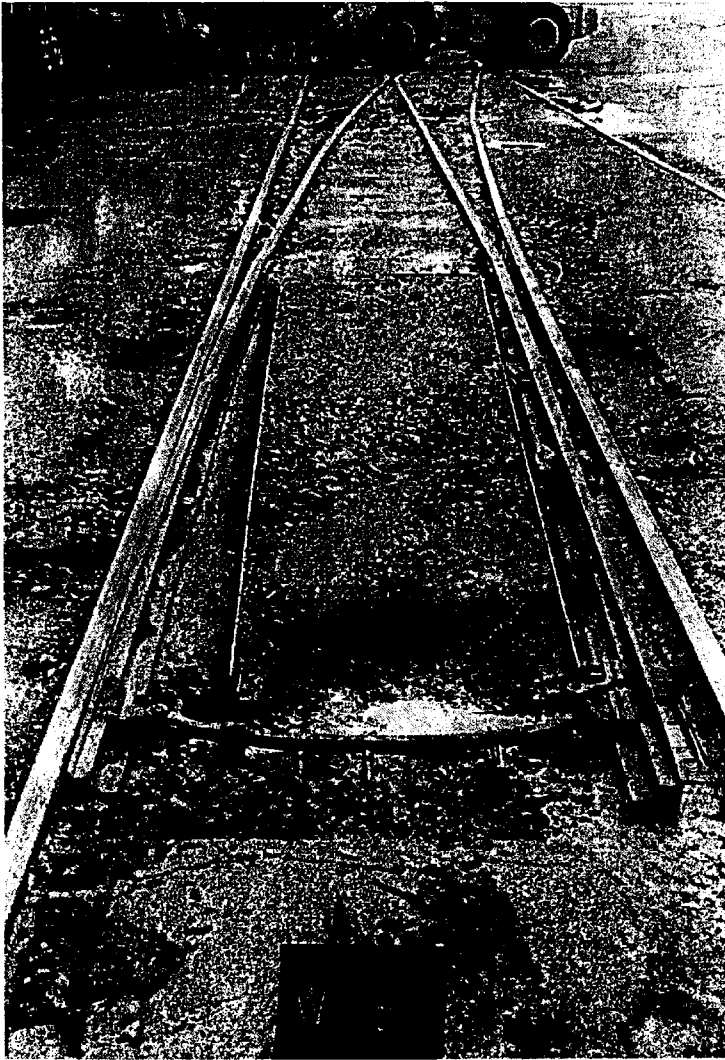
N° 83

The switch is filled up to the top of the sleepers. In the blade area and the end of the right switch ending it is covered up to the top of the head of the rails with asphalt. The joining area is also covered with asphalt. The asphalt cover left over is destroyed. In the central and the frog part areas the joints are heavily moving up and down during a pass over. As a consequence the fastening of the surface is mainly broken out. The screwing of the lugs are loose. The joints are acute in the arch. The water from the area on the right side of the track runs off into the switch. Due to this there is stagnant water in the switch and the areas are silted. The switch channel is also silted. The stretcher rod bends because of traffic. The right branch of the switch ascends behind the frog part.

General condition: Poor.

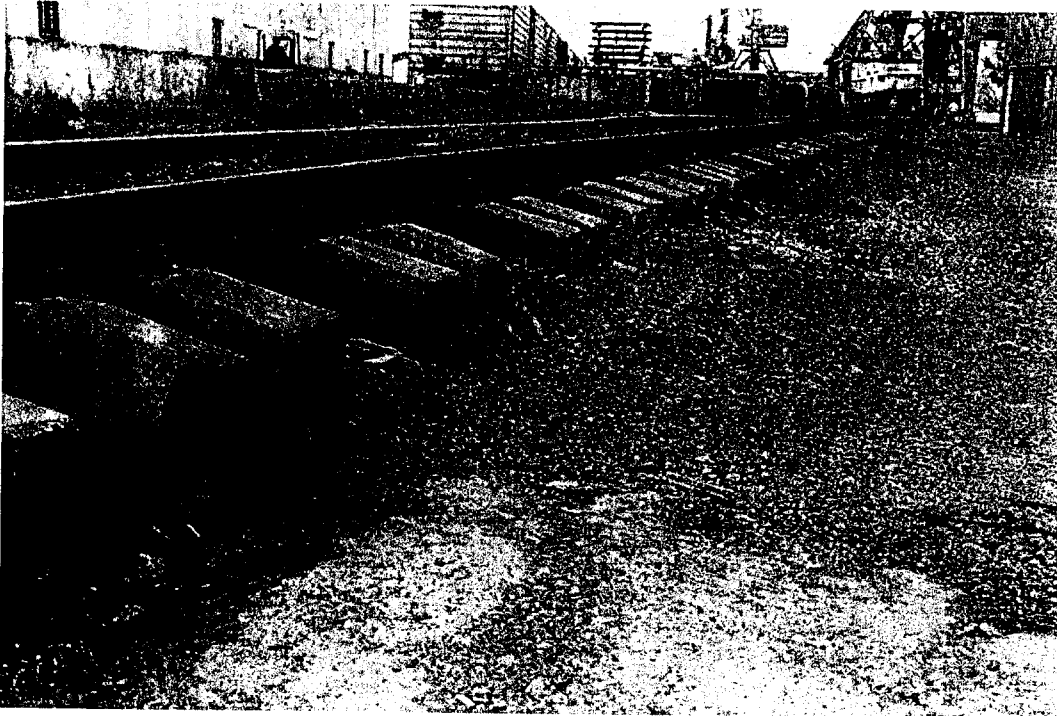
Track / рельсовый путь № А (from switch 68 to 64 / от стрелки 68 до 64)

The track is filled up to s of the height of the sleepers. Its position is parallel in-between a road and a wall. The water from the road runs off into the track area. The track lies in water and is very overgrown with cabbage. The draining takes place through an outlet by the wall. The gauge is supported by single concrete sleepers and holders of flat bar iron. The rails are worn off at their height. Adapters of a length of 15-20 cm have partly been inserted in the rail joints. The fastenings of the nails and the screwing of the lugs are loose. The joints are acute in the arch. The track is moving up and down during a pass over.

General condition: Poor.

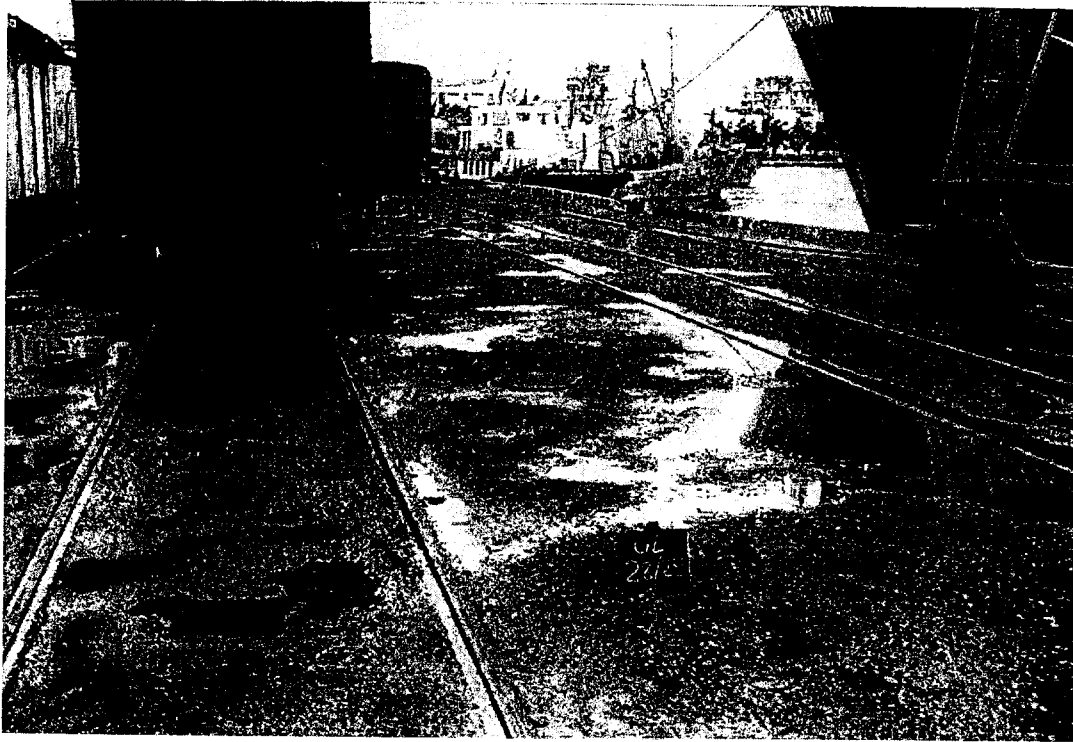
Track / рельсовый путь N° 28

The track is filled up to above the top of the sleepers and covered with asphalt up to the top of the head of the rails. The parallel area is covered with asphalt as well. The track is considerable stable. The screwing of the lugs for the rail joints are loose. The joints are moving up and down during a pass over. Due to this the surface fastening is partly broken up. In these areas there is stagnant water in the track.

General condition: Fair.

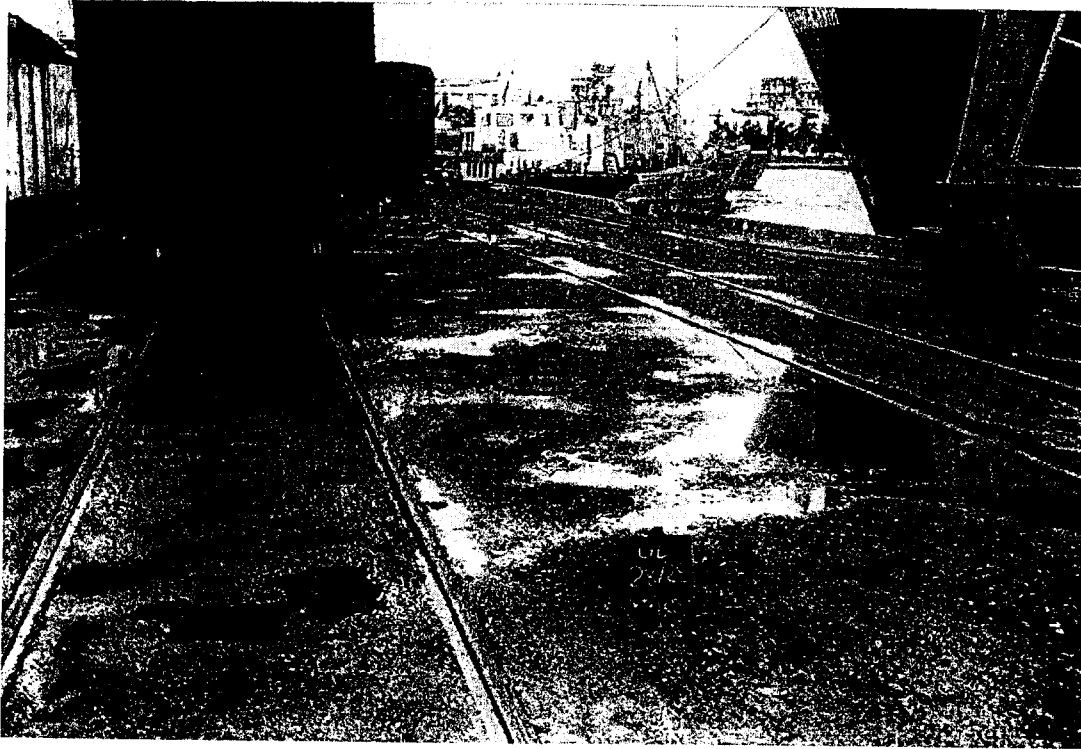
Track / рейсовый путь N° 29

The track is filled up to above the top of the sleepers and covered with asphalt up to the top of the head of the rails. The parallel area is covered with asphalt as well. The track is considerable stable. The screwing of the lugs for the rail joints are loose. The joints are moving up and down during a pass over. Due to this the surface fastening is partly broken up. In these areas there is stagnant water in the track.

General condition: Fair.

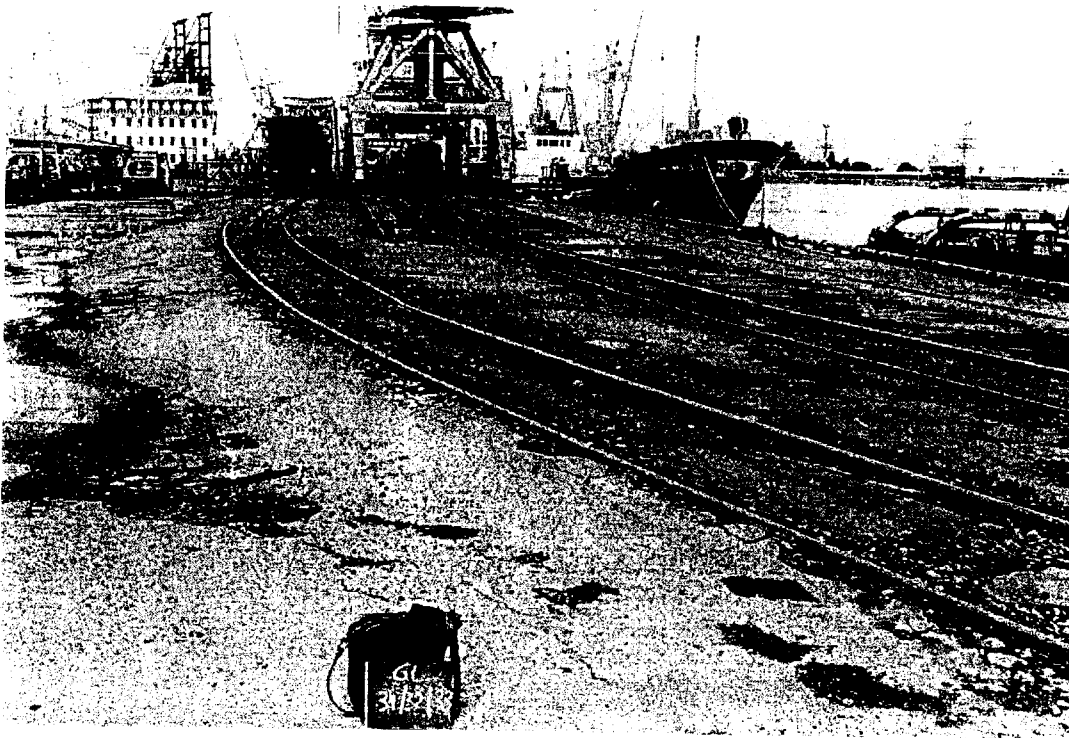
Track / рейсовый путь № 31

The track ascends up to the front area of Berth 7. The track is filled up to the top of the sleepers and covered almost up to top of the head of the rails with asphalt. It is partly worn out because the track is moving heavily up and down during a pass over. The level of the track is higher then the parallel area at the left side, which also is covered with asphalt. The lining of the asphalt is pulled up to the top of the head of the rails, ongoing from almost 2m in front of the external rail. The screwing of the lugs for the rail joints are loose. The joints are acute in the arch.

The level of the track is almost 30 cm higher then the area at the left side and the crane rails. The track is filled up to the top of the sleepers and covered up to the top of the head of the rails with asphalt. It is partly worn out. The track and especially the rail joints are heavily moving up and down during a pass over. The track ends at the ending of Berth 7.

General condition: Poor.

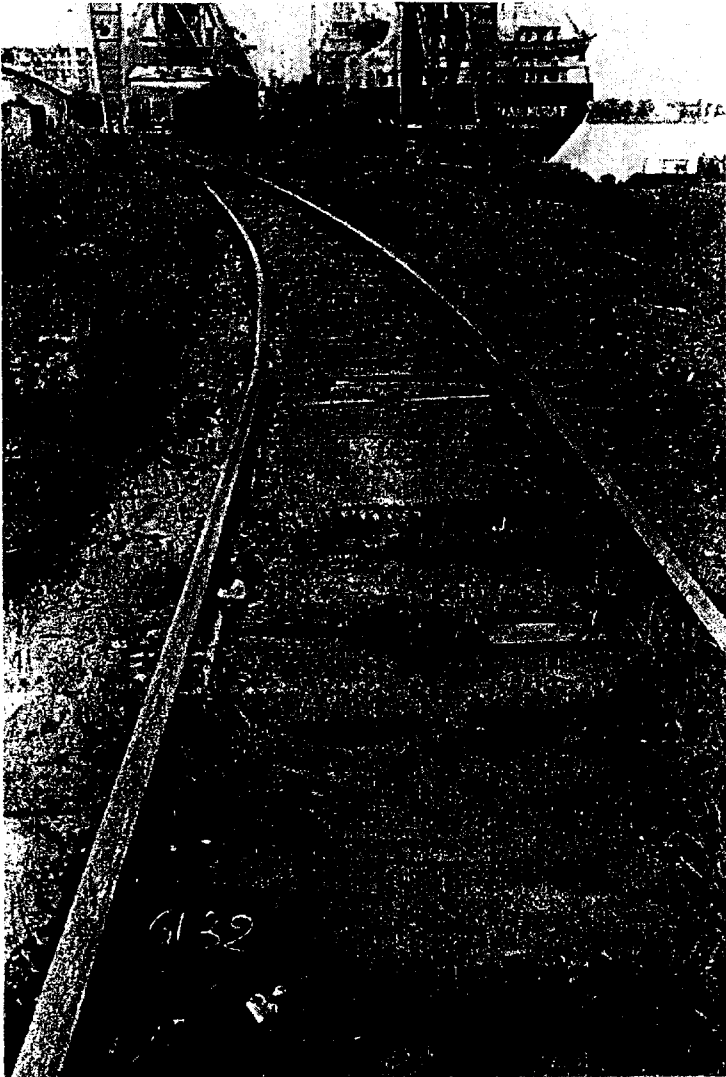
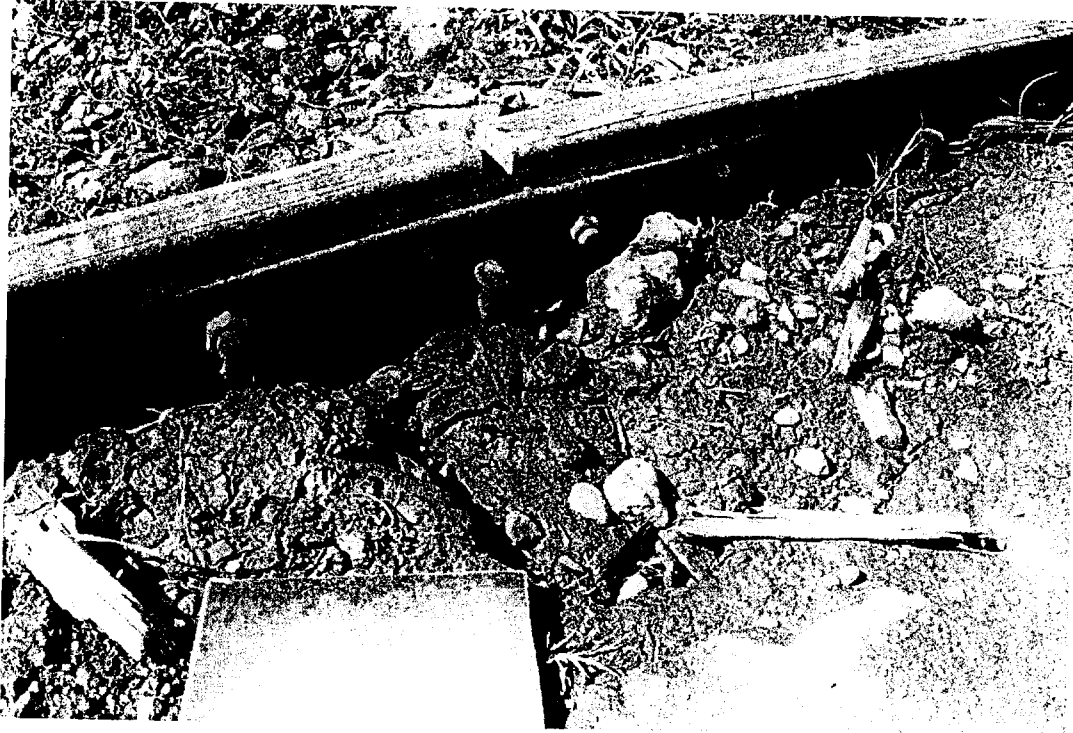
Track / рейльсовый путь № 32

The track descends from the passage of the bridge/switch 64 to the port. The track is filled up to the top of the sleepers and overgrown with cabbage. Behind the level crossing 01 runs water from a higher lying area down into the track area. Due to this there is stagnant water and formation of silt. The gauge is supported by holders of flat bar iron. The fastenings of the nails and the screwing of the lugs are loose. The joints and the track are heavily moving up and down during a pass over.

The fastenings of the nails are loose. The joints and the track are heavily moving up and down during a pass over. At the area of switch 62 the level of the track is higher than track 33, the joint gaps are more narrow. The connections of the lugs are sometimes attached by 4 screws.

The track ascends up to the front area of Berth 7. The track is filled up to above the top of the sleepers and covered up to the top of the head of the rails with asphalt. It is partly worn out because the track is heavily moving up and down during a pass over. At switch 64b various holders support the gauge. The fastenings of the rails are partly missing. Same conditions behind switch 64b. The water from the parallel area on the left side runs off through the track area and then on to the central part of the quay plate. From there on the water runs through outlets directly into the water of the port.

The level of the track is lower than track 33. It has almost the level of the quay area. The track is covered with asphalt or concrete. The fastening of the rails is not noticeable, presumably like track 33. At the whole distance tracks lie under water on the inner side and the outside. The water is mixed up with silt and remains of loading (earth, grain). In the rail area the concrete cover is broken up.

The level of the track is higher than track 33. The track is filled up to the top of the sleepers. It is overgrown with cabbage. At the head of the sleepers up to track 33 there is only little bedding. The gauge is 1516 mm. The track lies in an almost dry area. The joints lie very close up to the sleepers. Due to this the track and the joints do not move very much (repair works have taken place?).

General condition: Fair - Poor.

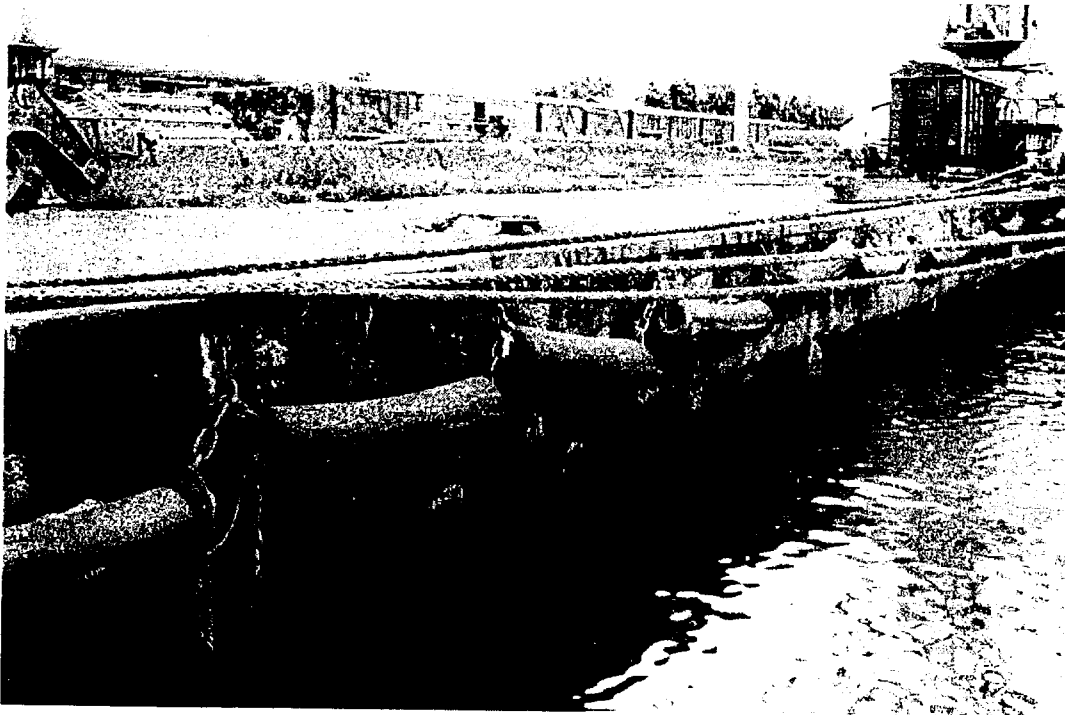
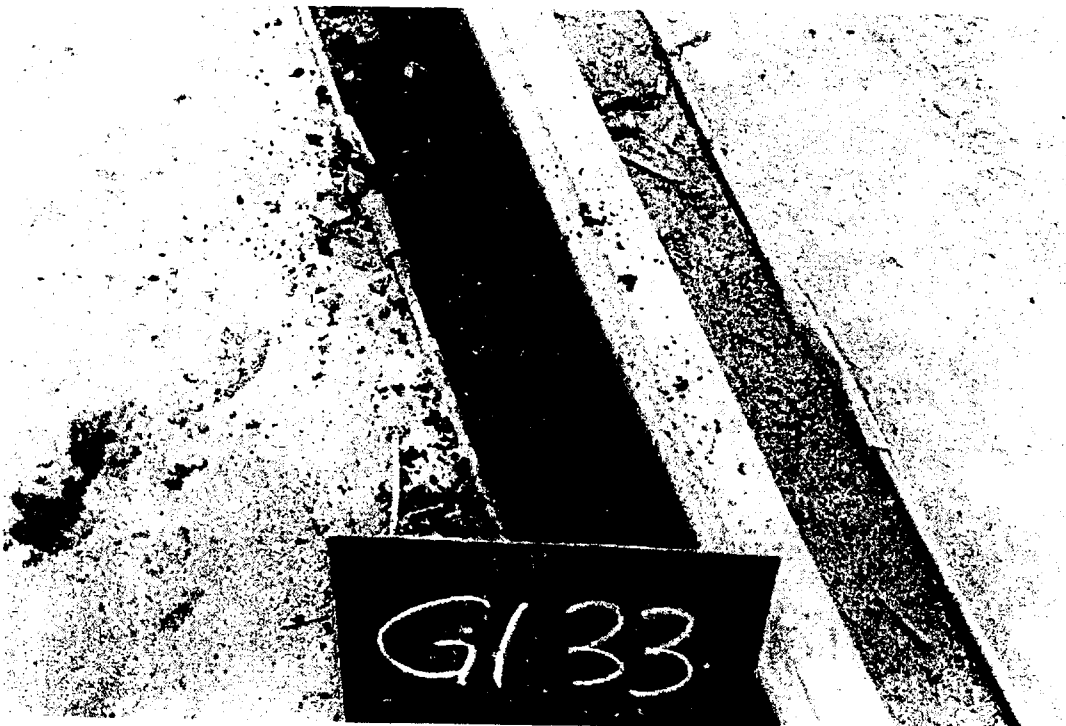
Track / рейльсовый путь № 33

The track descends from the passage of the bridge/switch 64 to the port. The track is filled up to the top of the sleepers and overgrown with cabbage. There is stagnant water and formation of silt. The gauge is supported by holders of flat bar iron. The fastening of the nails and the screwing of the lugs are loose. The joints and the track are heavily moving up and down during a passage.

The track is filled up to the top of the sleepers and overgrown with cabbage. The fastenings of the nails are loose. The joints and the track are moving heavily up and down during a pass over. In the area at switch 62 the level of the track is lower than the crane rails. In this area the track is covered almost up to the top of the head of the rails.

General condition: Fair - Poor.
