Feasibility Study of New Terminal
Facilities in the Georgian Ports
Phase 3 Report
Vol. IV - Civil Engineering
Aspects
May 1998

Volume IV

Civil Engineering Aspects

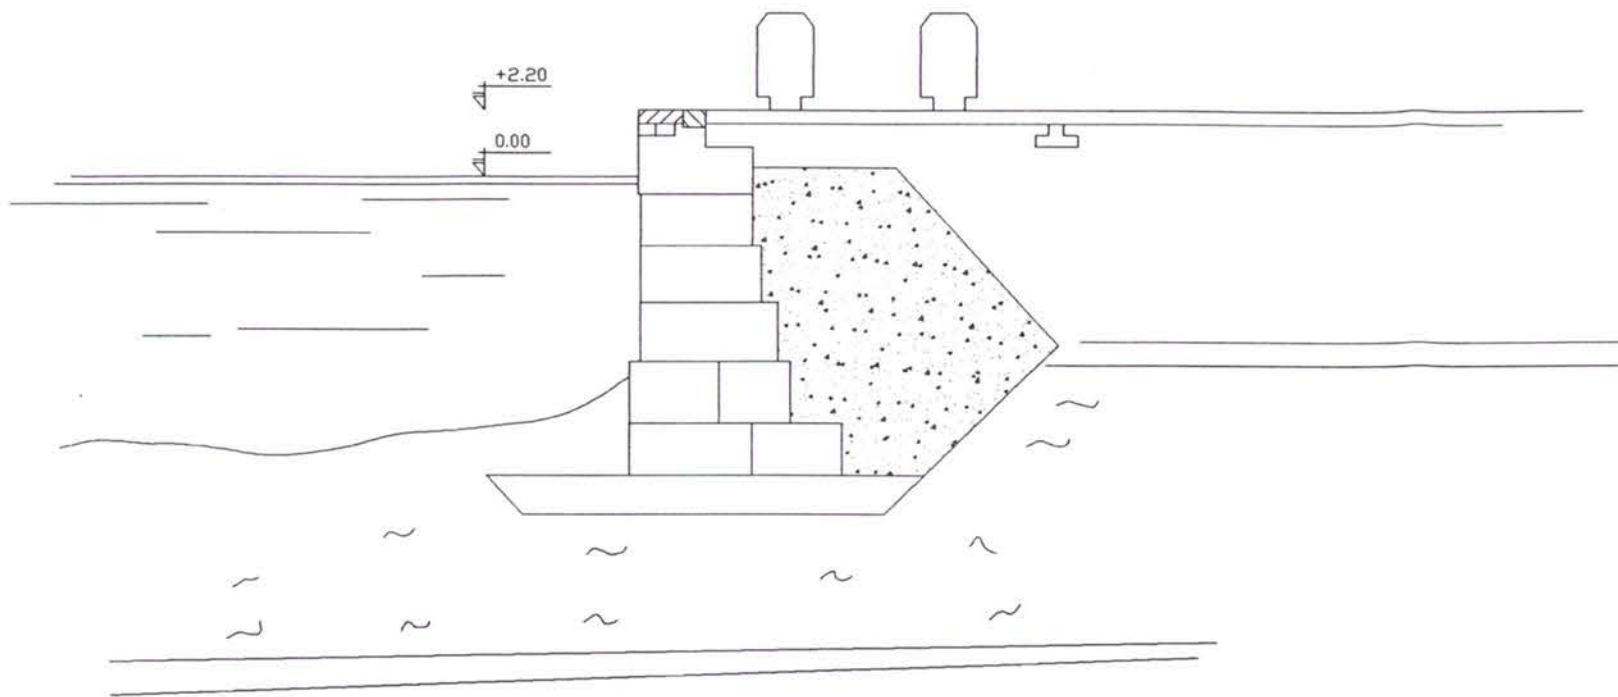
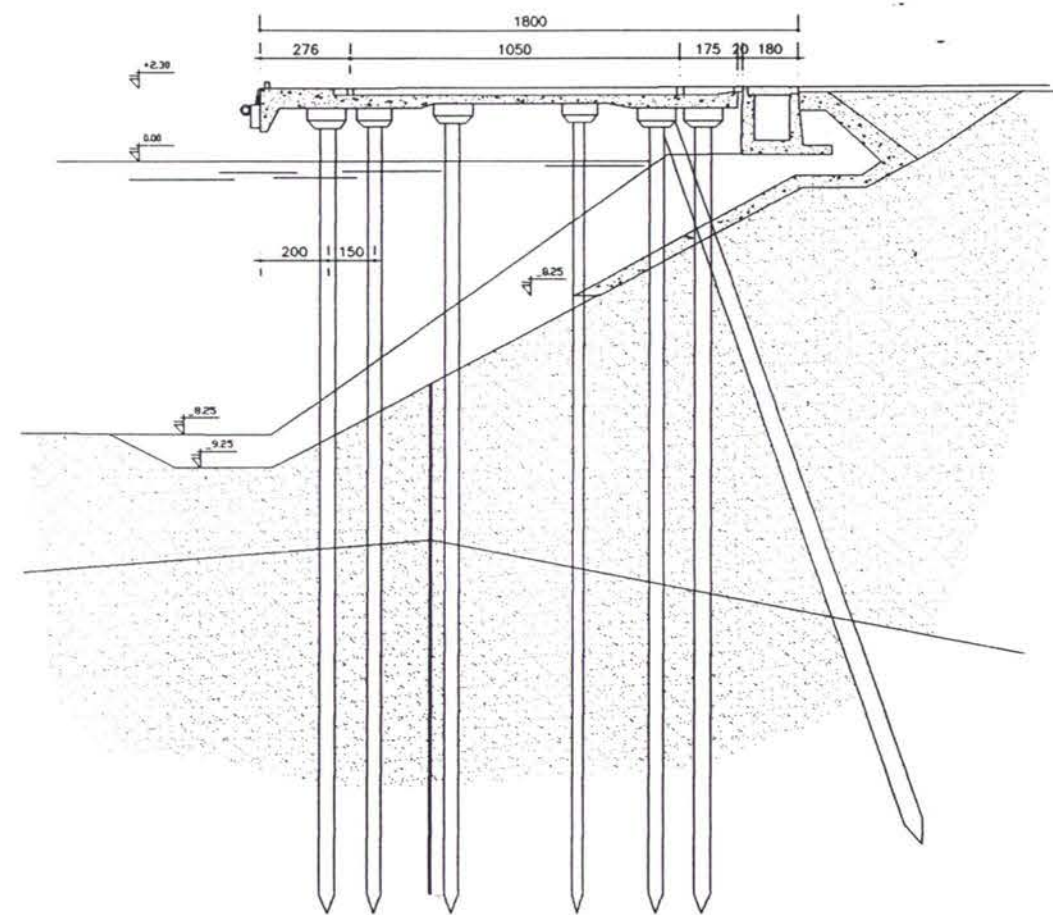
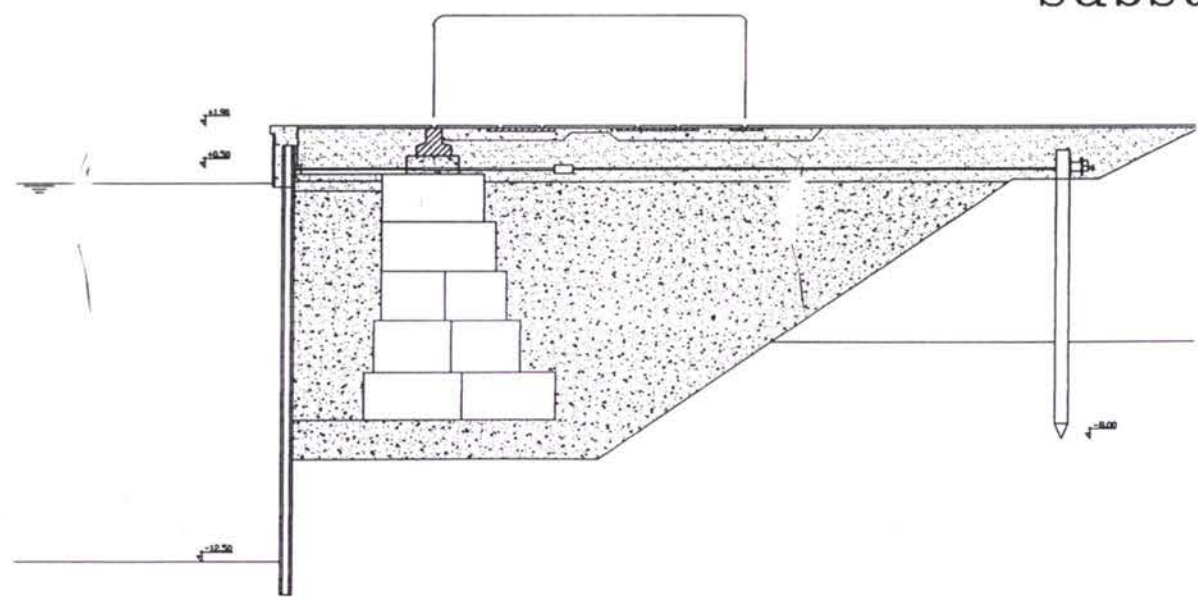
In 1978 berths no. 1 and 2 have been deepened up to 12.5 m and therefore enforced by sheetpiles in front of the block wall. The top part of the quay exists of a concrete beam construction. This beam in particular is in a poor condition. Especially the alignment of quay no 2 is not straight and damaged (see Photo P1; Annex IV.1.3). The fenders are in good condition. Overall the condition of these berths is satisfactory. Berth 1 is used for oil handling and berth 2 for bauxite and containers.

The construction of these berths consists of the original concrete block walls built in 1900-1910 (see Drawing 1.1.3). Considering the age the condition of the quay itself is satisfactory. The blocks are eroded over the years and the edges are substantially damaged. However, the lining and level are straight. The fenders are old and too small, while the chains connecting the fenders to the quay are very corroded and should be replaced. These berths are mainly used for dry bulk cargo handling.

The berth is constructed on concrete piles (L 22,5 m; 450 x 450 mm) and were built in 1968. On top of these piles a concrete construction supports the pavement and rail tracks. The condition of the concrete slabs at the quay side is very poor (see Photo P9; Annex IV.1.3). The fenders are old and too small, while the chains connecting the fenders to the quay are very corroded (see Photo P2; Annex IV.1.3). Berth 6 is mainly used for container handling and ro-ro, using berth 7 as ro-ro ramp.

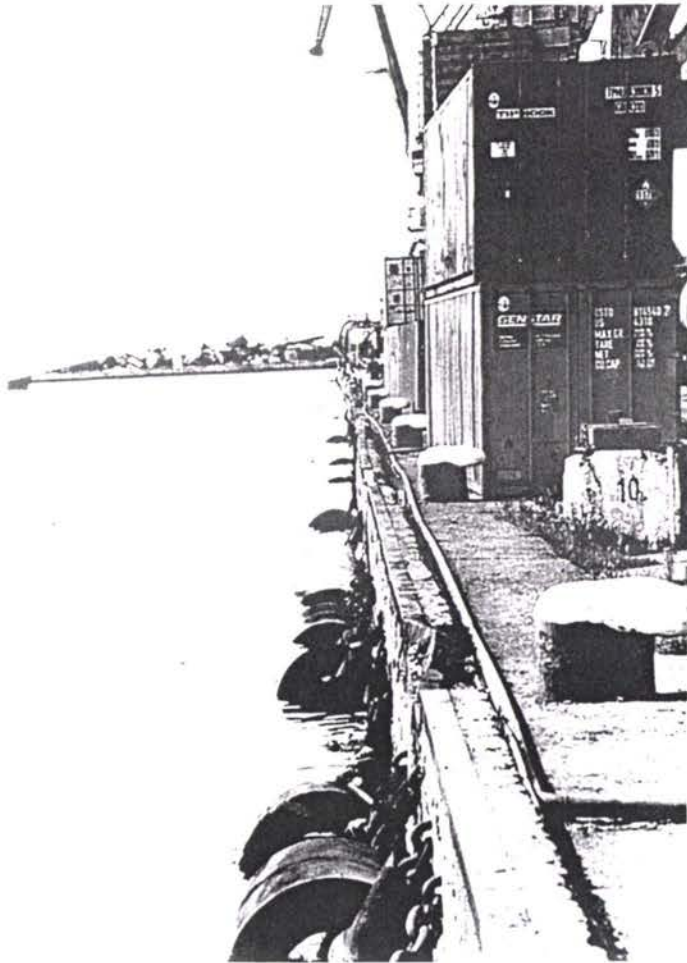
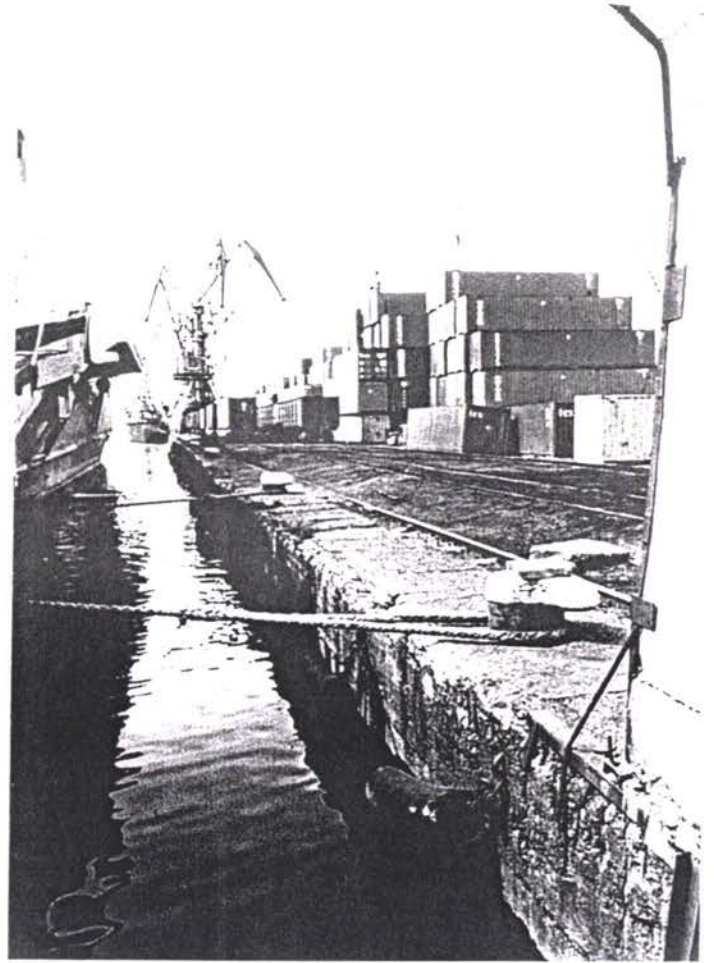
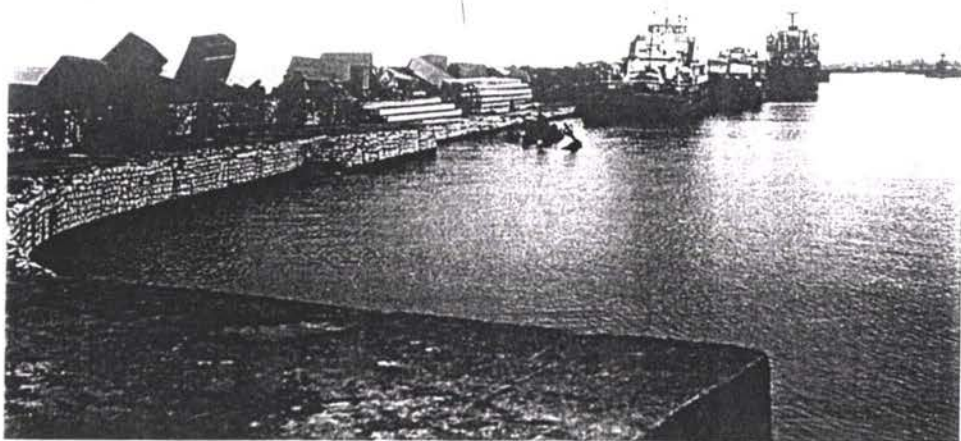
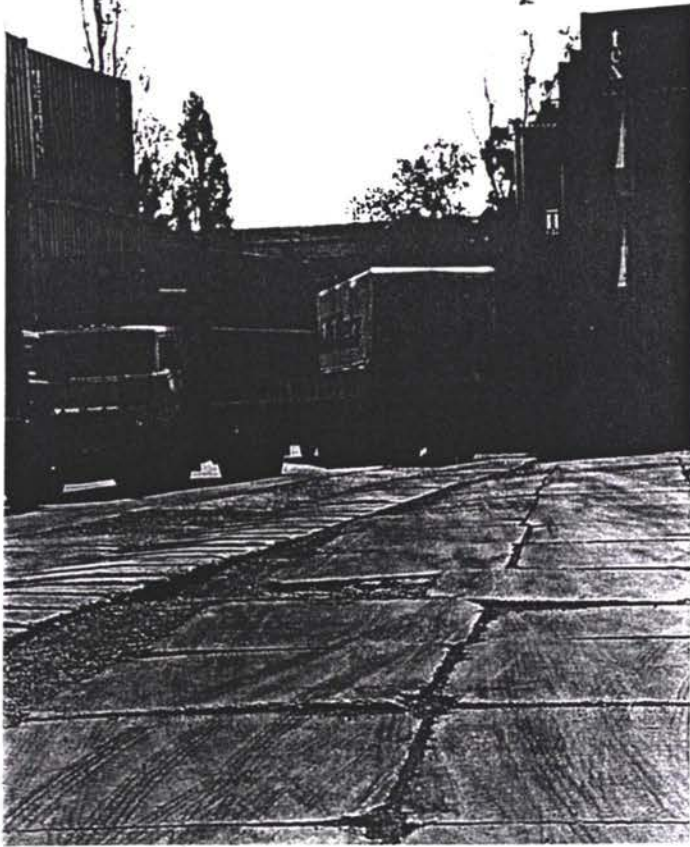
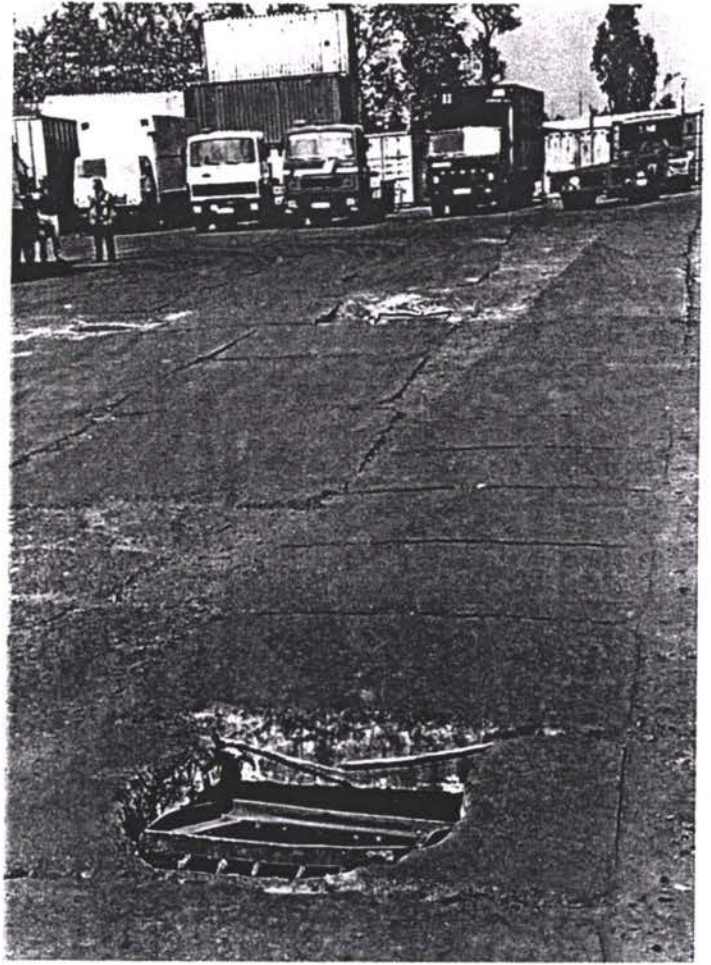
Photo Number	Description
Poti	
P1	Berth 1 and 2: The lining of the quay is not straight. The edge of the quay is damaged at some places. Containers are stored between the crane rail and quay.
P2	Berth 6: The edges of the quay wall are eroded, which results in corrosion of the reinforcement of the concrete. There is no pavement between the rail tracks. This berth is presently used for ro-ro and container handling.
P3	Breakwater: This is the south-western part of the breakwater. The subsidence is clearly visible. The level of the breakwater used to be horizontal. However, near the vessels the breakwater is subsided by approximately 1 meter.
P4 & P5	Storage area berth 7: These photo's of the container terminal illustrate the unequal subsidence of the concrete slabs, big holes in the pavement and large crevices between the slabs. This part of the storage area is also used by traffic from and to the ro-ro vessels at berth 6.

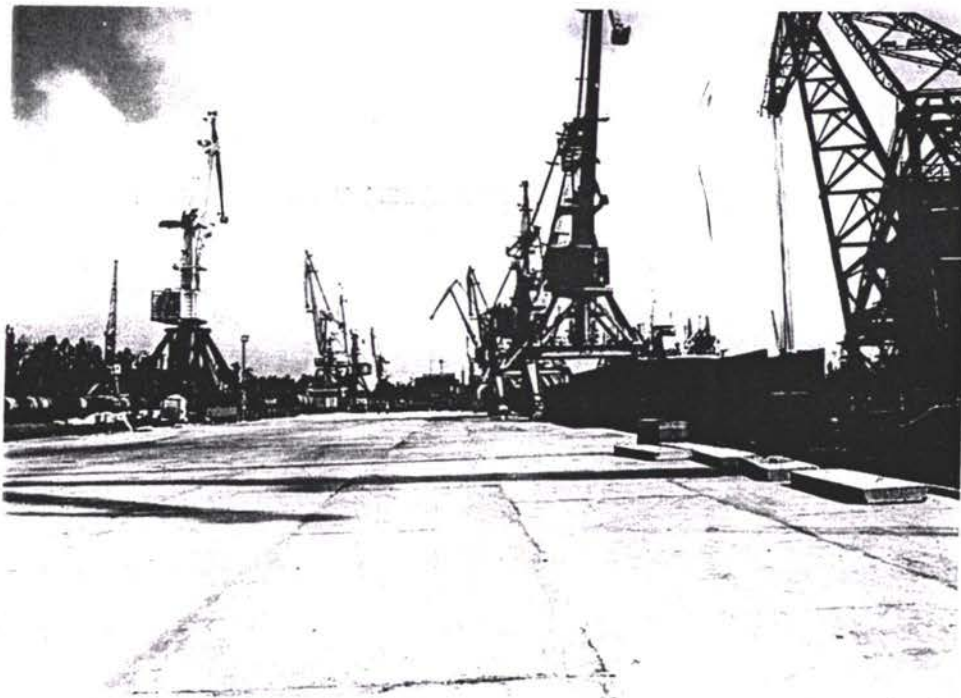
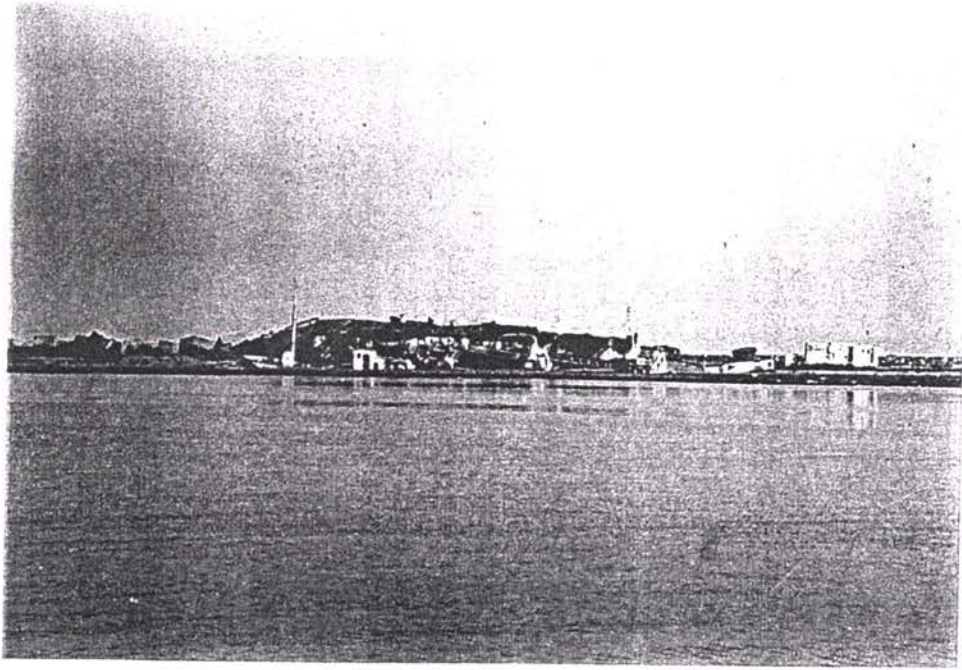
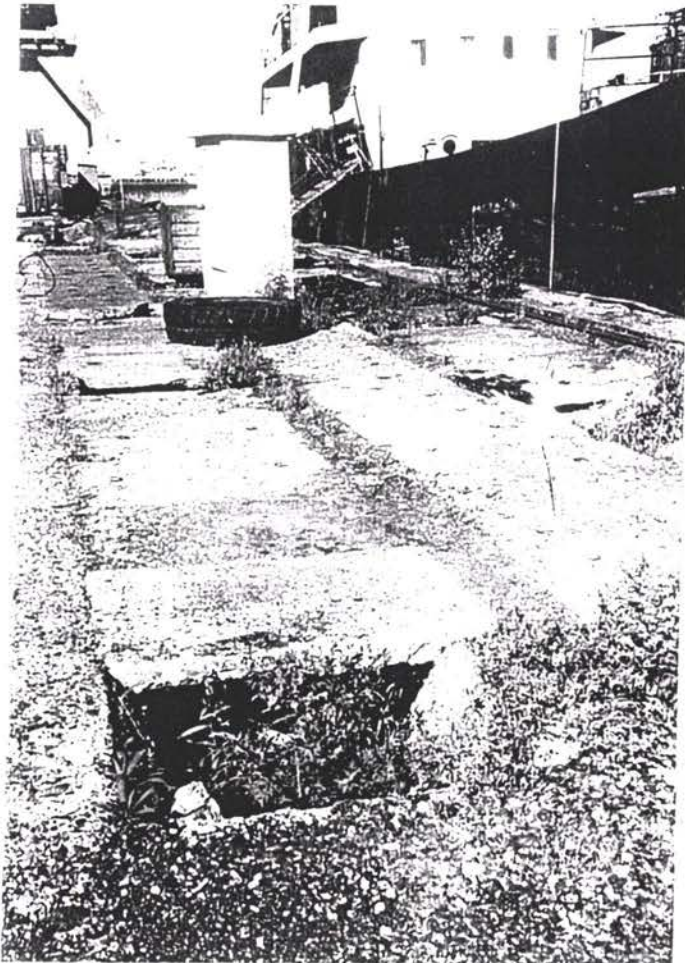
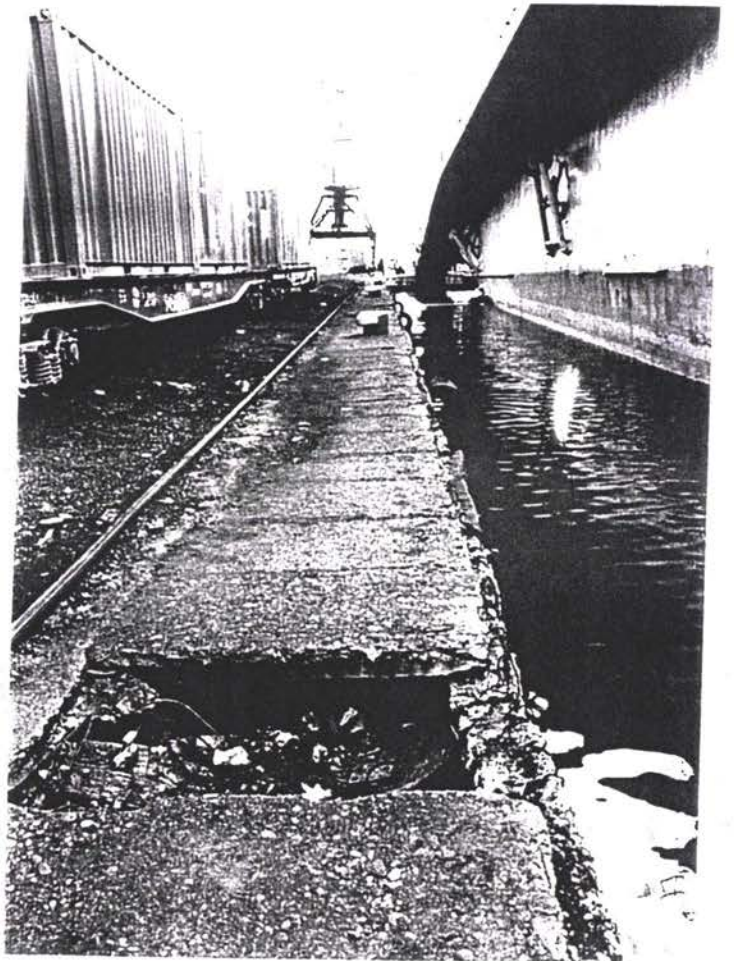
P6	Storage area berth 4: New concrete pavement at berth 4, which is presently under construction.
P7	Northern breakwater: This is a view on the inside of the northern breakwater overlooking the northern basin. The siltation problem is clearly visible. Old fishing vessels are "drowned" in the sand.
P8	Berth at shipping yard: The photo illustrates the condition of the pavement at the quay of the shipping yard. This berth is presently being used for general cargo handling.
P9	Berth 6: The quay construction and the pavement at the quay is unsatisfactory.
P10	Rail track berth 8: The photo illustrates the lining of the rail tracks.
P11	Rail track connections: An example of the condition of the rail tracks. On this photo the big gap between the rail tracks is illustrated causing damage to equipment and rail foundation.

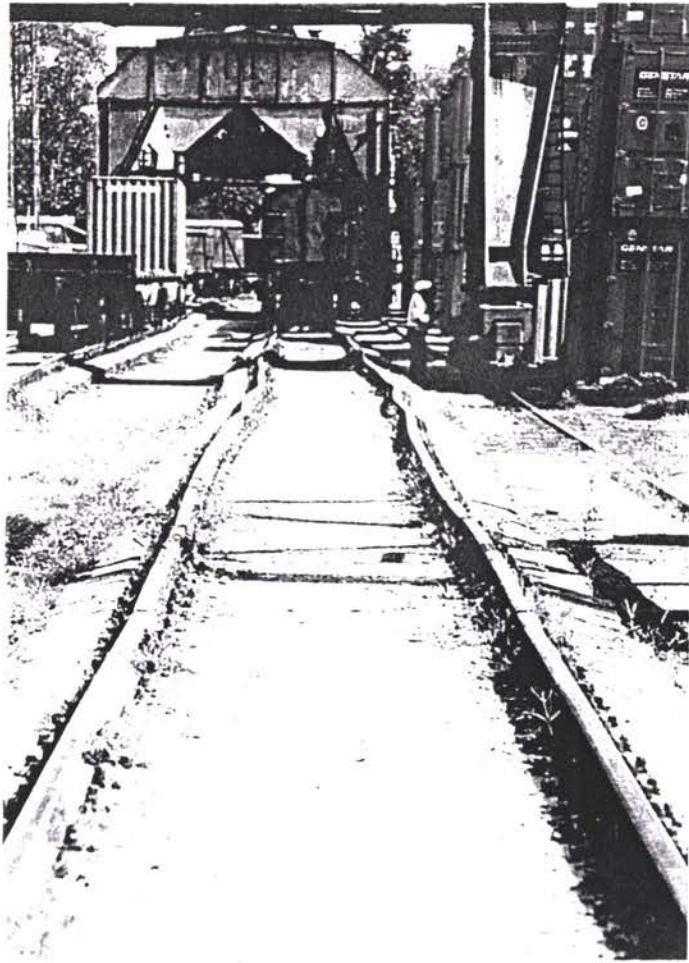
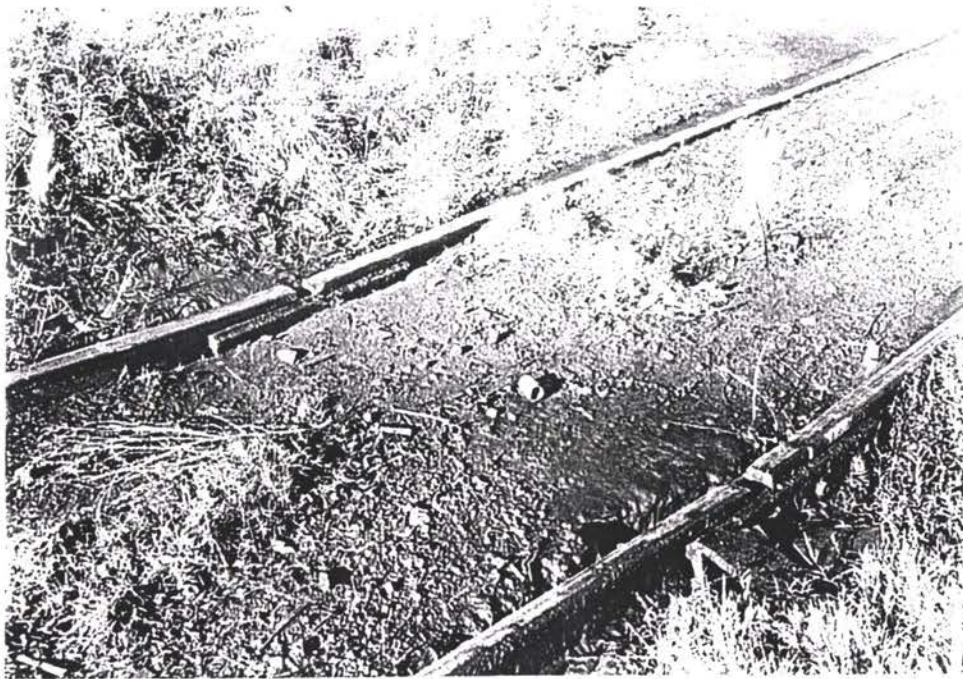
Rail and road connections are indicated in Drawing 1.1.2. An impression of the railway condition is shown on photo P10 and P11 (see Annex IV.1.3).

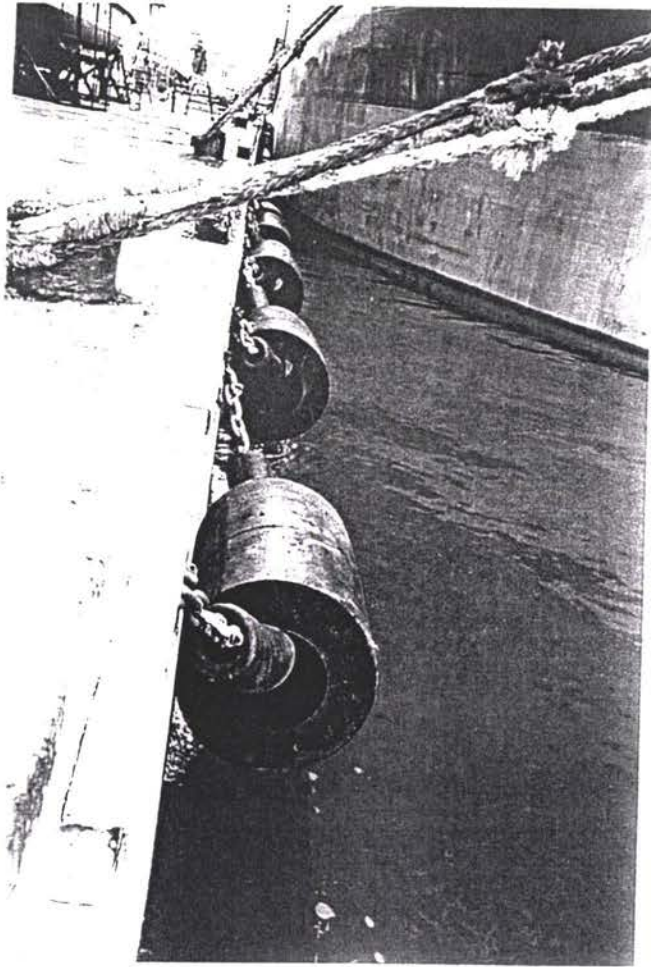
monolith concrete beam has been constructed. The fenders consists of round rubber fenders diameter 1 m connected with chains to the quay. The fenders and the quay construction are in a good condition (see Photo B1; Annex IV.1.3).

Photo Number	Description
Batumi	
B1	Berth 1: The quay wall of berth 1 is in a good condition.
B2	Berth 2: The superstructure of this berth and also of berth 3 is in a poor condition. Especially the steel beam is severely corroded.
B3	Warehouse 1: The photo illustrates the condition of the doors. However, the roofs of the warehouses are well maintained.
B4	Berth 7: The concrete of the superstructure is severely damaged at various places. The fenders are very small.
B5	Pavement: New rail tracks and new concrete pavement . The condition is good with sufficient drainage. However, the level of pavement is approximately 6 cm lower than the rail tracks.
B6	Railway crossing: This photo illustrates the condition of railway crossings.

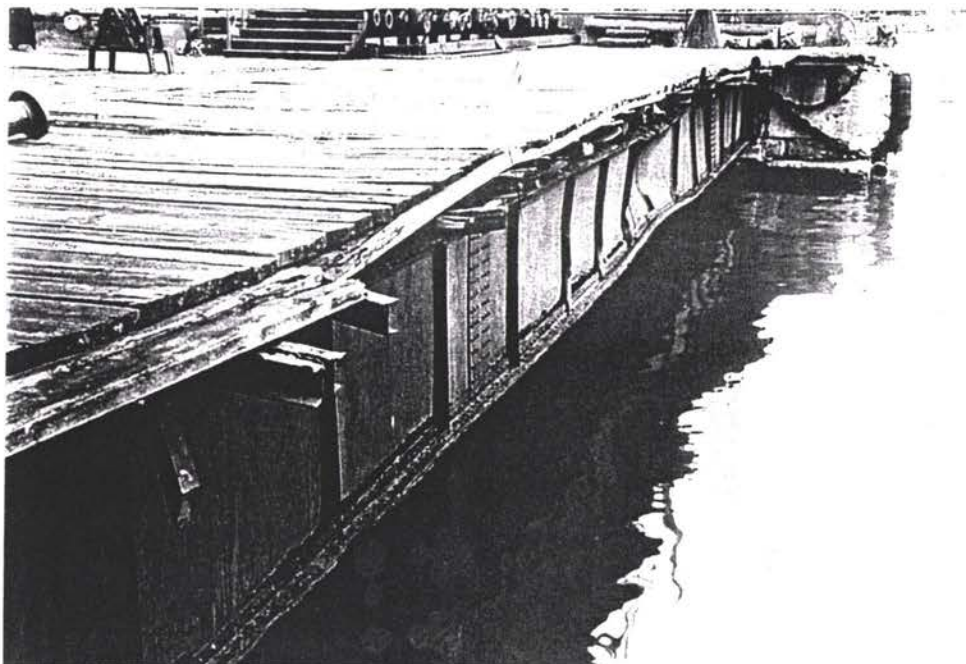
B2

Berth 2 and 3 are constructed simultaneously with berth 1 and the breakwater. Originally it consisted of a block wall quay with 6 m waterdepth. In 1928 the berth was reconstructed to enable mooring of larger vessels. Therefore two small pier constructions with a length of 30 m each has been constructed in front of the existing quay. This construction exists of a concrete block wall with concrete superstructure. The condition of the superstructure in particular is very poor. The concrete edges are damaged and the steel bridge construction between the 2 piers is severely corroded. The timber on this bridge construction is in a very poor condition (see Photo B2; Annex IV.1.3).

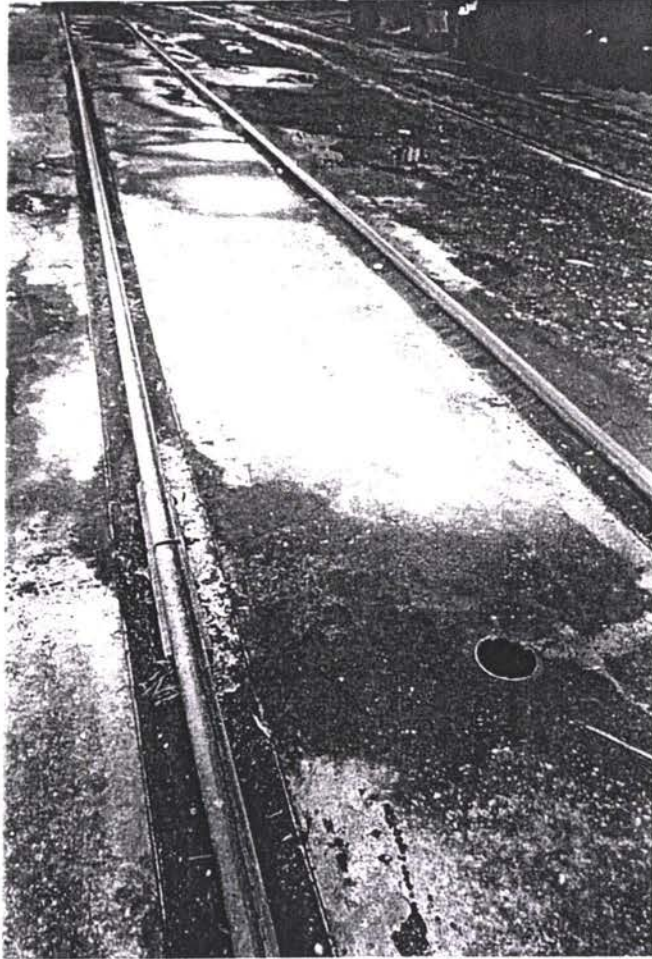
B5

The rail tracks on the berth 6, 7 and 9 are provided with pavement between the tracks. However the level is below track level, which makes railway crossing at the quay apron impossible for other port equipment. The waterside rail track of berth 6 and 7 has been renewed last year. Between the tracks the pavement exists of concrete (see Photo B5; Annex IV.1.3), which is in a good condition.
