**The European Union's Tacis Traceca Programme
For Azerbaijan, Kazakhstan and Turkmenistan**

**Supervision and Training of Navigation Aid
Equipments – Azerbaijan, Kazakhstan and
Turkmenistan**

*Final Report
August 2005*

Date of Report: August 2005
Reporting Period: Final Report (03 – 08.2005) – Supervision of Construction of Tug Boat
Author of Report: HPTI – HPC – Uniconsult Consortium

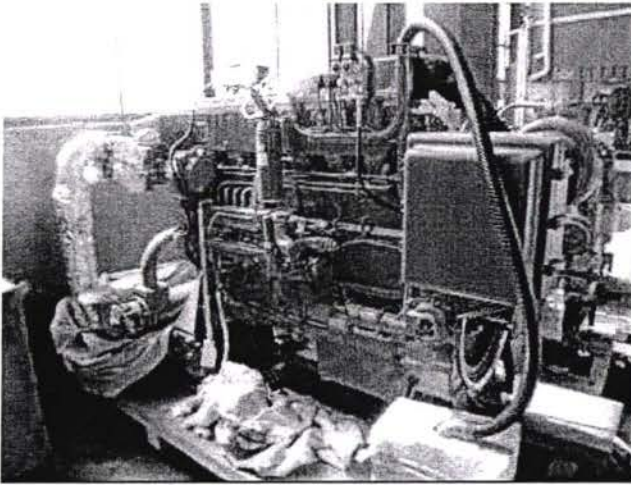
Picture 1: Fire fighting set with incorrectly insulated piping

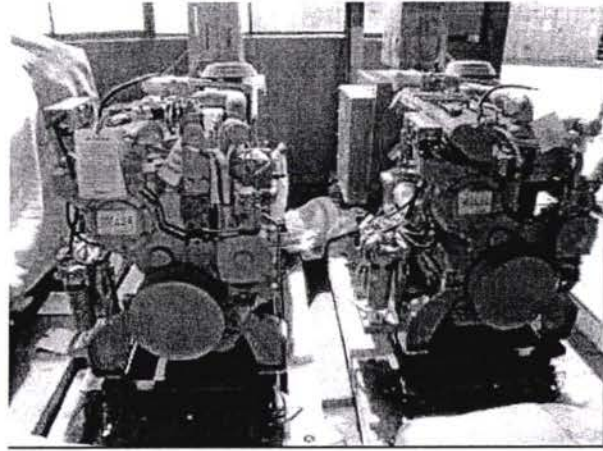
Picture 2: Generator sets waiting for installation

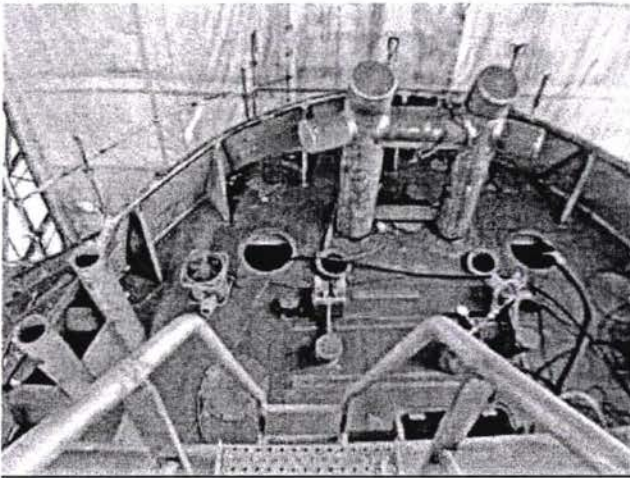
- The towing bitt and the chain stoppers have been fitted.

Picture 3: Main deck forward

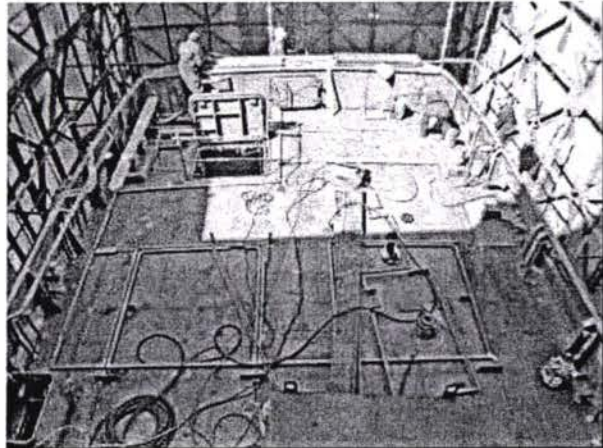
- The crane foundation is in place but welding not yet completed.
- The chain clamp (portside, for buoy handling) and the bulwark doors (portside, for buoy handling) are fitted.
- The foundation plates for an aft optional towing winch have been fitted.
- Stairs to navigation deck have been fitted.

Picture 4: Main deck aft

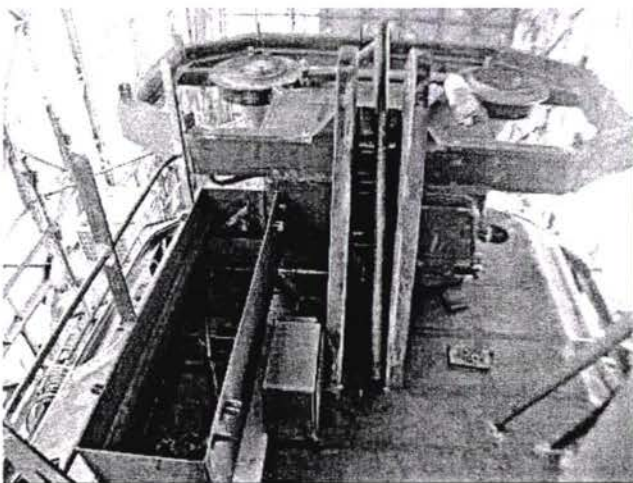
- Railing, battery box and piping for fire fighting has been installed. Foundations for the mast and the fire fighting monitors are in place.
- Accommodation on main and below deck is in place
- All cables have been fitted and the first coat of paint has been applied.
- Most piping installation is completed.

Picture 5: Top deck

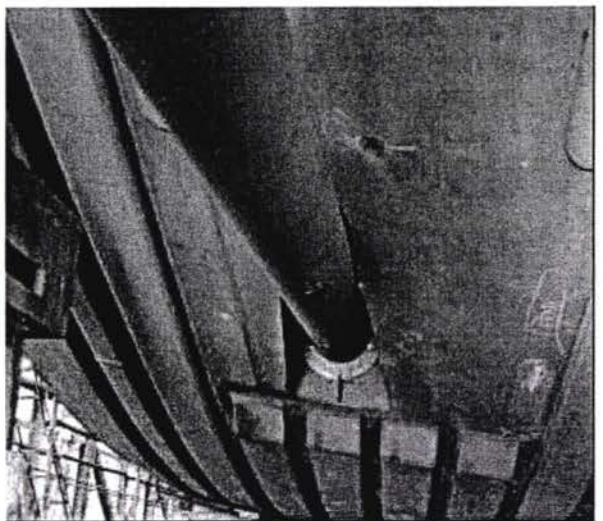
- All tanks except for tank #1 (void space) and tank #2 (freshwater) have been tested and accepted by LR.
- The chain locker is completed.
- Grinding/cleaning of the outside shell plating is still ongoing with about 70% completed.
- Stern tube brackets are welded in place; starboard was completed on 8 April, portside is to be completed on 10 April 2005.
- Mounting and welding of both nozzles is completed.

Picture 6: Stern tube

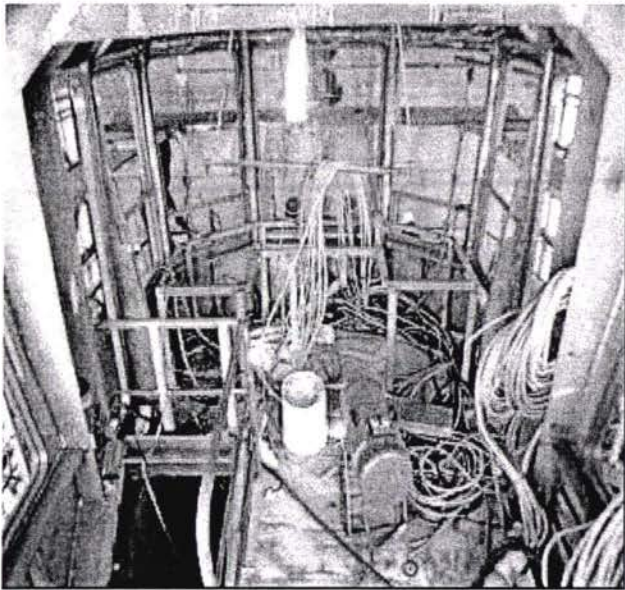
- Cable installation is ongoing. Windows were adjusted and prepared for welding.
- The first coat of paint has been applied inside and the floor is partly put in place.

Picture 7: Wheelhouse

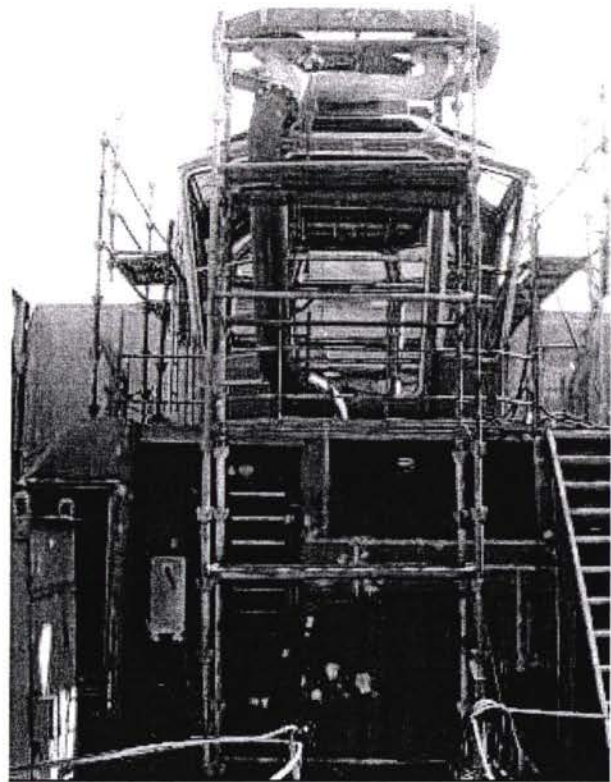
Picture 8: Fire fighting piping to wheelhouse deck

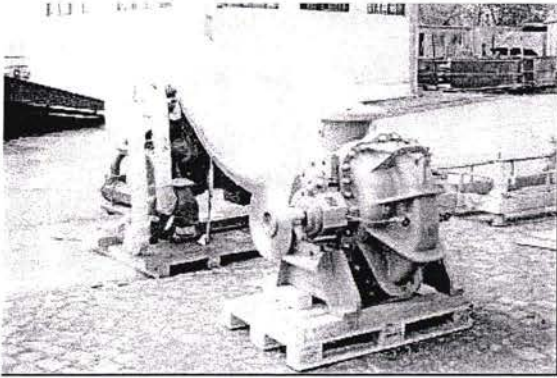
- Foundation blocks for the reverse reduction gears were in place.
- Foundation for the fire fighting engine was prepared and the fire fighting pump set was moved into the engine room

Fire fighting pump and diesel engine waiting for on-board installation

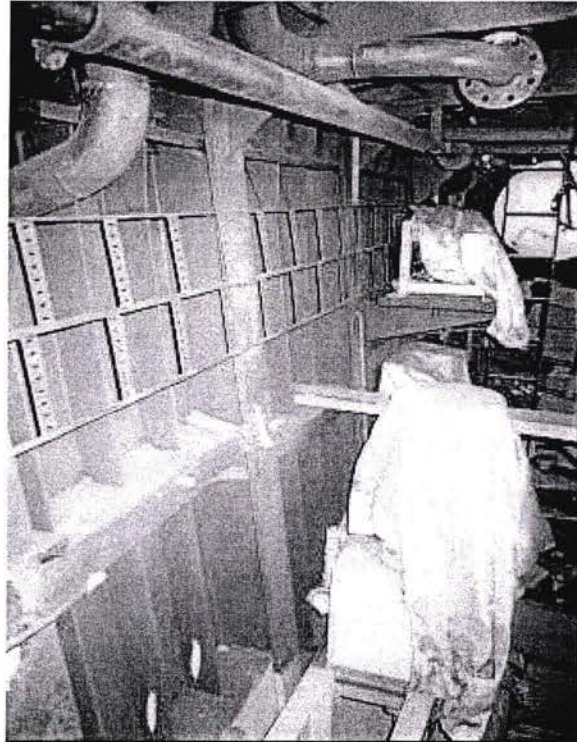
Engine room

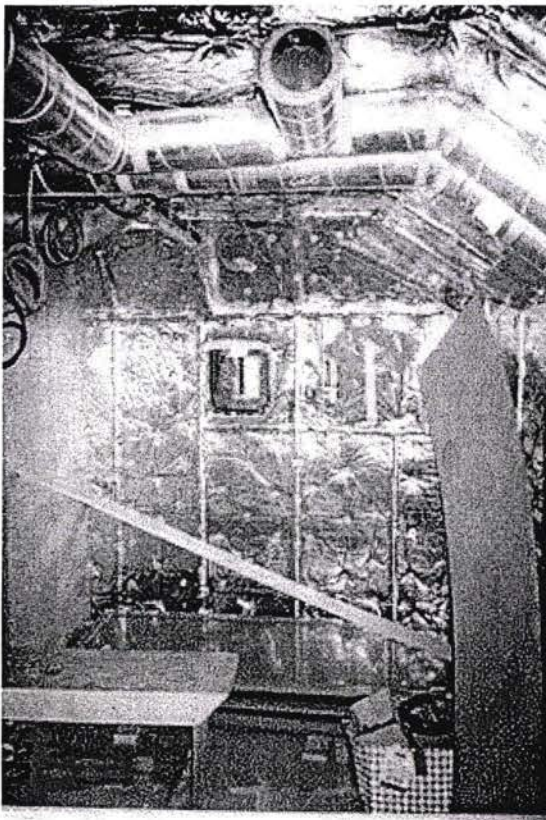
Mess room

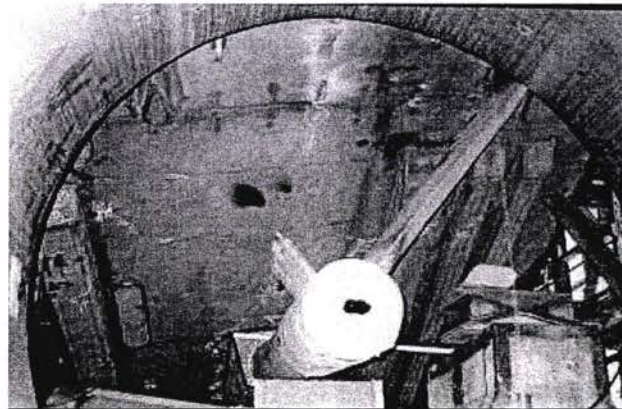
- The shipyard has misaligned both stern tubes and thus had to cut out both A-brackets of the portside stern tube and the inner A-bracket of the starboard side stern tube. Moreover, all welding of the stern tubes inside the engine room and at the passage through the hull need to be redone. The alignment after welding was checked by the surveyor of Lloyds' Register and accepted.

- A major mistake occurred during the alignment and welding of the two stern tubes into the hull. There was a misalignment that was not acceptable and required to cut off and replace three of the four struts of the two A-brackets. The hull penetration and the forward end of the two stern tubes in the engine room had to be cut free and re-welded. This mistake alone caused a delay of at least one week.

Repair and reinstallation of misaligned stern tube (1)

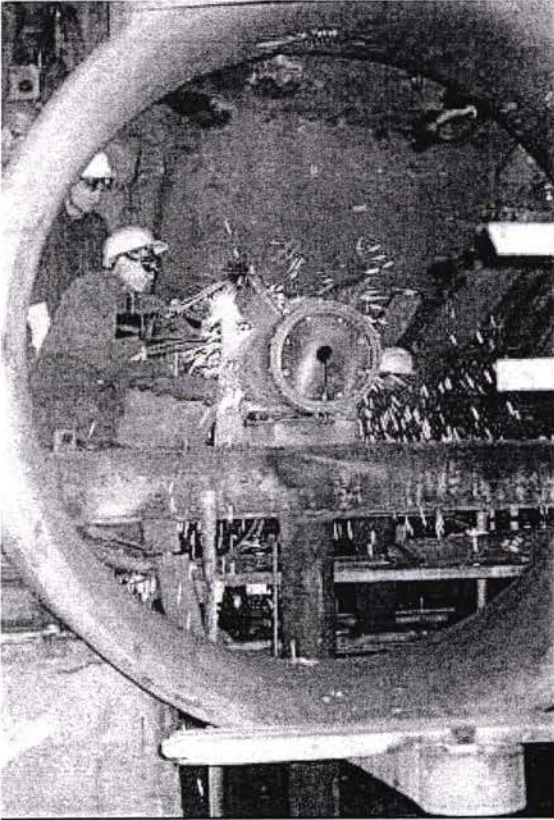
Repair and reinstallation of misaligned stern tube (2)

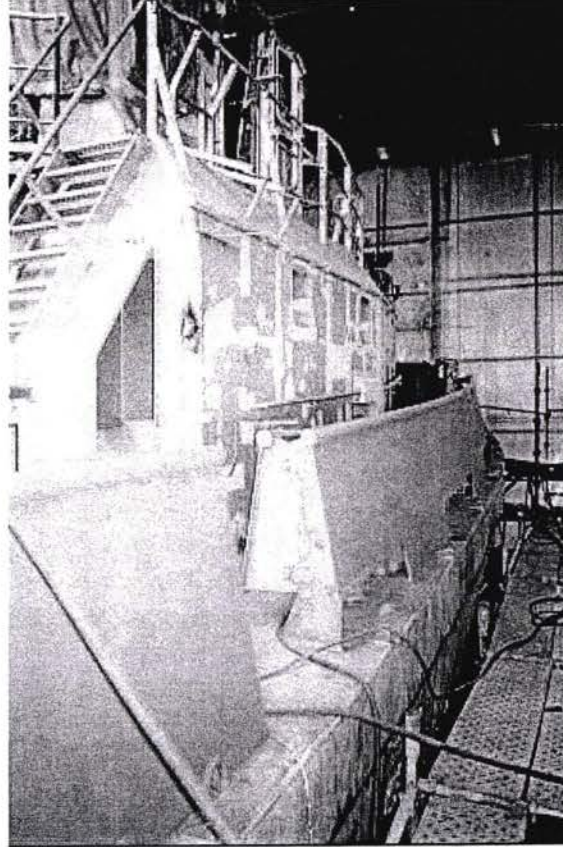
- The hull preparation for the first anticorrosion coat was under way for the whole week and the

first coat was applied to the shell plating and the bulwark.

Main deck starboard, first coating
