FEASIBILITY STUDY FOR THE REHABILITATION AND EXTENSION OF THE ROAD M3 CHISINAU – GIURGIULESTI/ROMANIAN BORDER

Europe Aid/125919/C/SER/MD

TABLE OF CONTENT

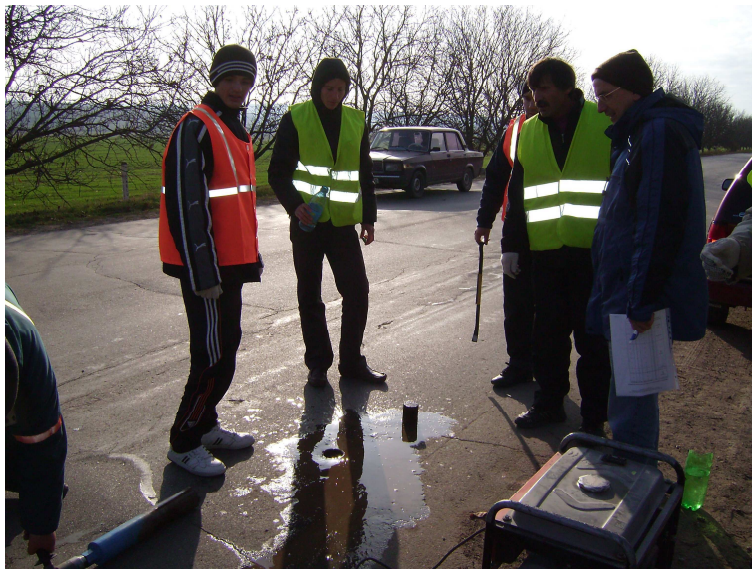
Figure 1-2.

Drilling and Extraction of Asphalt Cores

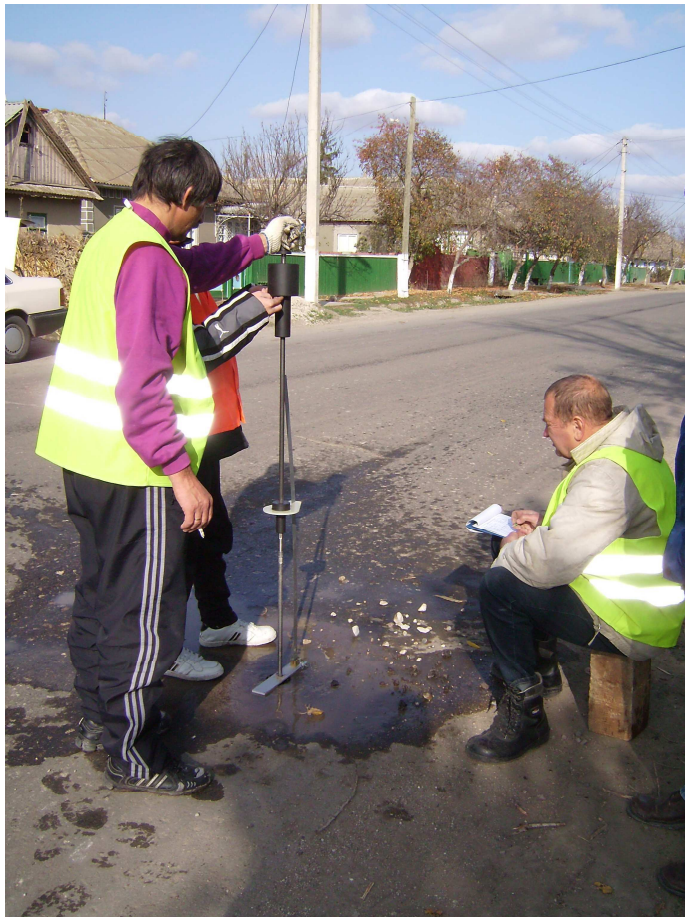
Figure 1-3.

Execution of Dynamic Cone Penetration (DCP) tests

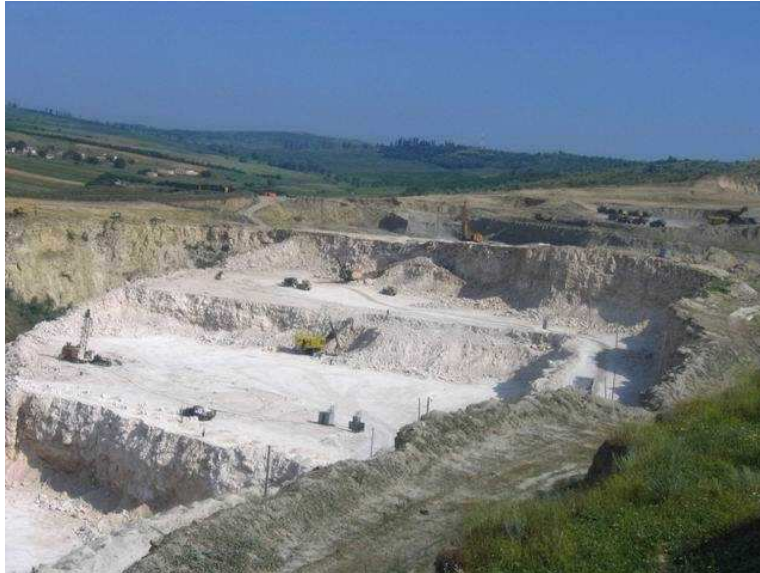
Figure 2-1.
Micauti Limestone quarry

The material, a limestone, is in general relatively soft and might only be suitable for incorporation in a road base or subbase course but not for production of asphalt and cement concrete. However comprehensive testing has to be done to show compliance with the project specifications and
