FEASIBILITY STUDY FOR THE REHABILITATION AND EXTENSION OF THE ROAD M3 CHISINAU – GIURGIULESTI/ROMANIAN BORDER

Europe Aid/125919/C/SER/MD

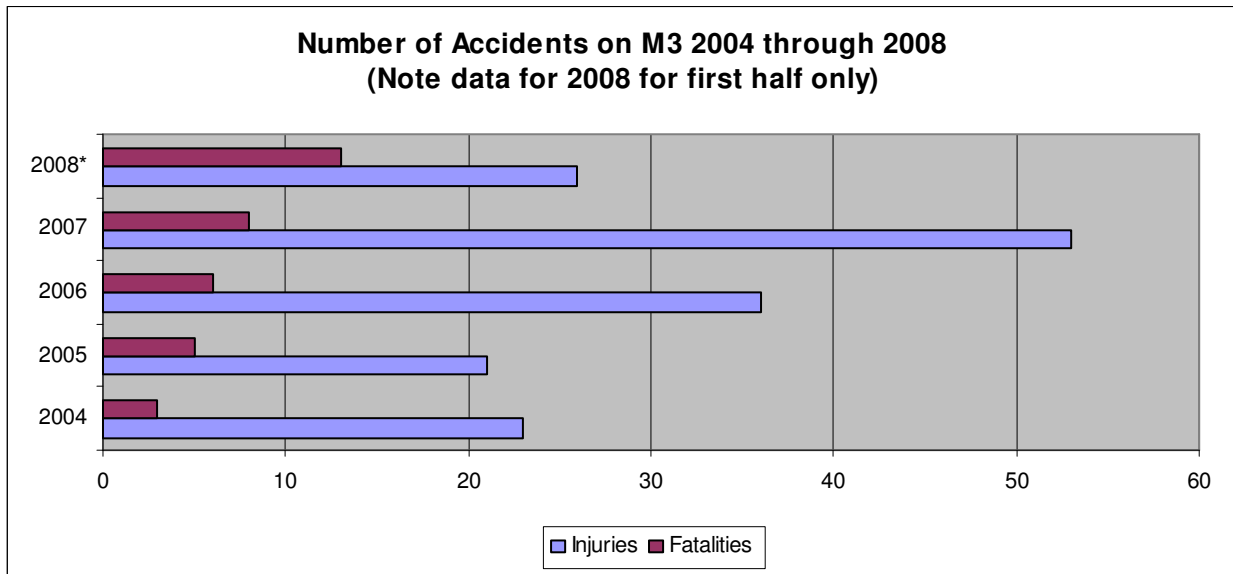
Figure 1. Number of accidents on M3 2004 through 2008

Between 1st of January.2004 and June 31st 2008 a total of 106 accidents (injury and fatalities) occurred along the study corridor. The recorded accidents resulted in 159 injuries and 35 fatalities. Figure 1 presents the number of injuries and fatalities by year. After a short decline between 2004 and 2005 absolute numbers of injuries as well as fatalities increased dramatically. Note that data for 2008 represents only first half of the year. Between 2004 and 2007 injury accidents increased by 130% and fatalities by 160%. The number of fatalities in the first half of 2008 (13) are almost as high as the total of 2006 and 2007 combined. It is also to note that traffic volume increased in the range of 3 to 5 percent annually). The maps in Annex 1 present the location of accidents on the M3 corridor.

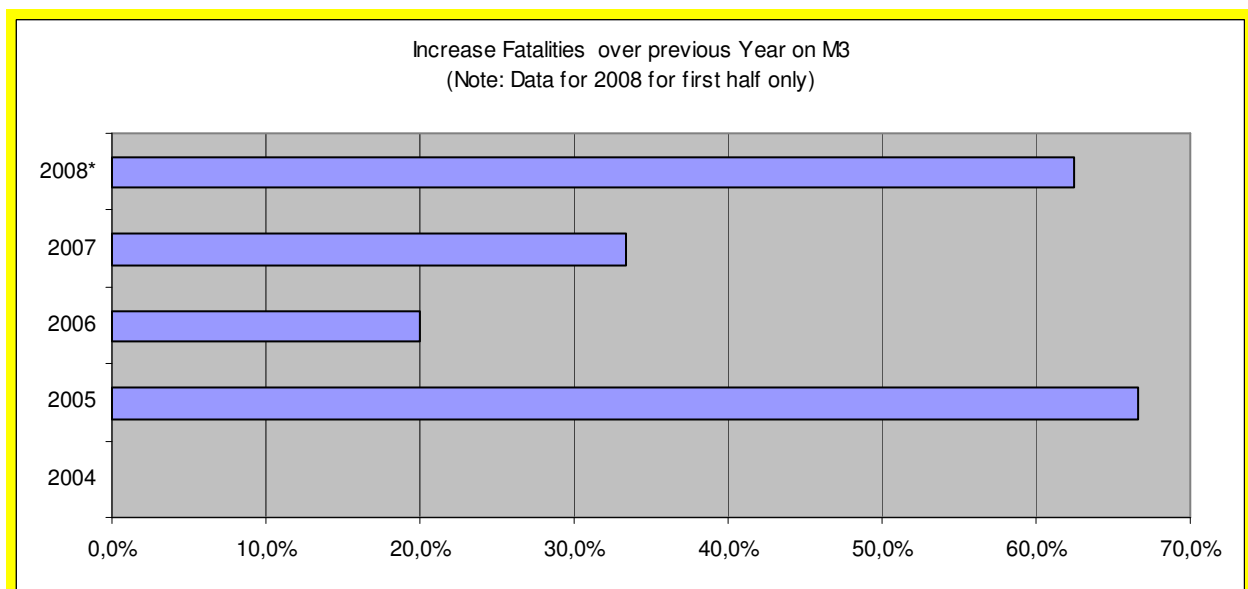
Figure 2. Increase of Fatalities over Previous Year

Noticeable is the continuous increase of fatalities relative to the previous years. Figure 2 presents the relative increase of fatalities over the previous year. In first half of 2008 7.4% of all fatalities in Moldova occurred on the M3 corridor.
