Development of the Port of Baku
Port Master Plan
Civil Engineering Assessment
Phase III Report, Vol IV
21 March 1997

Civil Engineering Assessment

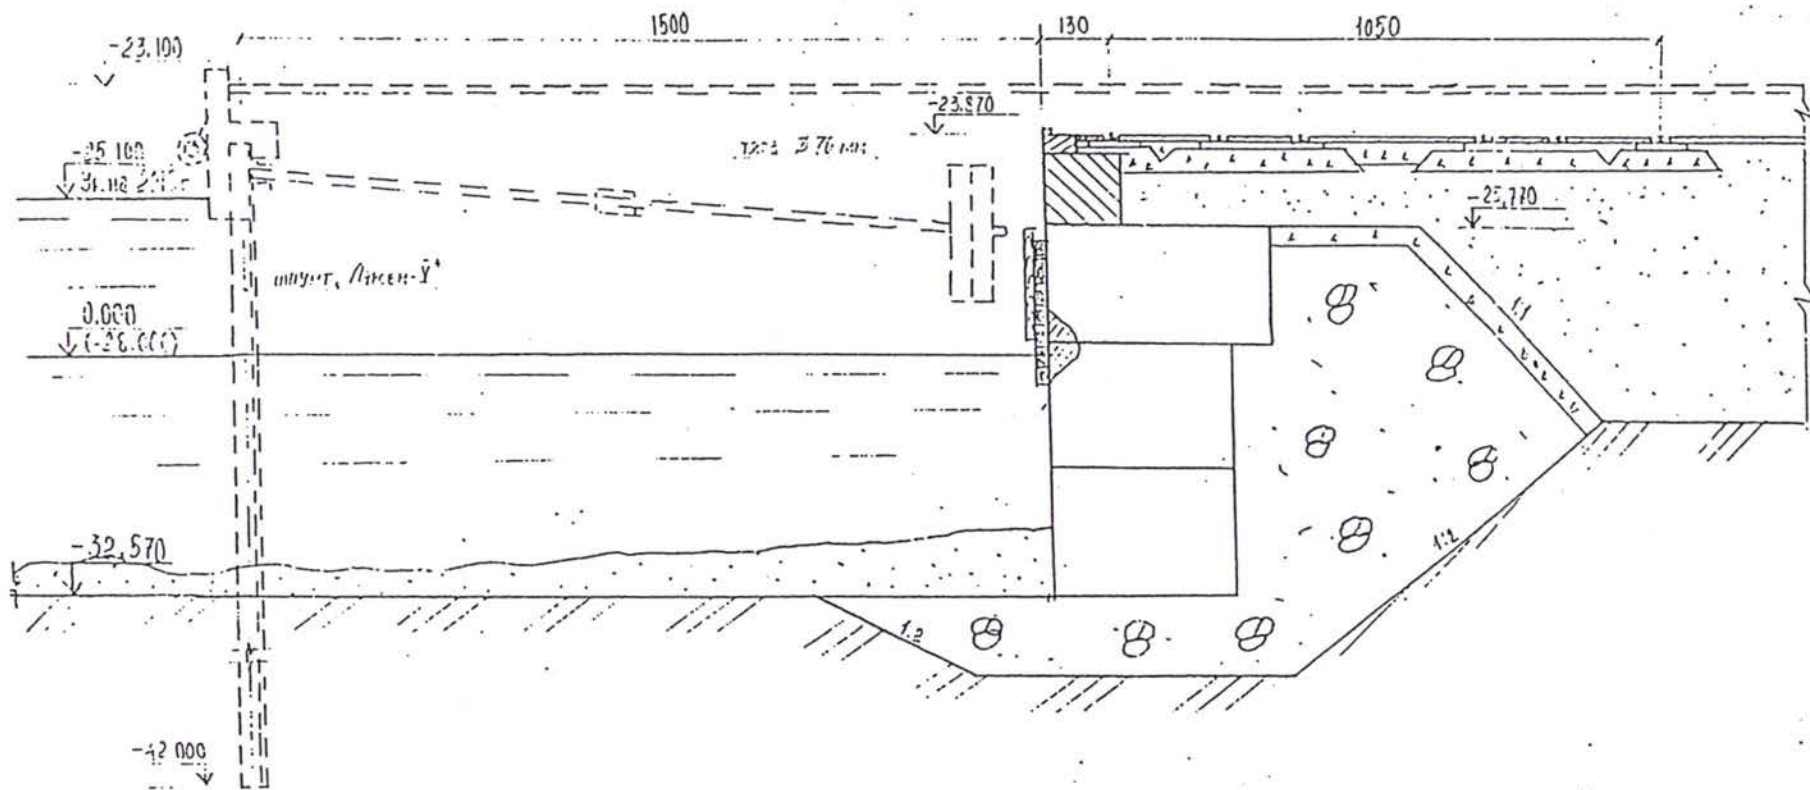
Fig 4.8 MAIN COMPLEX EASTERN QUAY

Fig 4.8 gives a cross-section of that quay construction.

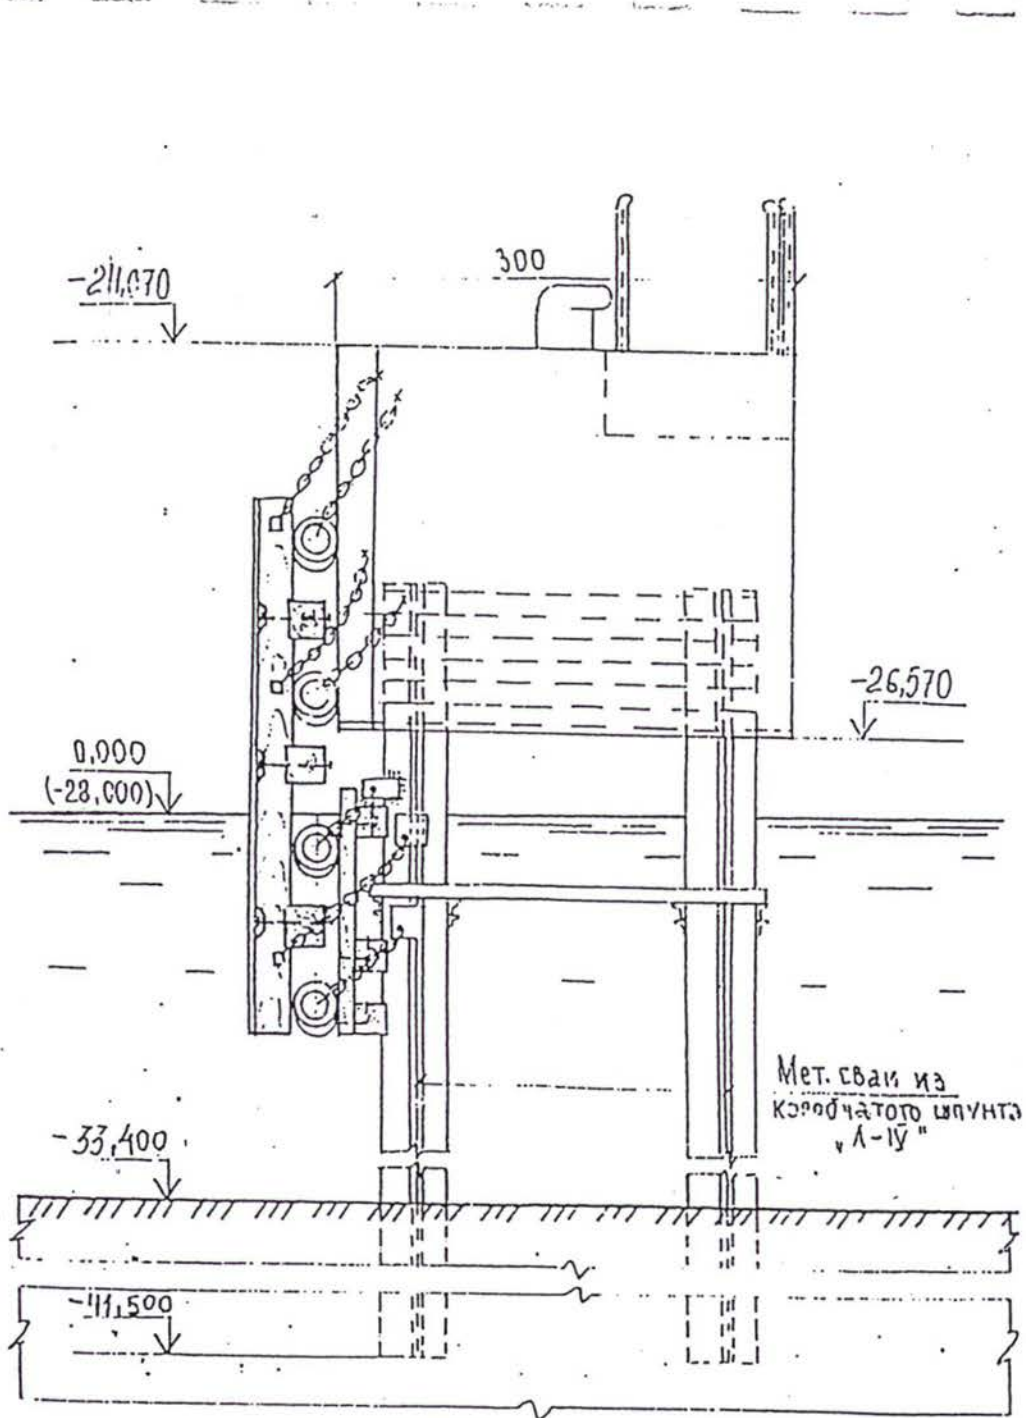
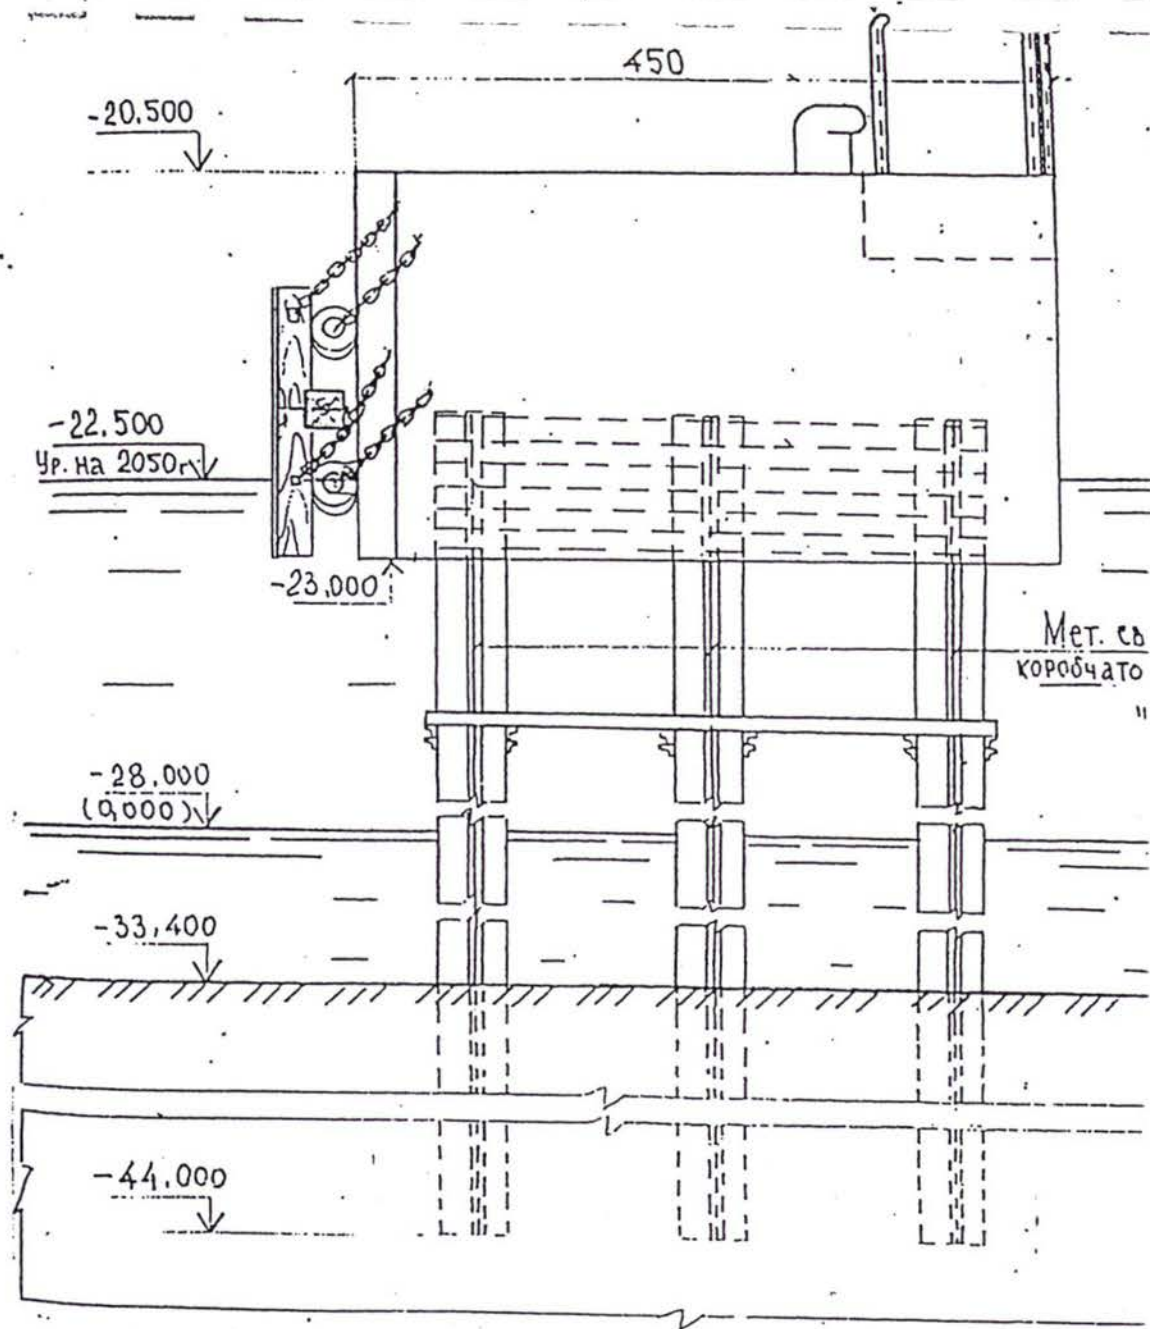
рис. 4.11 Плати для швартовки водных танкеров
 Fig 4.11 MOORING BLOCKS FOR WATER TANKERS

Fig 4.11 gives cross sections of the mooring points.

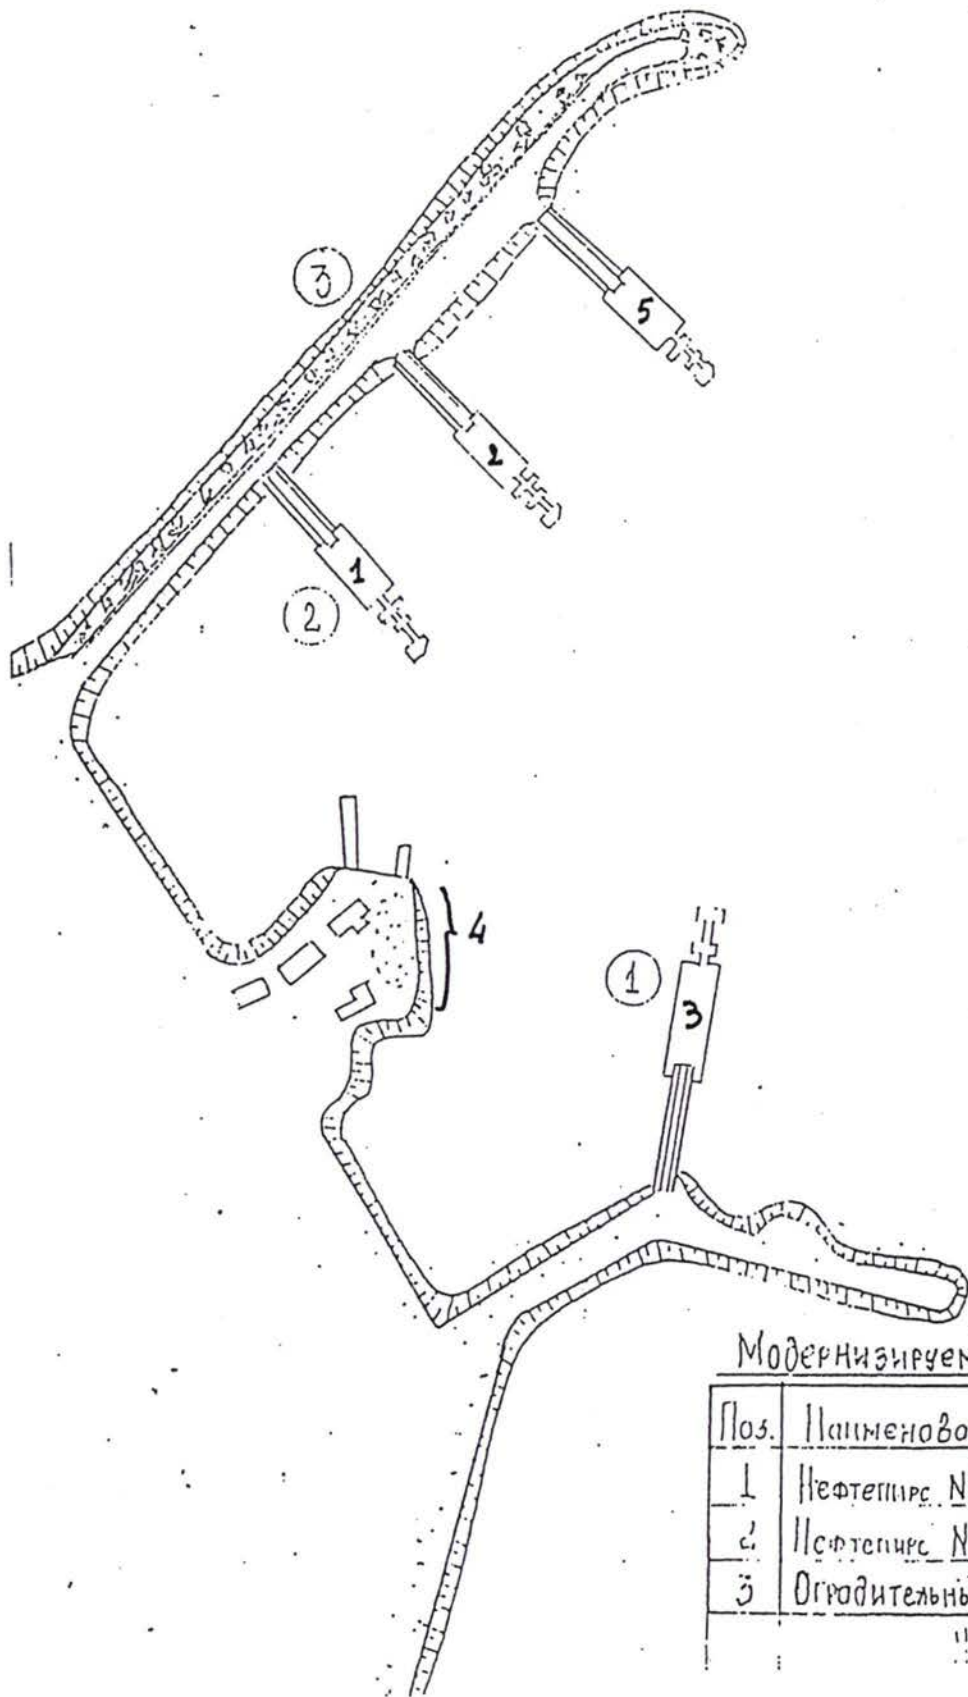
Fig. 4.16 OIL TERMINAL AREA 1/2000

Fig. 4.16 gives an overview of the oil terminal area. It indicates also the position of the different piers.
