TRACECA Project
Trade Facilitation (TNREG 9308)
Customs Border Post
Report - Appendix 1
October 1996

Surface Transport Customs Control Points

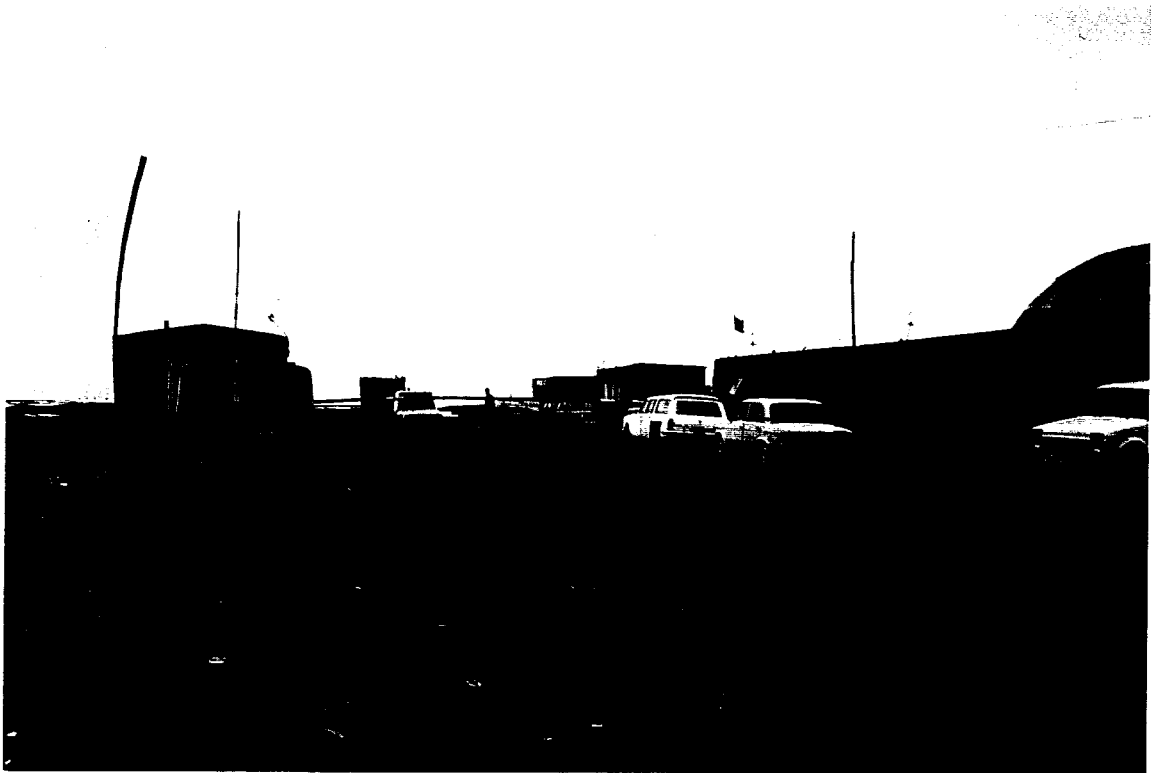
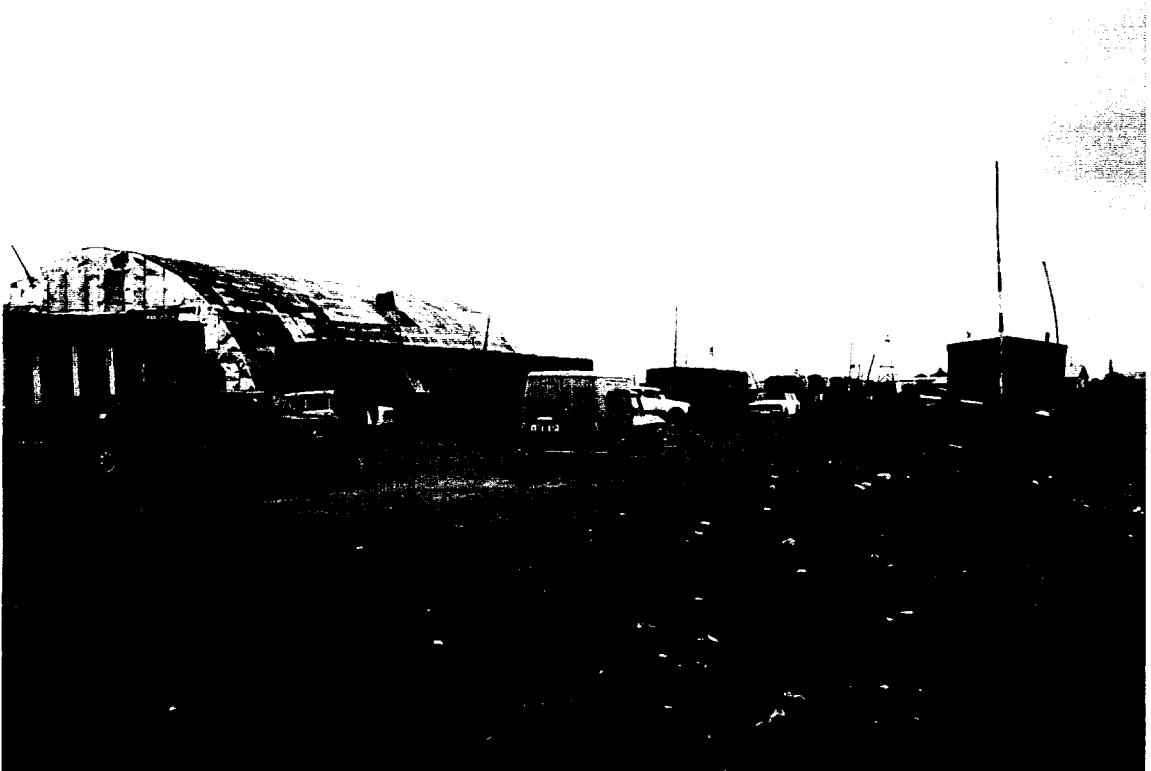
ARMENIA - Bavra

Buildings No and Condition: 4 huts in poor condition: one for Manager and private customers, one for officers, one for 2 deputies and one canteen/resthouse.

Location:	Remote location with good road Yerevan to Gyumri but poor up to the border. Major problems are adverse road conditions and security concerns on the Georgian side of the border. This is resulting in low volume and reduction in numbers of Armenian trucks in favour of Georgian. There is a proposal to rebuild the road with a World Bank loan.
Infrastructure:	Temporary huts split into different activities makes co-ordination more difficult.
Human Resources:	High staff turnover results in lack of trained personnel. Loss is partly due to harsh environment in winter.
Equipment:	None available so all manual process.
Procedures:	Adequate.
Performance:	Adequate.
Other:	This is the only border manned by the police, whereas all others are manned by Border Guards. Police are stopping vehicles for checks including breaking the customs seals. The reasons for this action was not clear and seems a duplication of customs responsibility. It can lead to significant delays of up to 3 weeks, particularly for export scrap to Russia.

- 1) Resolution of the problems regarding checking of vehicles by the police.
- 2) Provision of new office with appropriate facilities.
- 3) Supply of a reliable telephone link.
- 4) Consideration of provision of accommodation to put up stranded drivers in winter.

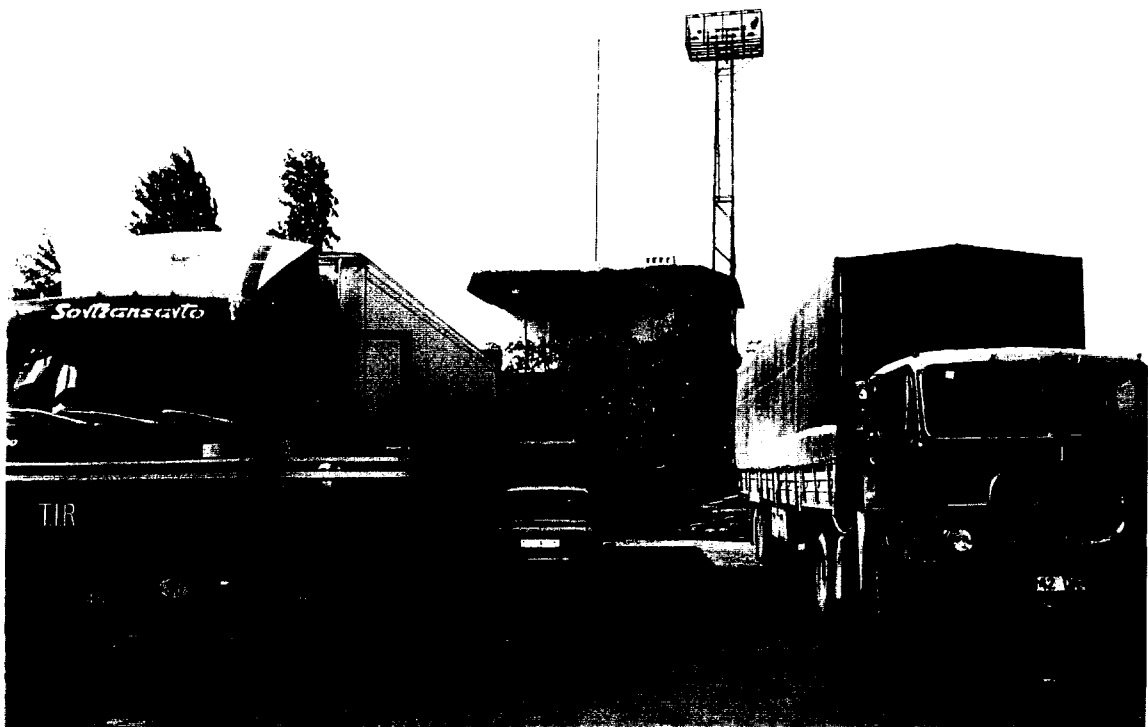
AZERBAIJAN - Baku

Buildings No and Condition:	the Georgian ports. Main office consists of a two room building adjacent to the loading ramps. The Chief has a separate office building approx. 50 metres to the north. Plans are underway to purchase/rent an additional two storey building adjacent to the terminal area as rest facilities.
Parking Areas:	There is limited parking available in the terminal area for approx. 20 trucks. In practice, export vehicles are held in the adjacent port road system until a sailing is programmed.
Site Access:	Access to the ferry terminal is off one of the main roads in the city.
Site Security:	Undertaken by both border guard and Police with gates and pole barriers.
Adjacent Road/Rail Conditions:	The immediate access roads to the terminal are narrow and in poor condition with loss of surfacing. These roads are used for parking and transfer of goods resulting in significant congestion.

- 1) A total redesign of the ferry terminal is required. This could involve provision of new Customs facilities with all facilities being housed in a single building. Inspection areas would also be required with a traffic management system within the site.
- 2) Supply of office equipment, including computers.
- 3) Provision of additional detection equipment.

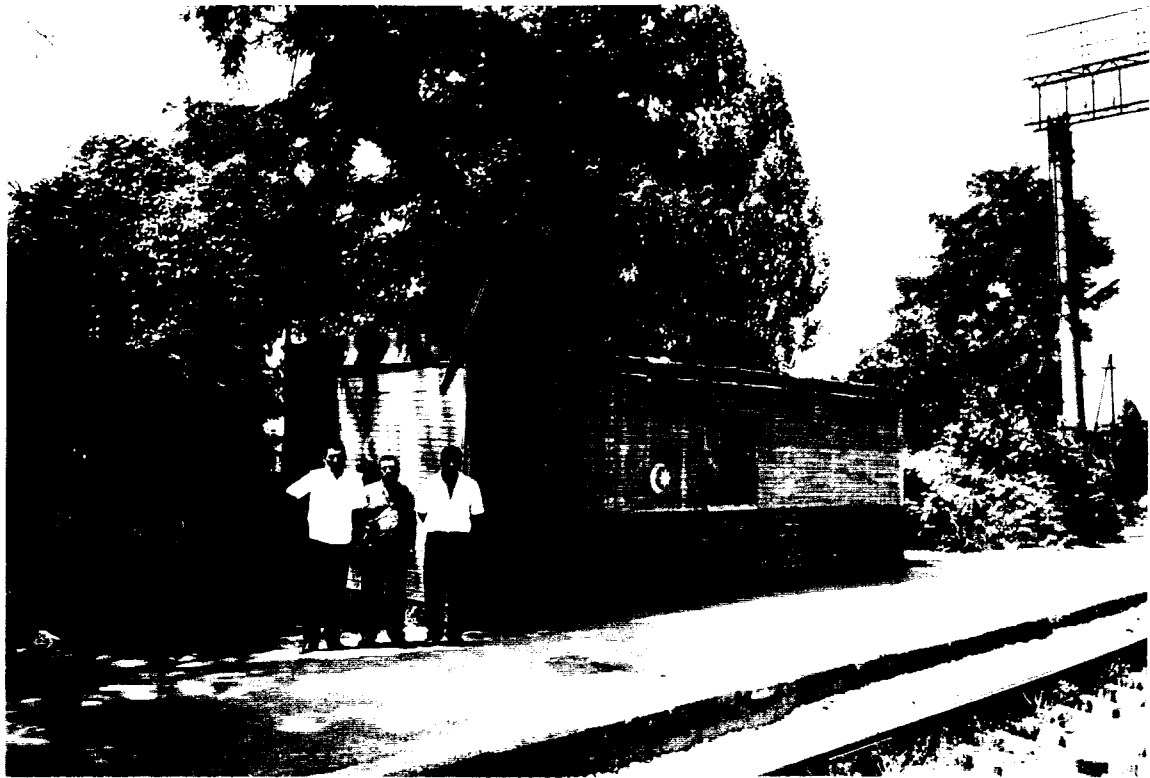
AZERBAIJAN - Yalama

Buildings No and Condition: Single building with 4 rooms and hallway including canteen and rest room. Structure in moderate condition.

- 1) Provision of a modern office building or unit.
- 2) Supply of an improved communication system.
- 3) Provision of additional detection equipment.
- 4) Supply of a printer for computer.

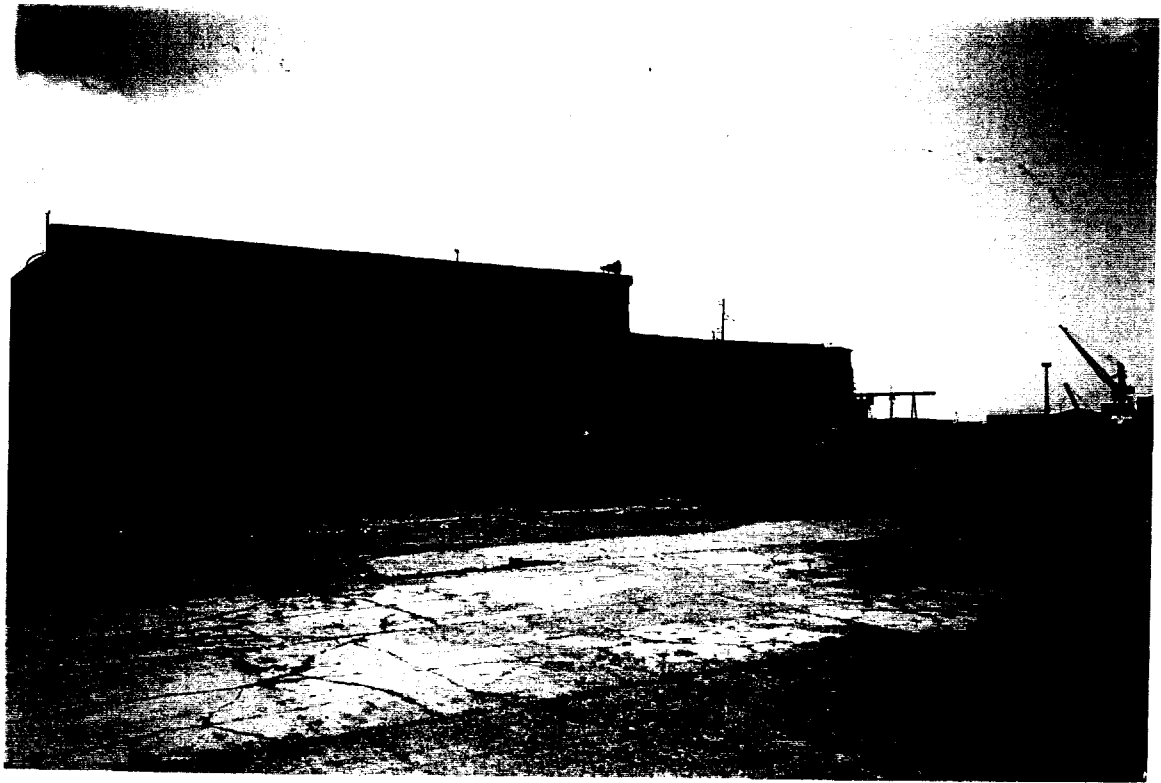
KAZAKHSTAN - Aktau

Location:	Remote location with very poor road connections. Border difficult to control as open semi-desert.
Infrastructure:	Current buildings unsatisfactory and work on the new building suspended.
Human Resources:	Adequate, though indicated as understaffed.
Equipment:	Lack of communication, detection and data processing equipment.
Procedures:	Adequate.
Performance:	Indications of slow clearance times but road conditions result in convoys thus causing bunching of arrivals for processing.
Other:	Lack of road infrastructure.

- 1) Plans for reconstruction of the port should include provision of office facilities for Customs.
- 2) Supply of a computer for registration purposes.
- 3) Provision of an independent telephone system connection to regional office in town.
- 4) Possible supply of transport to enable visits to berths. Current system reliant on use of own cars.

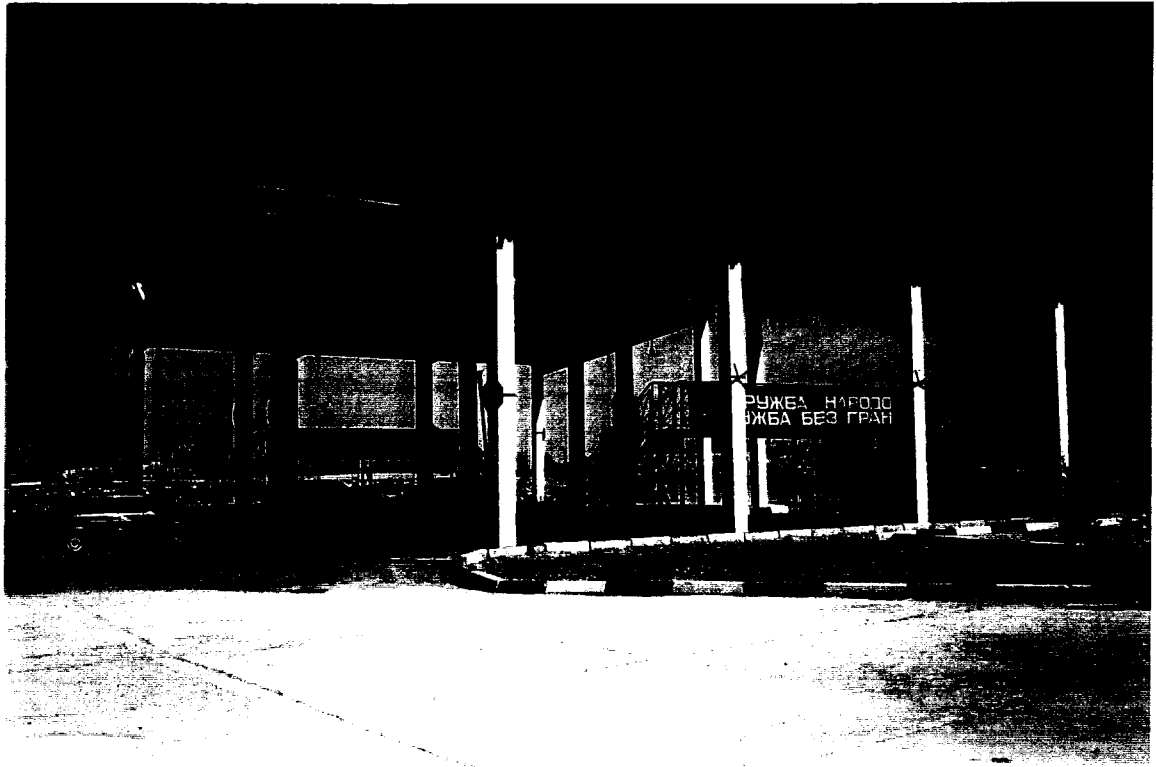
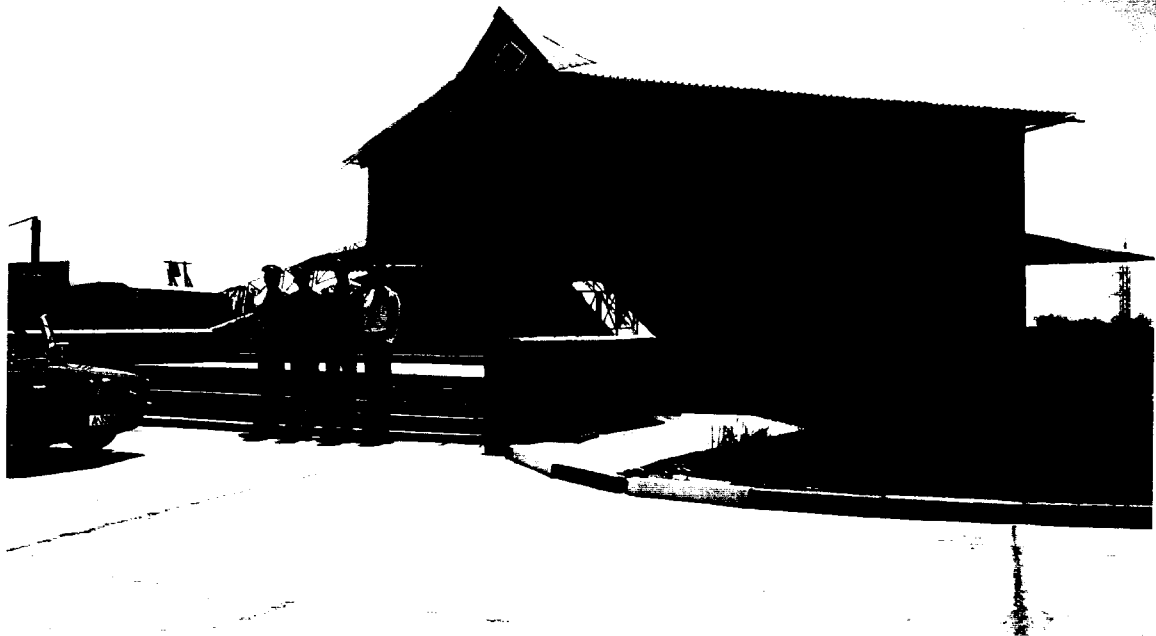
KYRGYSZTAN - Akzhol

Buildings No and Condition: New border complex provided under an aid agreement with France with technical assistance being provided by Dassault. It consists of an office block with 6 rooms, an overhead canopy, inspection pits and a weighbridge.

- 1) Fitting out of the building with office furniture.
- 2) Provision of computers for registration and possible linkage to main clearance system proposed in aid package. This will require installation of telephones and standby generator.
- 3) Supply of additional detection equipment.

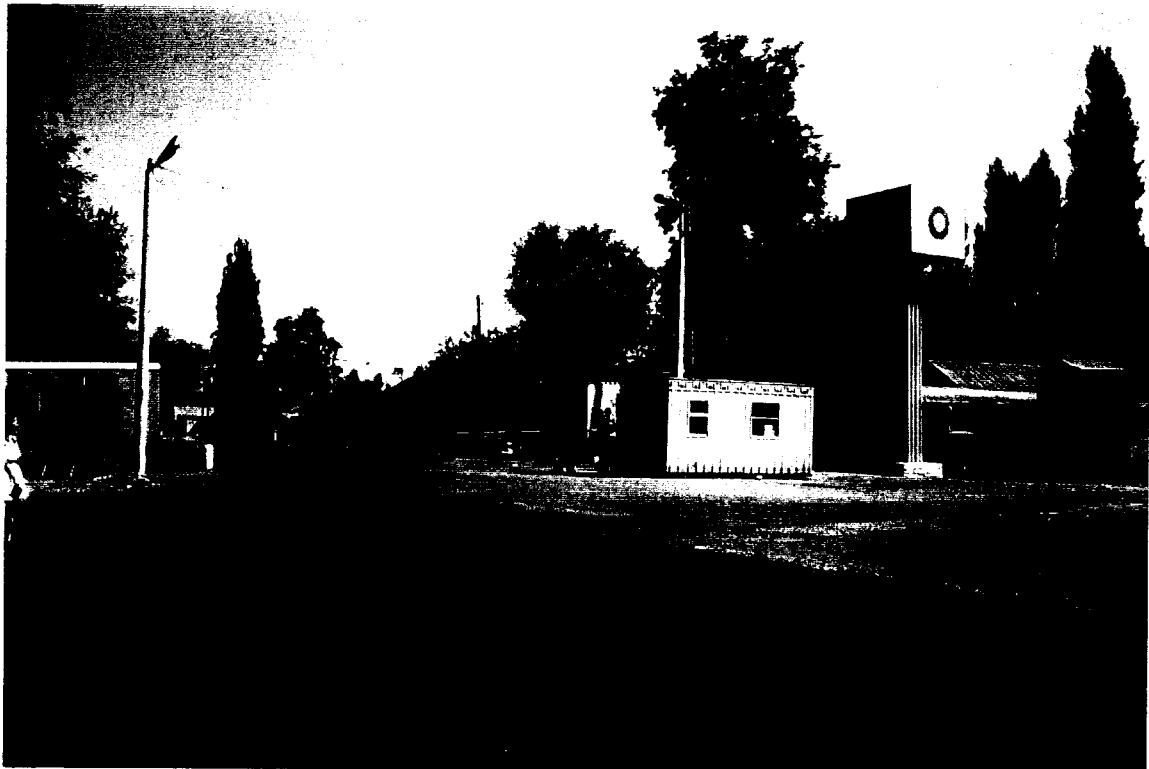
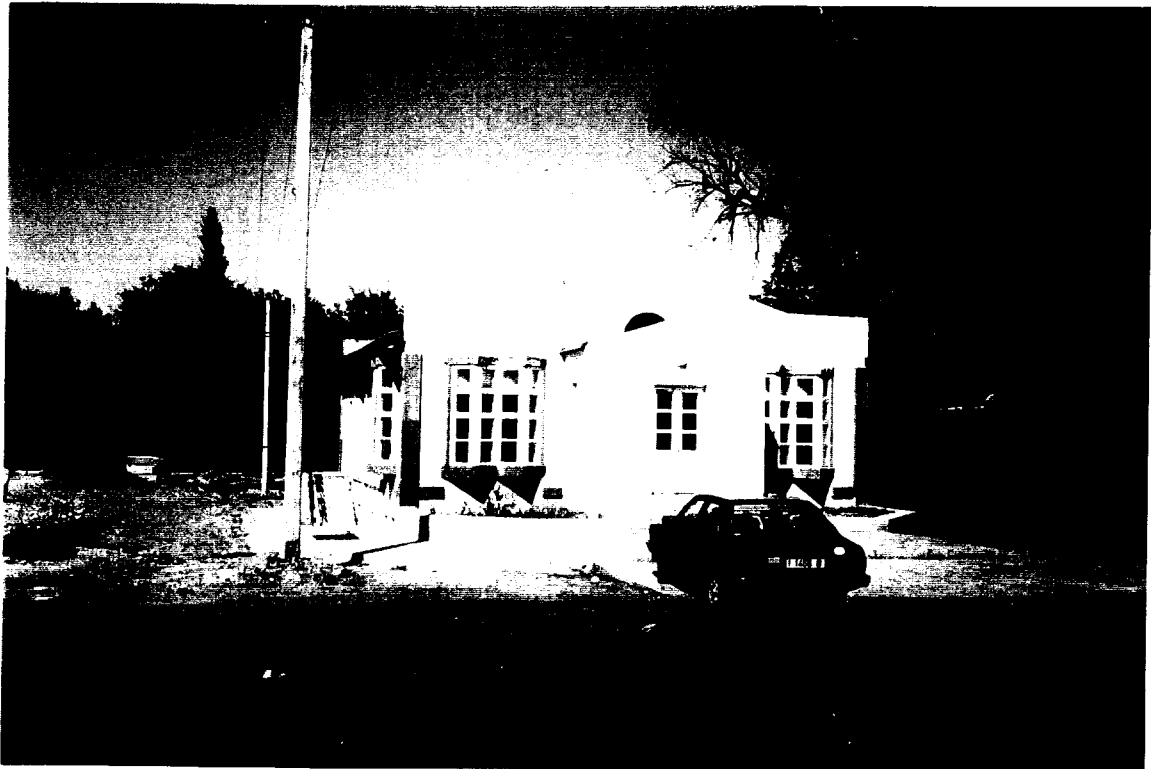
KYRGYSZTAN - Chaldovar

Office Equipment: Office furniture and safe.
Data Processing: None.
Communication Equipment: Radio link with regional office but currently broken. No telephone.
Power: Problems especially in winter.
Control/Detecting Equipment: None.

- 1) Completion of the newly built facility. This will require some refurbishment as deteriorating due to lack of maintenance.
- 2) Fitting out of new office with office furniture, a computer and reliable communication system.
- 3) Provision of a standby generator.
- 4) Supply of basic detection equipment.

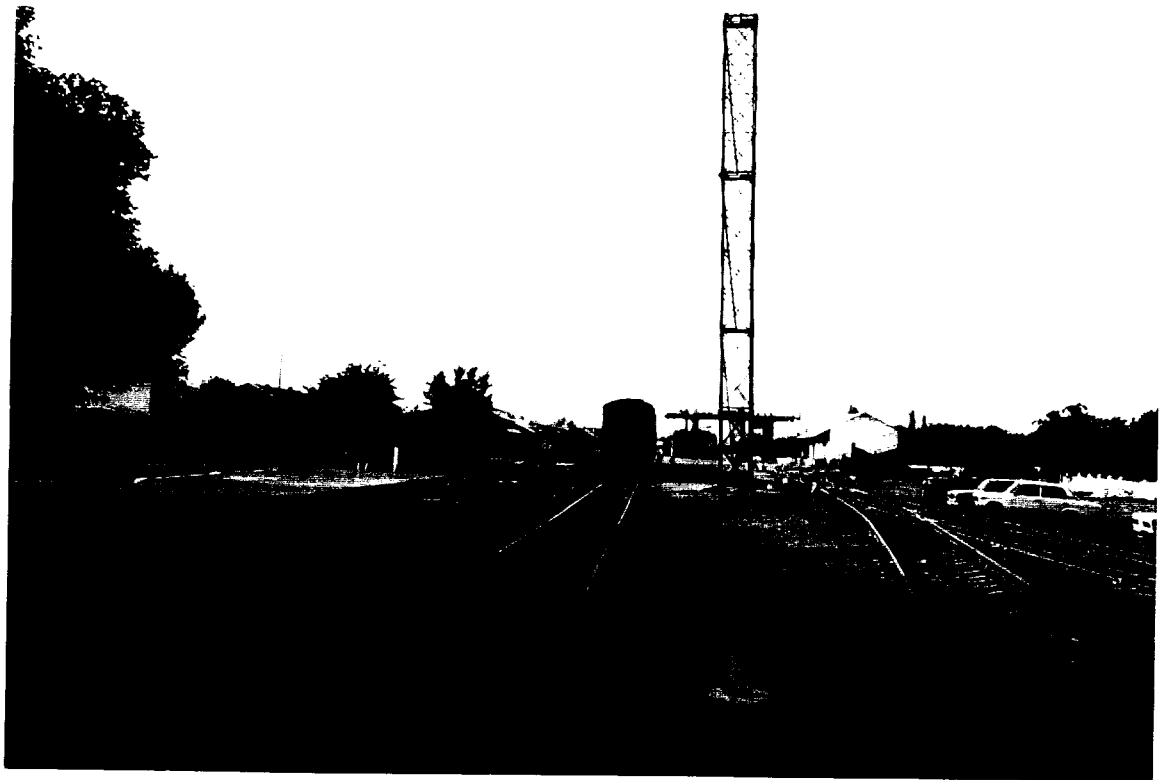
KYRGYSZTAN - Osh

Location:	Good location in main freight yard.
Infrastructure:	Building in reasonable condition but poor furnishing.
Human Resources:	Adequate.
Equipment:	Lack of data processing and detection equipment.
Procedures:	Adequate.
Performance:	Adequate.
Other:	None.

- 1) Refurbishment of office with additional room for meeting importers/exporters/forwarders.
- 2) Supply of independent communication system, rather than total reliance on rail system.
- 3) Provision of computer for registration purposes.
- 4) Supply of basic detection kit.

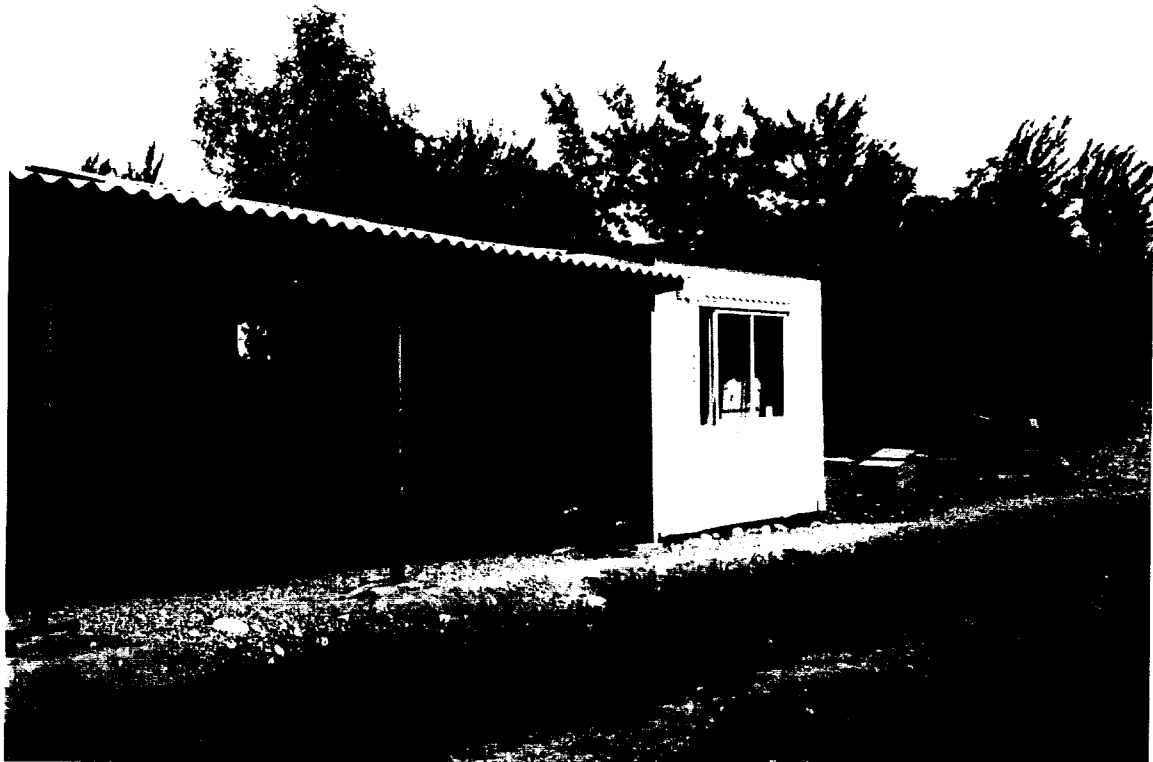
KYRGYSZTAN - Dostuk

Location:	Good location on main road.
Infrastructure:	Buildings all in poor condition.
Human Resources:	Adequate.
Equipment:	Lack of data processing, communication and detection equipment.
Procedures:	Adequate. Placing of clearance facility can delay trucks at the border but this is not major problem with current volumes.
Performance:	Adequate.
Other:	None.

- 1) Provision of new modern facilities.
- 2) Supply of reliable telephone link.
- 3) Provision of computer for registration and statistical work.
- 4) Supply of standby generator.
- 5) Provision of basic detection kit.

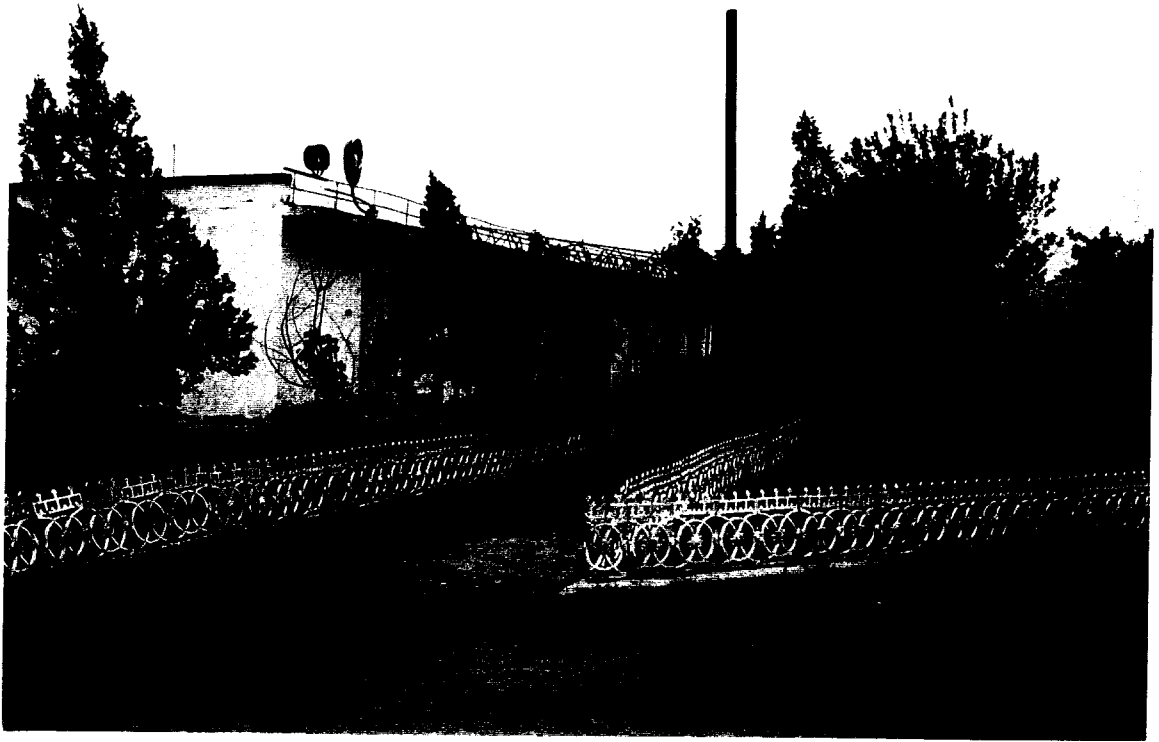
TAJIKISTAN - Hoskadi

Buildings No and Condition: One room rented from owners of rail depot. Structure sound but in need of refurbishment.

Location:	Depot is located in area with harsh climatic conditions. It is in a rail consolidation depot for cotton shipments with rail sidings. It is 200 metres away from the main line.
Infrastructure:	All services are undertaken in the single room, thus it is necessary to undertake office work in the sleeping quarters.
Human Resources:	Adequate.
Equipment:	No office or detection equipment.
Procedures:	Adequate.
Performance:	Adequate.
Other:	None.

- 1) Rented area should be refurbished to present better image and improve living conditions. Office area should be partitioned to provide separate office and rest areas.
- 2) Provision of basic office furniture and equipment.
- 3) Consideration should be given to supply of a generator and heating/air conditioning equipment.
- 4) Installation of a more reliable communication system.

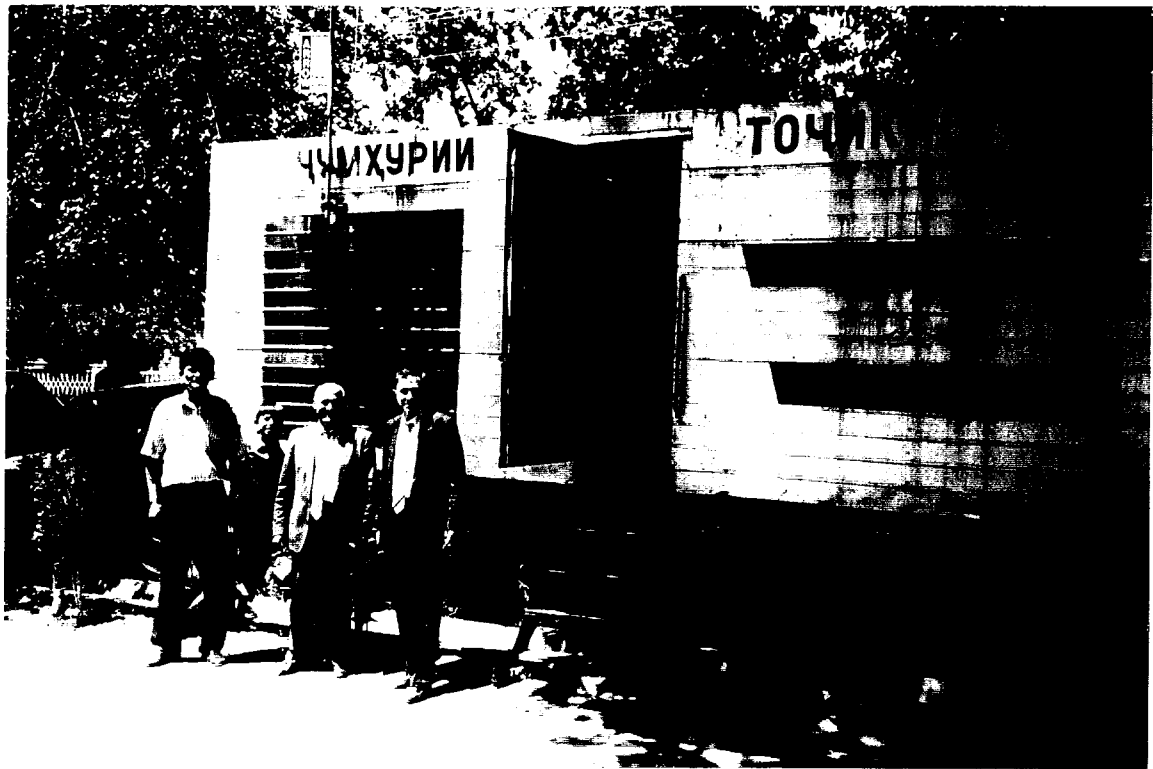
TAJIKISTAN - Pakhtbad

Location:	Located in middle of city in main marshalling yard but with poor customer access.
Infrastructure:	Inadequate temporary facilities. Plans are to rent office in new rail building on completion.
Human Resources:	Adequate.
Equipment:	Lack of both office and detection equipment.
Procedures:	Adequate.
Performance:	Export clearance could be improved but may not be significant factor.
Other:	None.

- 1) Move to new offices in rail building when they are completed.
- 2) Provide computer for registration purposes.
- 3) Supply more reliable communication system.
- 4) Provision of basic detection kits.

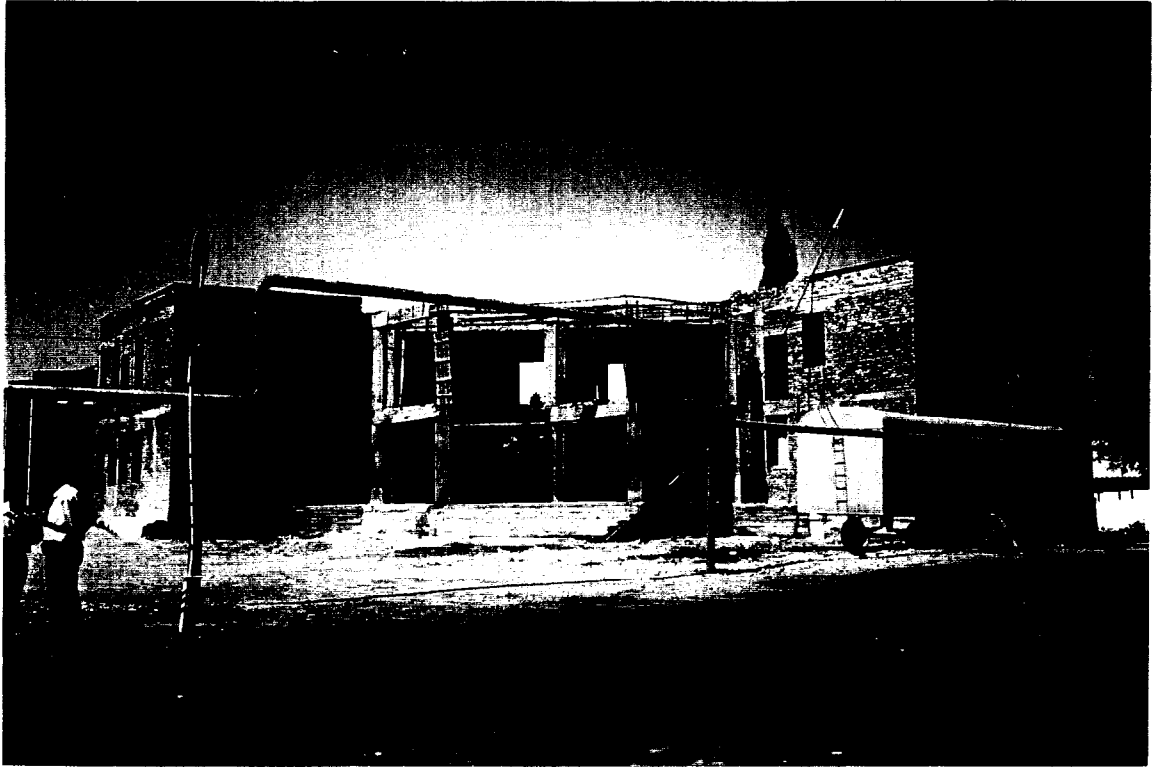
Infrastructure: Current unit in poor condition. Work on the new office block and associated warehouse has recommenced.

- 1) Complete the office block to accommodate all border services.
- 2) Investigate potential to improve telecommunications system.

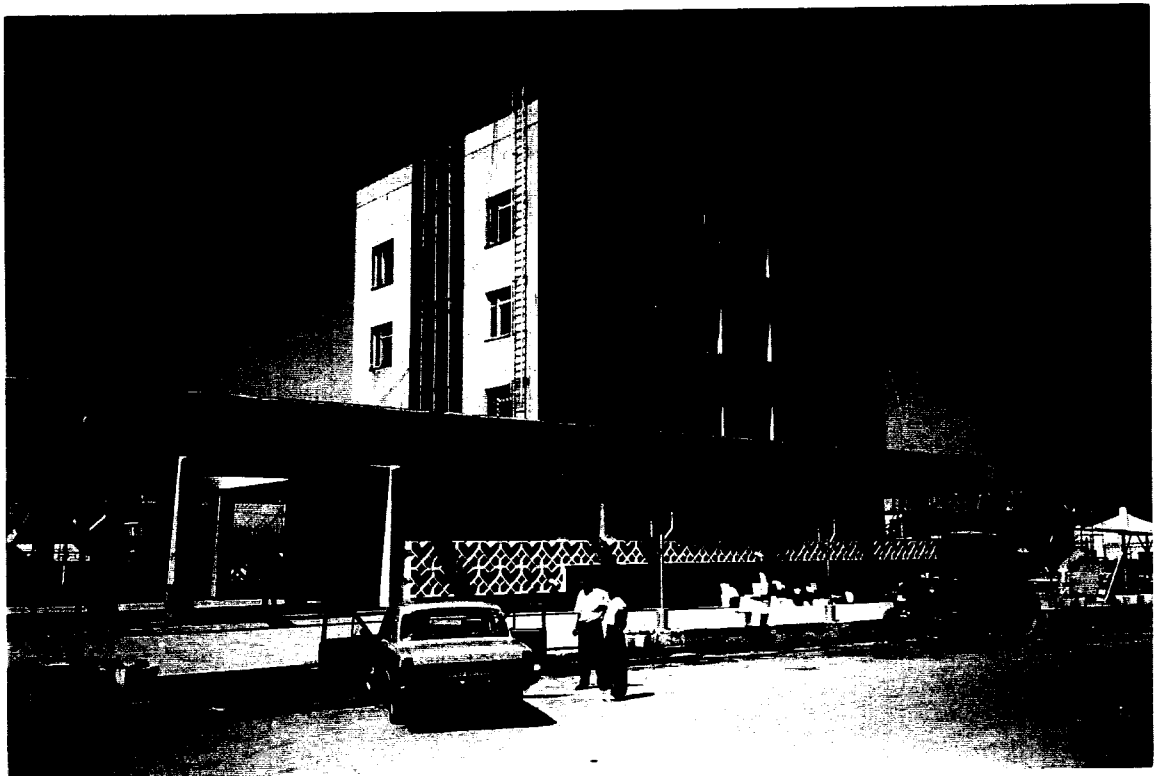
Location:	Good location in central station.
Infrastructure:	Building in reasonable condition.
Human Resources:	Adequate.
Equipment:	No computer and shortage of communication equipment.
Procedures:	Adequate.
Performance:	Adequate.
Other:	Concern was expressed as to the open access to wagon in the sidings.

- 1) Provision of computer and printers for recording of traffic movements.
- 2) Supply of additional checking equipment - metal detectors.

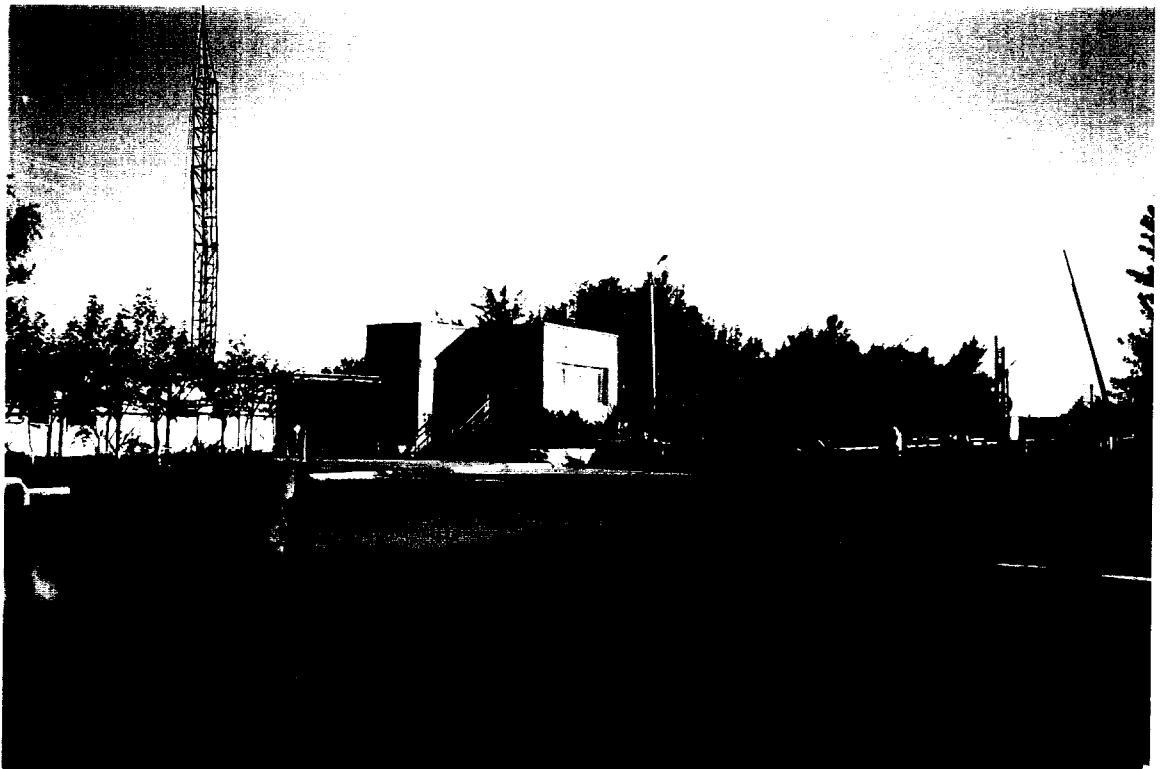
Location:	Suitable location but very poorly signed making difficult to find for inexperienced drivers.
Infrastructure:	Existing unit in poor condition. New office block under construction but work suspended.
Human Resources:	Adequate.
Equipment:	Lack of communication and data processing equipment.
Procedures:	Adequate.
Performance:	Adequate.
Other:	None.

- 1) Improvements in road signage.
- 2) Completion on new facilities.
- 3) Installation of a reliable telephone system.
