Feasibility Study of New Terminal
Facilities of the Georgian Ports Plan

Survey of the railway installations in the port of Poti

Annex 9

Review of Present Facilities under Railway Engineering Aspects

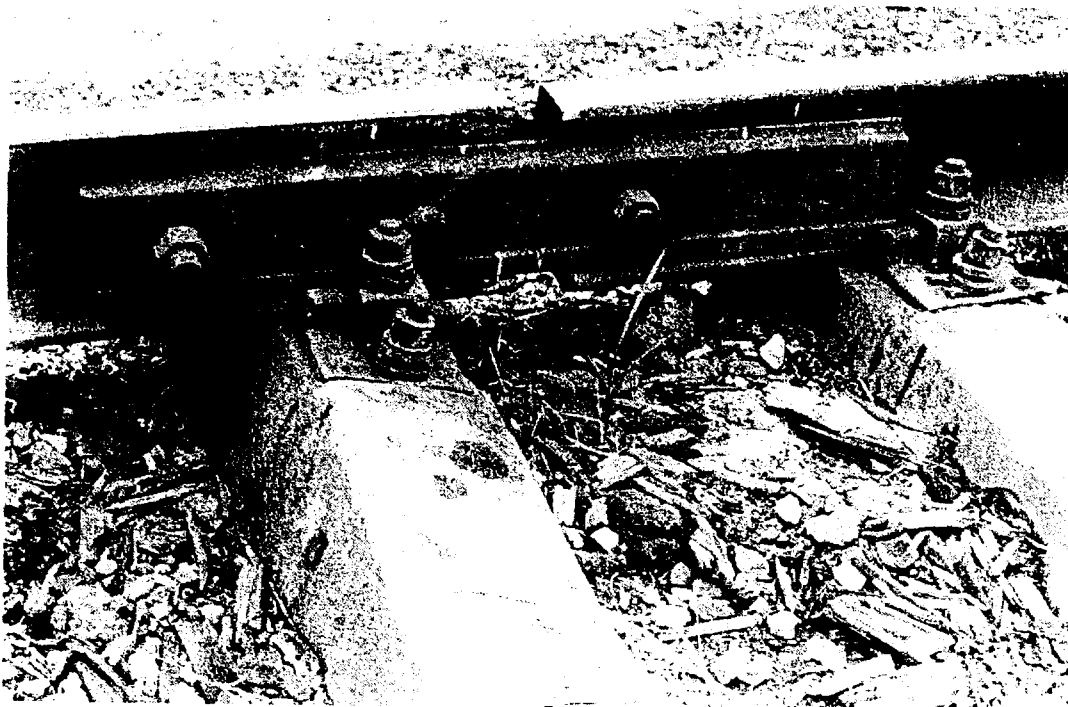
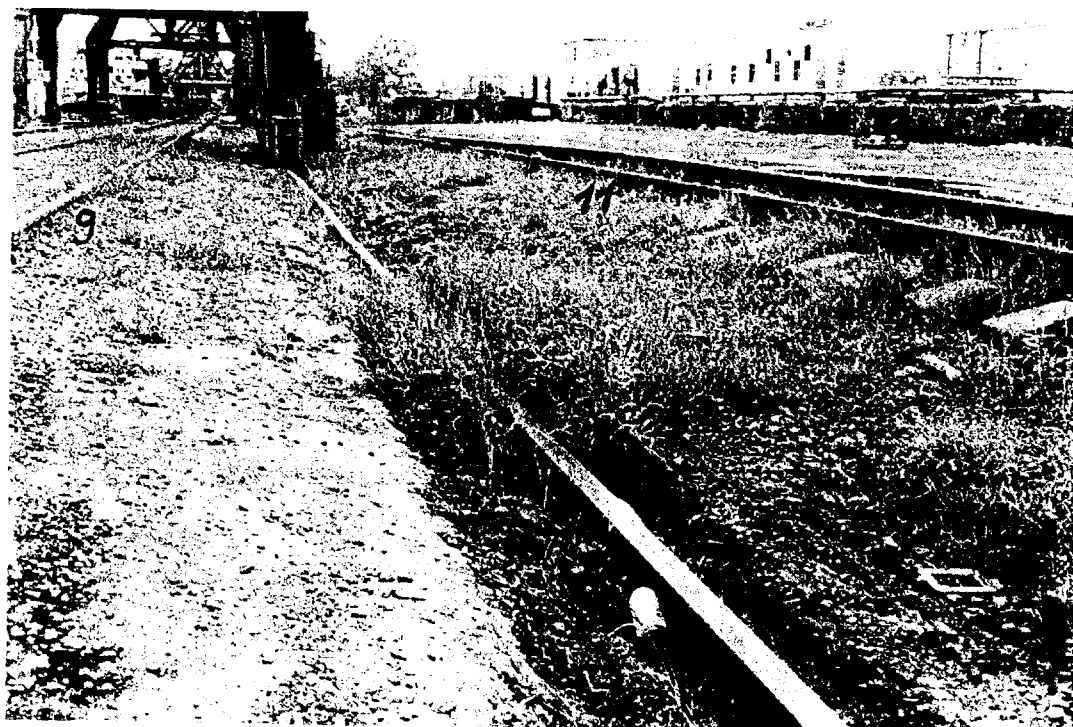
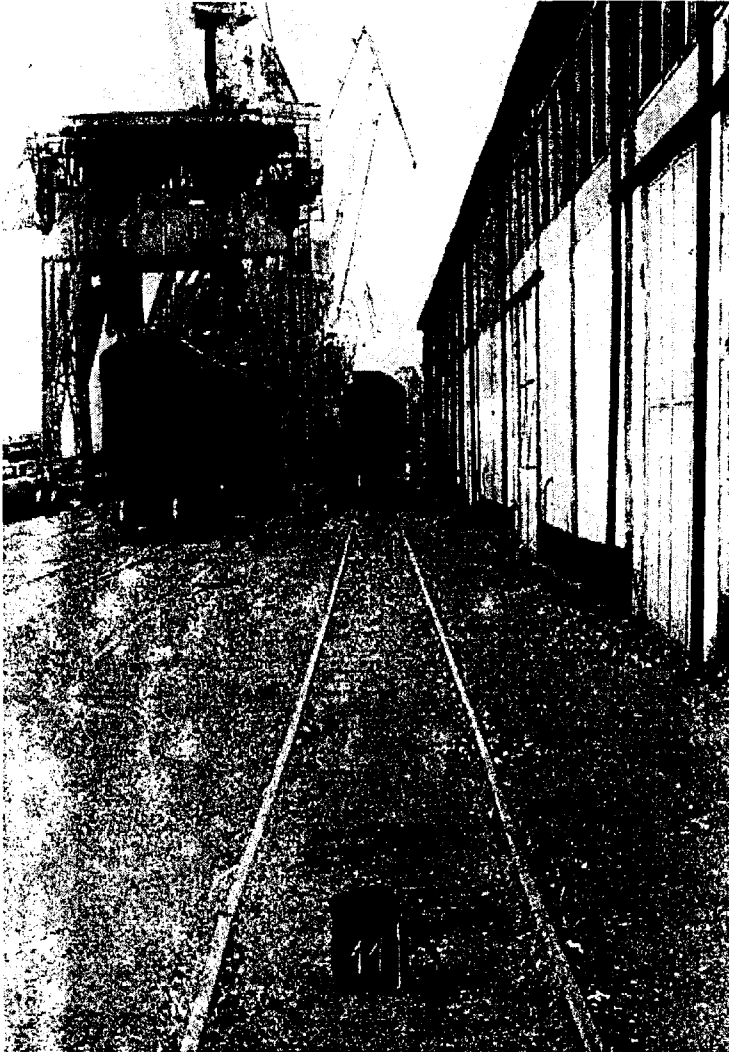
The track is covered up to the top of the head of the rails. Its level is a bit higher than the level of the crane rail.

General condition: Poor.

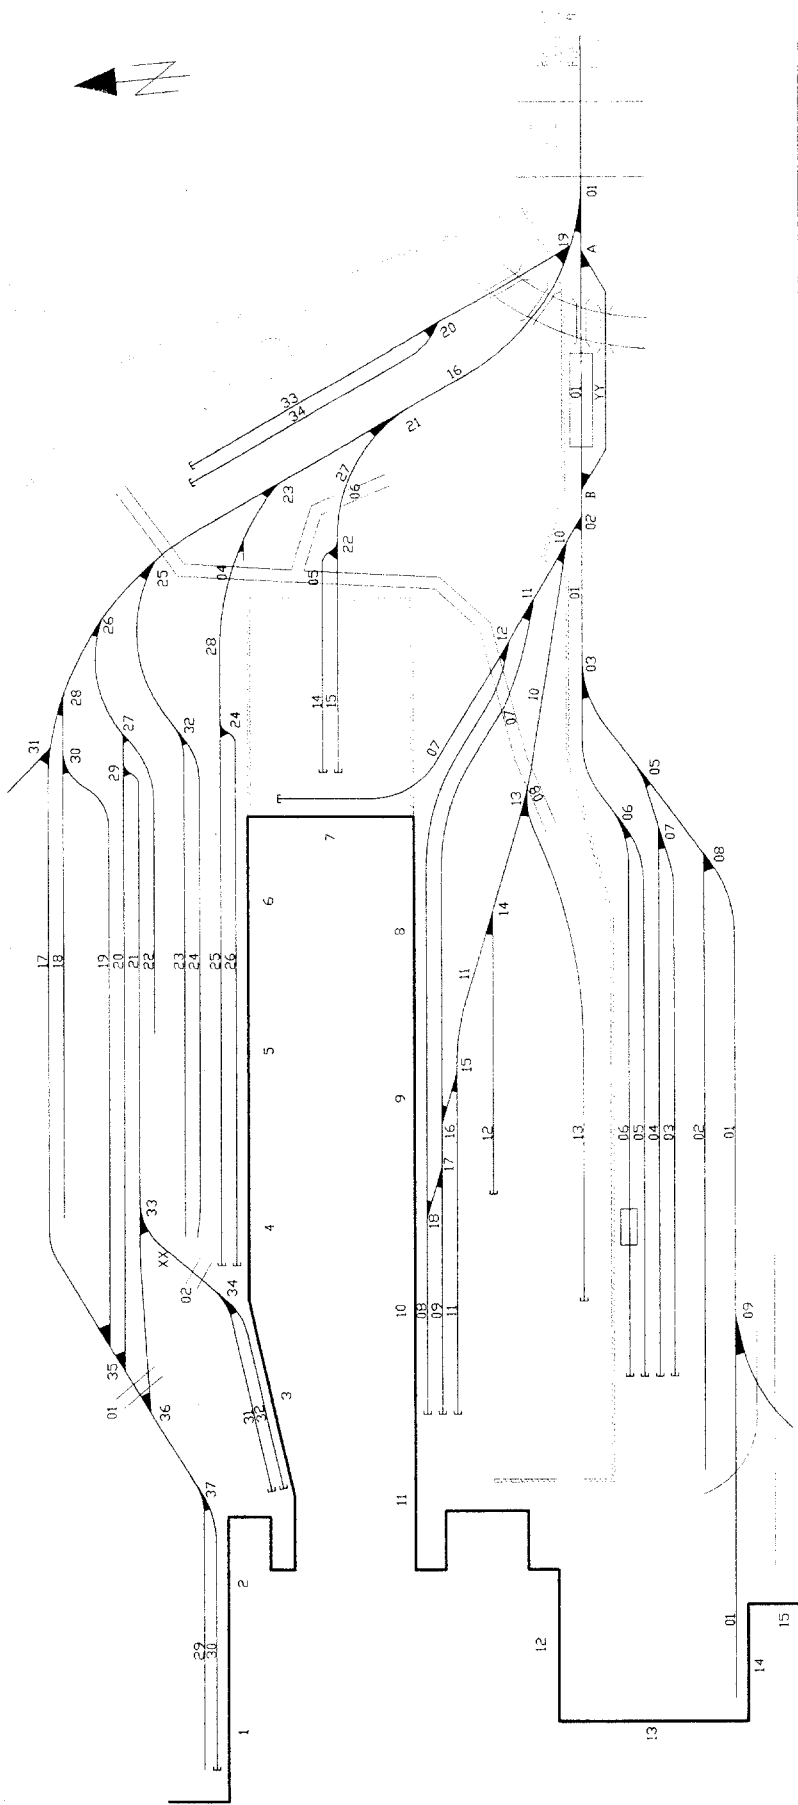
The level of the crane rails is 40 cm higher than the track.

General condition: Fair.
