Feasibility Study of New Terminal
Facilities of the Georgian Ports Plan
Survey of the railway installations in the port of Batumi
Annex 10
30 October 1997

Volume III - Annex 10

Review of Present Facilities under Railway Engineering Aspects

1 Survey of the railway installations in the port of Batumi

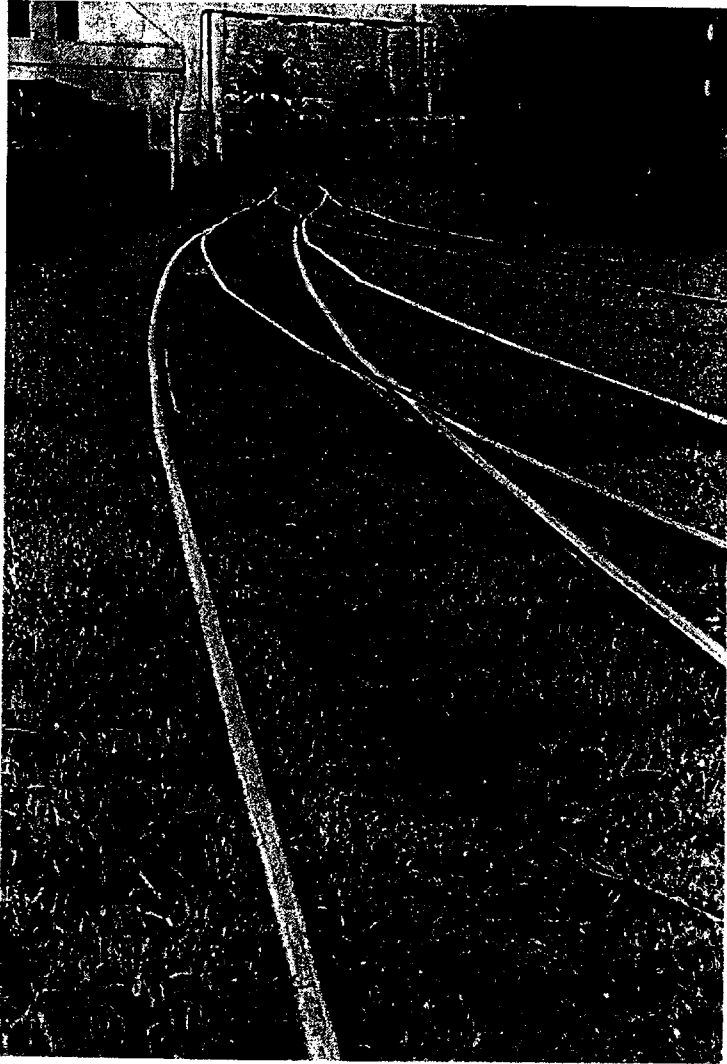
Picture: Annex - page 12

The switch turned into a switch with an internal arch. It is filled up to the top of the sleepers. The switch as well as the switching equipment and the rod channel lie in water and are very overgrown with cabbage. The water can not run off because the area is in-between a ramp and a wall. The slide chairs of the switch are nailed and the holders of the stock rails are attached by screws. The screws do not fit tight. The switch blade is broken away. The rails are worn apart and have a ridge. All fastenings are loose. In the frog part area the sleepers are partly rotten. The rails are supported by screwed-on sleepers. The top of the frog part gets stroked. The gauge is supported by holders of flat bar iron and additionally pulled in sleepers. The screwing of the holders are partly loose. The switch is heavily moving up and down during a pass over. The screwing of the lugs is loose. The joints are acute in the arch. The joint gaps are partly filled in by adapters of 15 cm length.

General condition: Poor.
