FEASIBILITY STUDY FOR THE REHABILITATION AND EXTENSION OF THE ROAD M3 CHISINAU – GIURGIULESTI/ROMANIAN BORDER

Europe Aid/125919/C/SER/MD

TABLE OF CONTENT

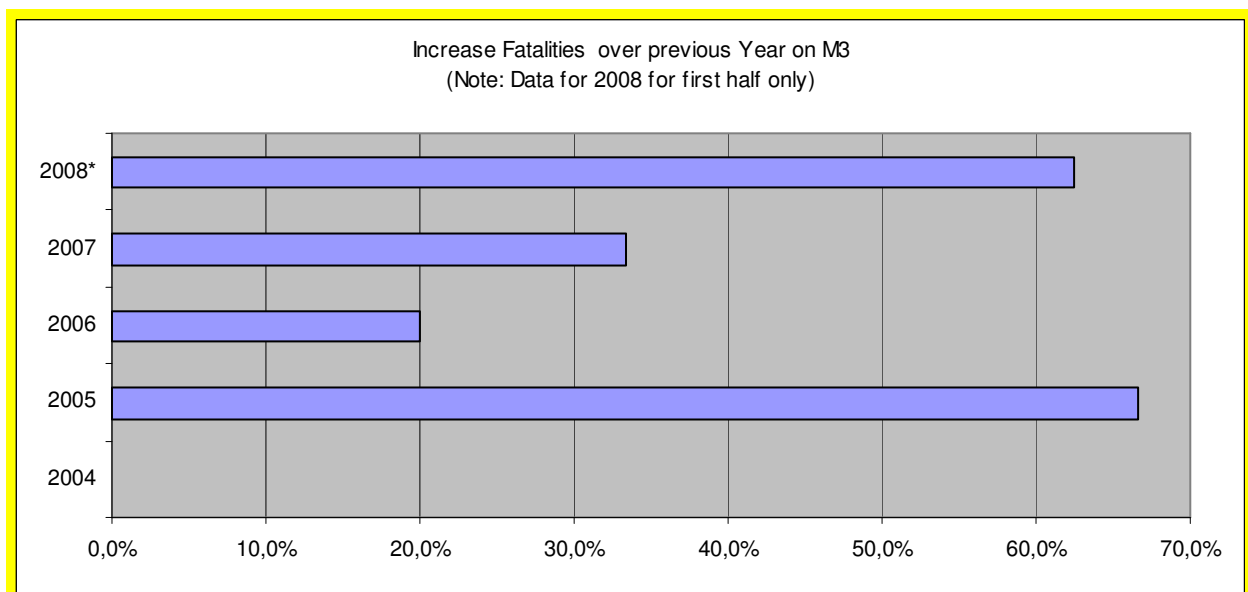
Figure 2. Increase of Fatalities over Previous Year

Noticeable is the continuous increase of fatalities relative to the previous years. Figure 2 presents the relative increase of fatalities over the previous year. In first half of 2008 7.4% of all fatalities in Moldova occurred on the M3 corridor.

Source: Consultant, data Ministry of Internal Affairs
